Protection of Floating Roof Petroleum Storage Tanks against Lightning Strokes

F. M. Mohamed, A. Y. Abdelaziz

Keywords—Crude oil, fire, floating roof tank, lightning protection system.

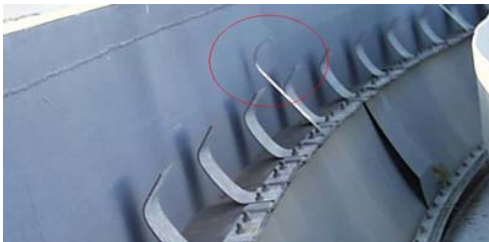
- 1) Dissipation array system (DAS) located above the telecom tower.
- 2) Spline pole system (SPS) located above lighting tower.
- 3) The shell is bonded to the tank through (shunt straps), and there was damage in some of these shunt straps; consequently, it is not connected to the tank shell as per Fig. 2.
- 4) The existing shunts are not electrically connected to the tank shell because of the heavy crude oil components, such as wax, tar, and paraffin, etc., that cover the inner wall of the tank, and thus breaking the electrical connection between the tank shell and shunts.

Fig. 2 Shunt not making contact with Out-of-Round Tank Shell [1]

- 1) The existing lightning protection system around the tank failed to absorb the lightning strokes and failed to provide a protection of the tanks against lightning strokes.
- 2) There is damage in the existing shunt strap system, and also, the tank inside wall is coated with heavy crude oil which leads to the discontinuity between the tank shell and the shunts which lead to the firing of the tank rim seal.
- 3) The company should review all the existing shunt straps, and replace the damaged shunt straps with new ones, change the tank rim seal, make necessary maintenance

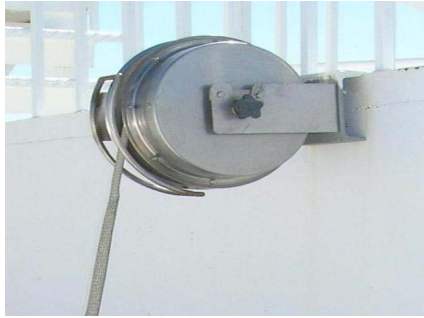
Fig. 3 LEC Retractable Grounding Assembly (RGA) on Floating Roof Tank [1]

- 3) It is also common practice to install bypass conductors between the roof and the tank spaced at intervals no more than 30 m around the circumference of the floating roof. For the new floating roof tank that shall be under our case study, it has a length of at least 49 m because the dimension of the tank (90 m diameter and 18 m in height). The installation of the bypass conductors is easy, inexpensive, and can be installed on both new and existing tanks. The bypass conductors shall have an impedance that is less than that of presented by shunts, so it shall attract the intermediate and long-duration component of the lightning-stroke current to pass through it rather than the shunts. However, the bypass conductor end-to-end voltage may be so high as to cause a dielectric breakdown of the insulating surrounding air. This lead the tank owners to use a retractable conductor wound on a spring-tensioned reel (RGA), instead of the standard conductor. Lightning Eliminators & Consultants (LEC) [1], has developed a roof-shell bonding mechanism (RGA) which is better than the conventional type of bypass conductor. RGA is complete with a spring to retract the conductors on the wheel. The length of the bypass conductor is always keeping the minimum length regarding the location of the floating roof at the top or the bottom of the tank. Also, a typical retractable grounding assembly (RGA) of floating roof tank is shown in Fig. 3. Due to the large diameter of the floating roof tanks (FRT's), and order to increase the electrical connection between the roof and the shell of the FRT, it is recommended to install multiple RGA's on the floating roof tank. The RGA should be installed at intervals no more than 30 m around the circumference of the floating roof [1]: so, in our case, the recommended number of RGA's shall be not less than 10 m, as the tank diameter is 90 m, and the circumference is about 285 m. Although RGA is better than conventional cables, it provides optimal solution for the tank protection against lightning

- 4) Installation of the retractable bypass conductor (RGA's), in addition to the existing shunt straps system, can be installed to existing and new tanks in the future.
- 5) Checking that all the tanks in the zone of the tank fire are connected to the earthing network, as per the applicable code.
- 6) Installation of an Early Streamer Emission (ESE) air terminal system on the tank shell according to the tank diameter.
- 7) Performing lightning risk assessment analysis for the new floating roof tanks that shall be installed in areas subjected to frequent lightning activity.
