Assessing the Sheltering Response in the Middle East: Studying Syrian Camps in Jordan

Lara A. Alshawawreh, R. Sean Smith, John B. Wood

Abstract—This study focuses on the sheltering response in the Middle East, specifically through reviewing two Syrian refugee camps in Jordan, involving Zaatari and Azraq. Zaatari camp involved the rapid deployment of tents and shelters over a very short period of time and Azraq was purpose built and pre-planned over a longer period. At present, both camps collectively host more than 133,000 occupants. Field visits were taken to both camps and the main issues and problems in the sheltering response were highlighted through focus group discussions with camp occupants and inspection of shelter habitats. This provided both subjective and objective research data sources. While every case has its own significance and deployment to meet humanitarian needs, there are some common requirements irrespective of geographical region. The results suggest that there is a gap in the suitability of the required habitat needs and what has been provided. It is recommended that the global international response and support could be improved in relation to the habitat

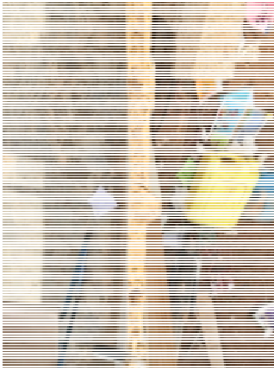
Fig. 4 A section in the wall [13]

- **Walls and roofs:** The prefabricated shelters were made from polyurethane insulated sandwich panels. A section of the wall can be seen in Fig. 4, which was recycled from a shelter's wall and used as a side garden fence. The shelters' quality differs from one to another, but the majority have weaknesses in building fabric leading to air,

dust and water ingress. This is a contributing source towards health problems affecting camp residents.

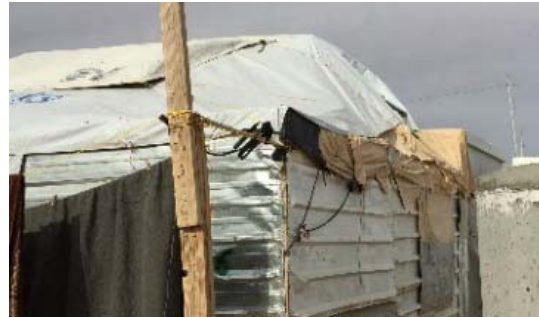
Fig. 6 Extended area example [13]

In an attempt to seal the shelters, especially the roof-wall junctions (Fig. 5), the residents covered the roofs using fabrics they had or bought them, if they could afford them. Some families also tried to expand their shelters by enclosing a space using corrugated sheets and then covered it with fabric,

which is not a durable solution and cannot replace a proper roof (Fig. 6). The expanded area fulfilled some major needs such as providing separated sleeping areas for different genders and ages within the family, or providing a separate area for socializing and receiving guests. Social interaction can be an important aspect to communities in general. This is perhaps more critical for refugees to assist interaction and alleviate the trauma of leaving their home and country.

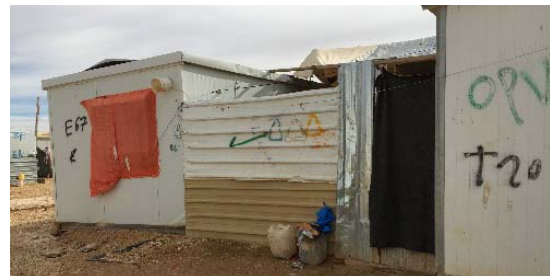
Fig. 7 A covered window to protect the privacy [13]

ventilation function of the shelters. Residents covered their windows from the outside or from the inside (Fig. 7) due to passers-by being able to look into the shelter. Residents stated that having privacy was a necessity and a priority and aligned strongly with cultural and religious beliefs.

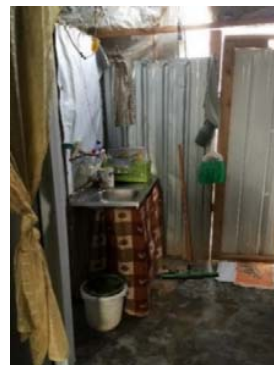
Fig. 8 Self-built kitchen [13]

- *Facilities:* When the camp was first opened, the kitchens and toilets provided were communal. Problems occurred when using such communal facilities from both cultural and privacy/security perspectives. It was found that when residents could afford some materials, they adapted and self-built private facilities adjacent to their shelters. These adaptations included enclosing additional space with corrugated sheets, wood and canvas, if the residents were able to afford materials (Figs. 8 and 9).
- *Outdoor areas:* The courtyard is an important cultural feature in Syrian homes and enclosing an outdoor space

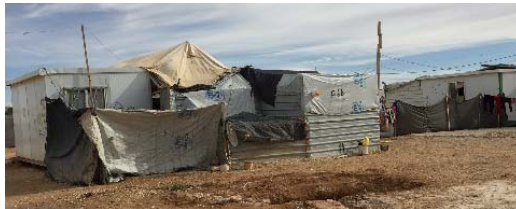
Fig. 10 Private outdoor area [13]

was found to be very important to the camp residents. They often enclosed a space next to their shelter or between two shelters with canvas or corrugated sheets, as shown in Fig. 10. One of the main benefits of such a private area was for women residents to have access to an outside space. This provided safety, privacy and aligned to their cultural needs.

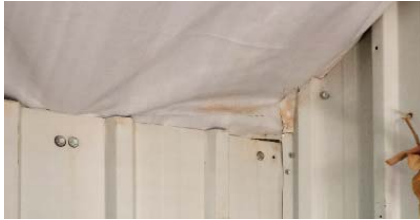
Fig. 14 Sharp edges in cladding [15]

- **Walls and roofs:** The junctions between the walls and the roof are not well-sealed and were found to leak water and dust. Residents mentioned they preferred a flat roof rather than a pitched roof, as they thought this would be easier to seal and it was more familiar to them. Due to the camp's strict policies regarding making any changes to the shelters, residents could not change the roof. The wall heights were low; however, the pitched roof design did provide more head-room. The overlapping of the internal metal cladding sheets resulted in sharp edges, as shown in Fig. 14, and residents had stated that injuries had occurred.

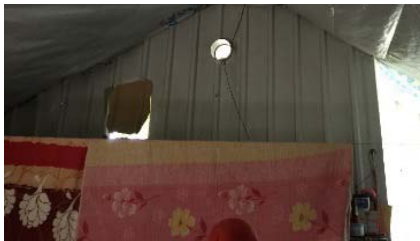
Fig. 15 Blanket dividers [15]

The shelter is a basic design involving a one-room plan. The original design had indicated 'partitioning wires' to support fabric room dividers, but were never installed. Residents believe that it is not acceptable culturally nor religiously to have different ages and genders sleeping in the same room. They erected their own fabric dividers using their own sheets or blankets as and when required (Fig. 15).

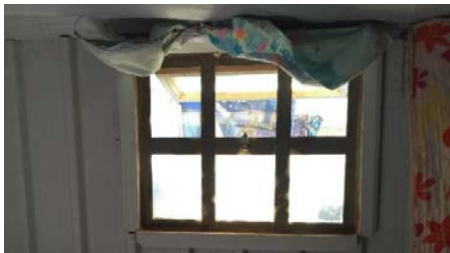
Fig. 16 The T-shelter window [15]

- *Windows:* Shelters in Azraq camp have only one small window (Fig. 16). The problem is increased as residents close their windows and shade them using fabrics because they directly overlook public areas or other residents' windows and do not provide adequate privacy.

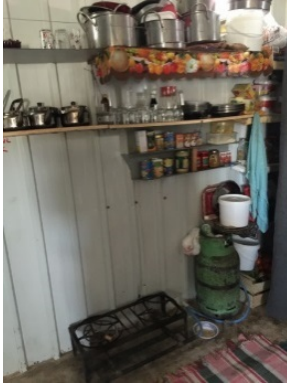
Fig. 20 Kitchen tools [15]

The residents were not provided with private or communal kitchens. Cooking equipment was given to residents to utilize in a corner of their shelters as a kitchen space. This included stoves and gas cylinders as shown in Fig. 20. Cooking inside the shelters was one of the causes behind the respiratory problems the residents had mentioned.

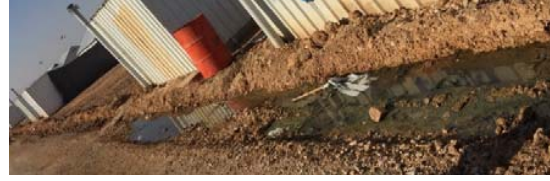
Fig. 23 Surface runoff wastewater [15]

- **Drainage:** The absence of a drainage system is a problem in the Azraq camp. The residents formed ditches to outside pits and aligned different ditches to form a network of surface wastewater channels adjacent to the streets, as shown in Fig. 23. In addition to hygiene problems, it also leads to accessibility issues for people with special needs and elderly, trying to cross over the wastewater.
