# Reinforced Concrete Bridge Deck Condition Assessment Methods Using Ground Penetrating Radar and Infrared Thermography

Nicole M. Martino

**Abstract**—Reinforced concrete bridge deck condition assessments primarily use visual inspection methods, where an inspector looks for and records locations of cracks, potholes, efflorescence and other signs of probable deterioration. Sounding is another technique used to diagnose the condition of a bridge deck, however this method listens for damage within the subsurface as the surface is struck with a hammer or chain. Even though extensive procedures are in place for using these inspection techniques, neither one provides the inspector with a comprehensive understanding of the internal condition of a bridge deck – the location where damage originates from. In order to make accurate estimates of repair locations and quantities, in addition to allocating the necessary funding, a total understanding of the deck's deteriorated state is key. The research presented in this paper collected infrared thermography and ground penetrating radar data from reinforced concrete bridge decks without an asphalt overlay. These decks were of various ages and t

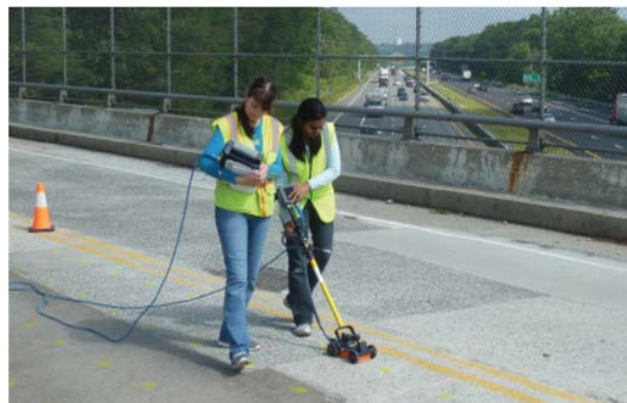
Fig. 2 Picture two of GPR data collection

Ground penetrating radar works by sending electromagnetic pulses through the subsurface of the deck with a high frequency antenna that travels over the deck, and in the direction of vehicular traffic. When those pulses come into contact with a material of differing dielectric property, like the concrete rebar interface, some of the signal is scattered and captured by the antenna’s receiver. Two examples of data collection using this method can be seen in Figs. 1 and 2.
