Triplet Shear Tests on Retrofitted Brickwork Masonry Walls

Berna Istegun, Erkan Celebi

Keywords—Triplet shears tests, retrofitting, seismic fabric, perforated brickwork, expanded glass granular.

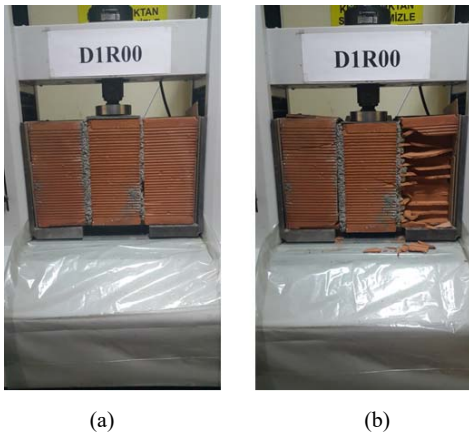
Fig. 6 (a) Initial state and (b) final state of D1R00-2

Similarly, triplet shear tests were performed for the D1R00-2 and D1R00-3 and the resulting crack forms are shown in Figs. 6 and 8, respectively.

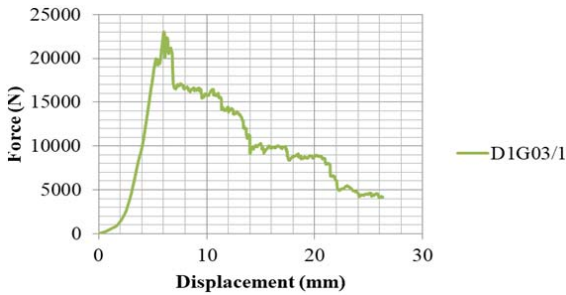
Fig. 11 Force-displacement diagram of the D1G03-1

As shown in Fig. 11, the maximum shear force F_{max} is obtained as 23033 N and the corresponding shear stress value f_v is calculated as 0.209 MPa for specimen of D1G03-1.

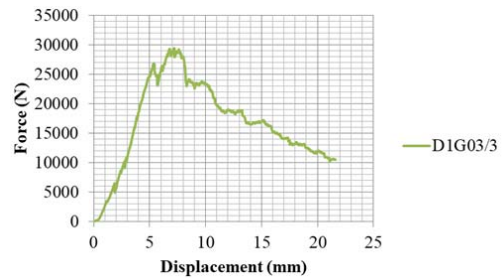
Fig. 15 Force-displacement diagram of the D1G03-3

For the D1G03-2 and D1G03-3 specimens; crack patterns, maximum shear loads and strength parameters were similarly determined. The failure mechanism of the test specimens under the vertical load is shown in Figs. 12 and 14. The maximum shear forces of the second and third sample of the D1G03 test set are equal to 24548 N and 29427 N, respectively (Figs. 13 and 15).

The values of f_v are 0.220 MPa and 0.267 MPa for D1G03-2

and D1G03-3, respectively. Single-sided retrofitted triplets exhibited more ductile behavior when compared to the reference samples. Furthermore, it was clearly observed that the unilateral strengthening application significantly increased the shear capacity of the masonry building units. The measured value of F_{max} is 32611 N for this case. Also, f_v is calculated as 0.296 MPa. The curve of force-displacement relationship for D1G04-T/1 is depicted in Fig. 17.
