# The Fracture Resistance of Zirconia Based Dental Crowns from Cyclic Loading: A Function of Relative Wear Depth

**Abstract**—This *in vitro* study focused on investigating the fatigue resistance of veneered zirconia molar crowns with different veneering ceramic thicknesses, simulating the relative wear depths under simulated cyclic loading. A mandibular first molar was prepared and then scanned using computer-aided design/computer-aided manufacturing (CAD/CAM) technology to fabricate 32 zirconia copings of uniform 0.5 mm thickness. The manufactured copings then veneered with 1.5 mm, 1.0 mm, 0.5 mm, and 0.0 mm representing 0%, 33%, 66%, and 100% relative wear of a normal ceramic thickness of 1.5 mm. All samples were thermally aged to 6000 thermo-cycles for 2 minutes with distilled water between 5 °C and 55 °C. The samples subjected to cyclic fatigue and fracture testing using SD Mechatronik chewing simulator. These samples are loaded up to  $1.25 \times 10^6$  cycles or until they fail. During fatigue testing, extensive cracks were observed in samples with 0.5 mm veneering layer thickness. Veneering layer thickness 1.5-mm group and 1.0-mm group were not different in terms of resis

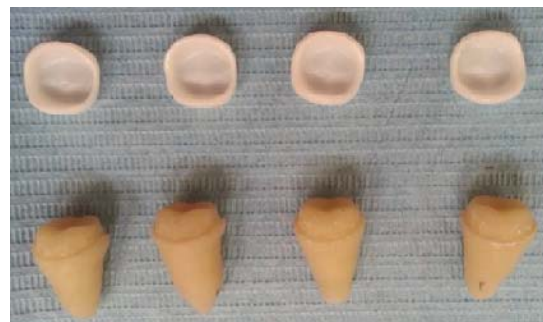
Fig. 2 Lateral view of fabricated abutments

To reduce shrinkage stress and cuspal deflection, the crown-fitting surface was filled with resin-based composites using the incremental layering technique buildup, and consequently, optimal adaptation to the crown can be achieved [17]. Each layer (about 2 mm thickness) was light cured for 40 seconds according to manufacturer's instructions using light curing device at 450 nm. The dies had a length not less than 8 mm below the gingival line to be able to embed them in the acrylic resin, and were checked visually to determine whether voids and defects are present, as shown in Fig. 2.

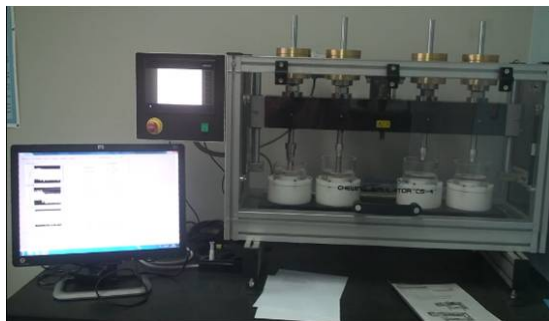
Fig. 3 Chewing simulator with the testing system's computer monitoring software

Specimens were subjected to cyclic fatigue and fracture testing using CS-4.2 SD Mechatronik chewing simulator (SD Mechatronik, Germany) as shown in Fig 3. The chewing simulator contains four test chambers, each chamber having an individual weight with a loading bar. A transverse bar that is mechanically driven by a stepping motor controls the horizontal and vertical movement links all bars. All chambers were filled with room temperature distilled water. To simulate the excursive movement of the human jaw, the sample's

buccal surface was mounted facing forward with the direction of the lateral. The simulator's movement is normally based on four biaxial movements: downward movement of the antagonist, lateral movement of the X-axis, upward movement and then movement of the X axis back to the starting point.
