Performance Analysis of Ferrocement Retrofitted Masonry Wall Units under Cyclic Loading

Raquib Ahsan, Md. Mahir Asif, Md. Zahidul Alam

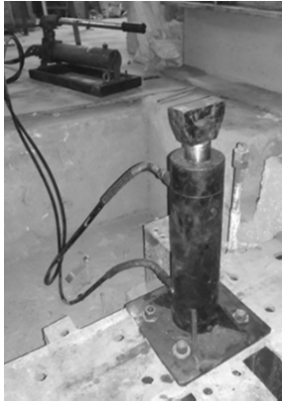
Fig. 5 Hydraulic Jack

After completion of preparation, the walls were ready to be tested by testing machine. A hydraulic jack was used to apply cyclic load to the specimens as showed in Fig. 5. The hydraulic jack was pressure operated and its maximum capacity was 150 Mpa. Two M-shaped steel frames were also used in this experiment. One steel frame was attached with the hydraulic jack.

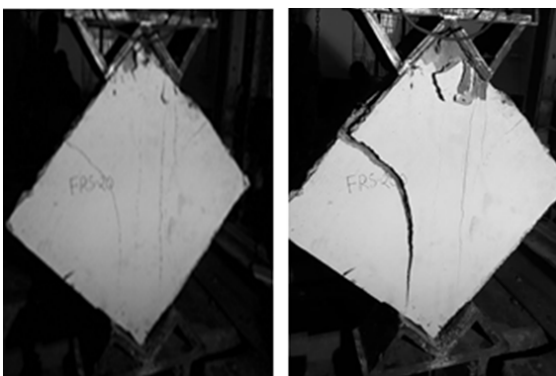
Fig. 11 (a) First Crack Pattern and (b) After Failure State of FRS-20

After applying partially reversed cyclic load on FRS-20, First crack on the surface occurred on the surface along the diagonal as shown in Fig. 11 (a) at the load of 258.79 KN during 5th cycle under compression and corresponding deformation was 5.7 mm. Gradually this crack extended further along the diagonal and was accompanied by a series of small cracks. Finally complete failure of the specimen occurred along the diagonal as shown in Fig. 11 (b) at the load of 280.59 KN and corresponding deformation was 5.9 mm. Failure occurred due to both mortar joint failure and brick

failure under compression.

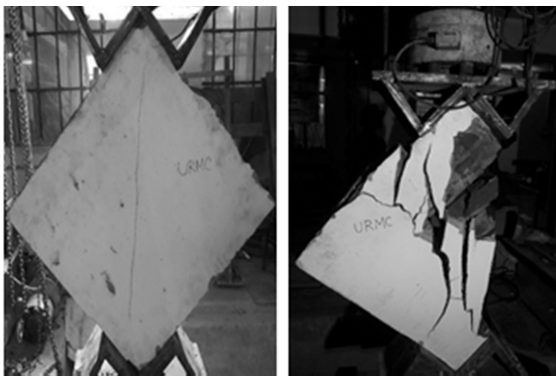
Fig. 12 (a) First Crack Pattern and (b) After Failure State of URM

After applying cyclic compression on URM, first crack appeared on the surface along the diagonal of the specimen as shown in Fig. 12 (a) at the load of 217.49 KN during 4th cycle under compression and corresponding deformation was 4.69 mm. Crack started to extend along the diagonal with the increment of load. Finally failure occurred by diagonal splitting of the specimen as shown in Fig. 12 (b) at the load of

248.61 KN and corresponding deformation was 4.93 mm. Failure occurred along the mortar joint.

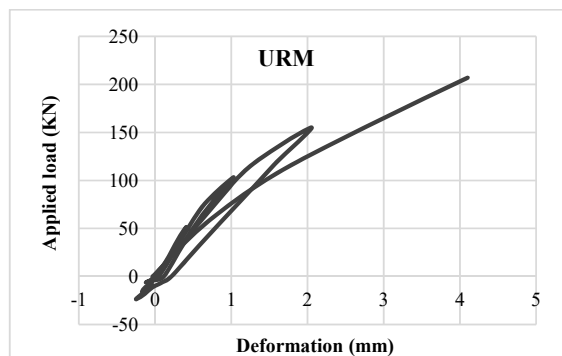
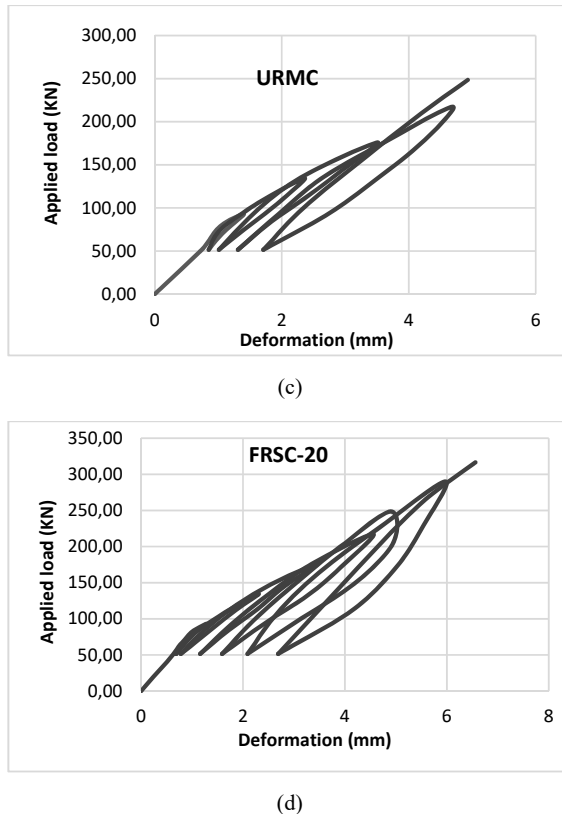
Fig. 14 Load-Deformation graph of (a) URM (b) FRS-20 (c) URM (d) FRSC-20

The load-deformation curves of all specimens are expressed in Fig. 14.

It is obtained from the graph that stiffness of the ferrocement retrofitted specimens is greater than the control specimens. The ferrocement retrofitted specimens also showed greater ductility. Stiffness of both retrofitted specimens and control specimens decreases with the increment of each cycle.
