# Evaluation of Cast-in-Situ Pile Condition Using Pile Integrity Test

**Abstract**—This paper presents a case study on a pile integrity test for assessing the integrity of piles as well as a physical dimension (e.g., cross-sectional area, length), continuity, and consistency of the pile materials. The recent boom in the socio-economic condition of Bangladesh has given rise to the building of high-rise commercial and residential infrastructures. The advantage of the pile integrity test lies in the fact that it is possible to get an approximate indication regarding the quality of the sub-structure before commencing the construction of the super-structure. This paper aims at providing a classification of cast-in-situ piles based on characteristic reflectograms obtained using the Sonic Integrity Testing program for the sub-soil condition of Narayanganj, Bangladesh. The piles have been classified as 'Pile Type-1', 'Pile Type-2', 'Pile Type-3', 'Pile type-4', 'Pile Type-5' or 'Pile Type-6' from the visual observations of reflections from the generated stress waves by striking the pile head with a handheld hammer. With respect to construction quality and integrity, piles have been furthe

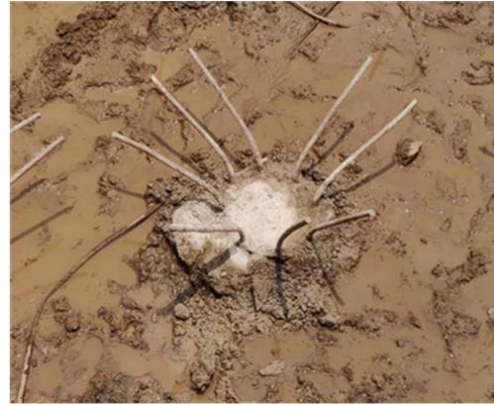
Fig. 2 Condition of prepared pile head

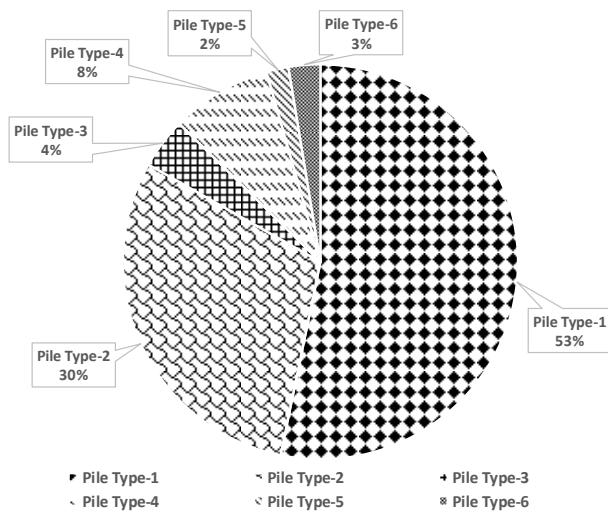
A classification of the tested piles has been presented through a pie chart in Fig. 9. From the pie chart it is found that out of 387 cast-in-situ piles 206 (53%) piles have been

identified as Pile Type-1, 116 (30%) as Pile Type-2, 16 (4%) as Pile Type-3, 32 (8%) as Pile Type-4, 7 (2%) as Pile Type-5 and 10 (3%) as Pile Type-6.

Fig. 9 Pile classification based on characteristic reflectograms

Piles have been further classified as ‘Satisfactory’, ‘May be Satisfactory’ and ‘Unsatisfactory’ through interpreting reflectograms in terms of integrity of the constructed piles and quality of construction materials. Piles classified as “Pile Type-1” can be considered as ‘Satisfactory’; “Pile Type-2”, “Pile Type-5” and “Pile Type-6” can be referred as ‘May be Satisfactory’; “Pile Type-3” and “Pile Type-4” needs to undergo further investigation since these piles can be recognized as ‘Unsatisfactory’.
