The Performance and the Induced Rebar Corrosion of Acrylic Resins for Injection Systems in Concrete Structures

C. S. Paglia, E. Pesenti, A. Krattiger

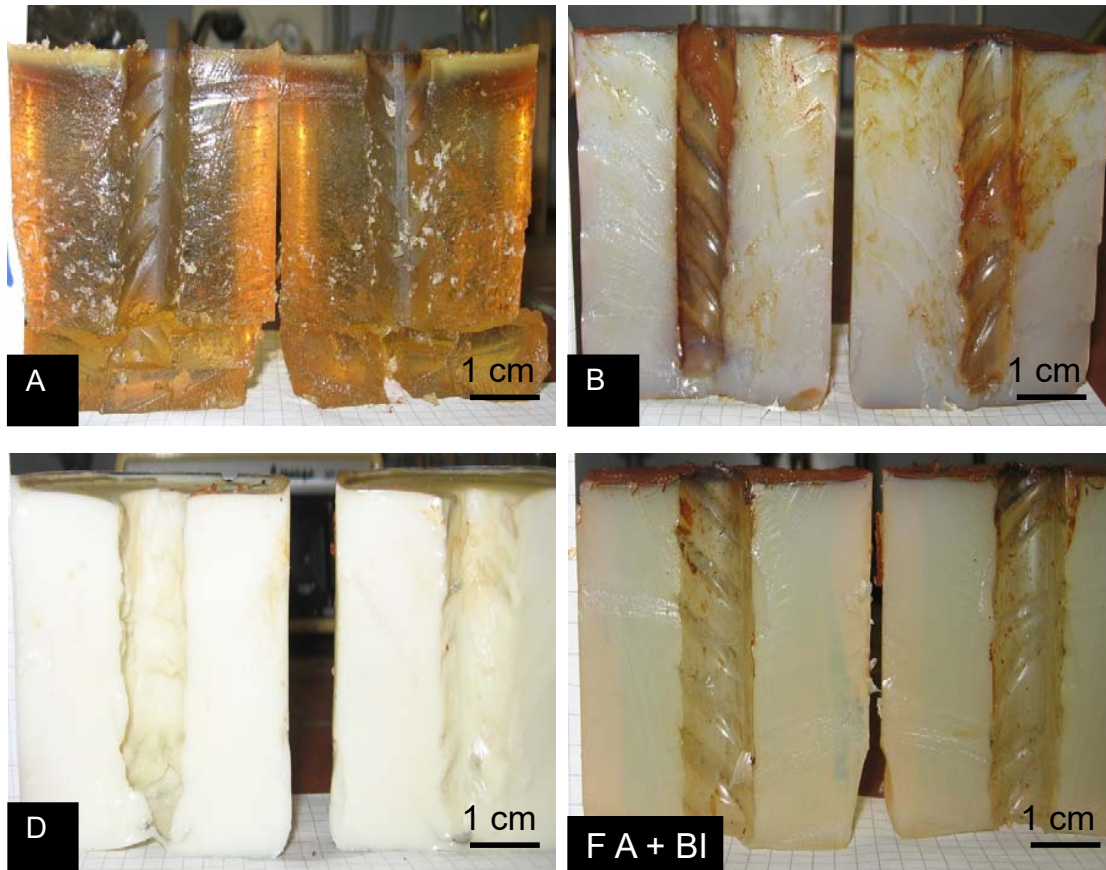
Fig. 10 Resin A: slight presence of corrosion products, in particular in the upper part of the resin (red-black colour) close to the aqueous solution. Resin B: uniform presence of corrosion products along the rebar region. Resin D: almost total absence of colouring effects due to the formation of corrosion products. Resin F/A+BI: uniform presence of corrosion products along the rebar region, in particular in the upper region close to the aqueous solution

In order to further clarify the presence of corrosion products, the resins were cut in two halves and examined with respect to the colour change along the regions where the rebars were placed. In this concern, it is clear that the resin D did not generally exhibit corrosion products along the rebar region, while the other resins indicate a presence of corrosion products, which contributed to the colouring of the resin along the rebar regions (Fig. 10).
