Assessing the Sheltering Response in the Middle East: Studying Syrian Camps in Jordan

Lara A. Alshawawreh, R. Sean Smith, John B. Wood

Abstract—This study focuses on the sheltering response in the Middle East, specifically through reviewing two Syrian refugee camps in Jordan, involving Zaatari and Azraq. Zaatari camp involved the rapid deployment of tents and shelters over a very short period of time and Azraq was purpose built and pre-planned over a longer period. At present, both camps collectively host more than 133,000 occupants. Field visits were taken to both camps and the main issues and problems in the sheltering response were highlighted through focus group discussions with camp occupants and inspection of shelter habitats. This provided both subjective and objective research data sources. While every case has its own significance and deployment to meet humanitarian needs, there are some common requirements irrespective of geographical region. The results suggest that there is a gap in the suitability of the required habitat needs and what has been provided. It is recommended that the global international response and support could be improved in relation to the habitat

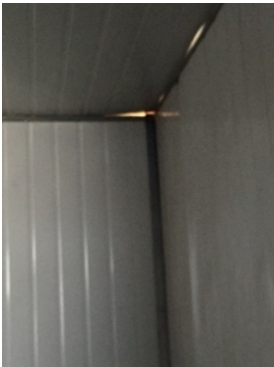
Fig. 5 Gaps between junctions [13]

In an attempt to seal the shelters, especially the roof-wall junctions (Fig. 5), the residents covered the roofs using fabrics they had or bought them, if they could afford them. Some families also tried to expand their shelters by enclosing a space using corrugated sheets and then covered it with fabric,

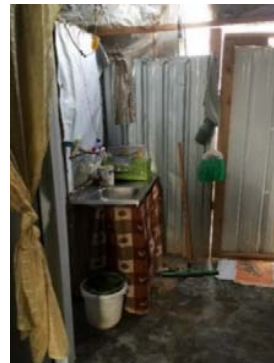
Fig. 8 Self-built kitchen [13]

- *Facilities:* When the camp was first opened, the kitchens and toilets provided were communal. Problems occurred when using such communal facilities from both cultural and privacy/security perspectives. It was found that when residents could afford some materials, they adapted and self-built private facilities adjacent to their shelters. These adaptations included enclosing additional space with corrugated sheets, wood and canvas, if the residents were able to afford materials (Figs. 8 and 9).
- *Outdoor areas:* The courtyard is an important cultural feature in Syrian homes and enclosing an outdoor space

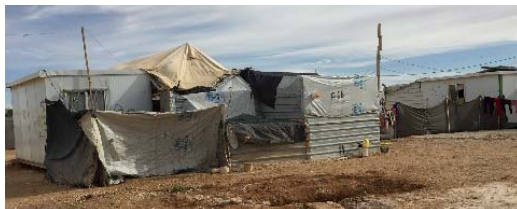
Fig. 10 Private outdoor area [13]

was found to be very important to the camp residents. They often enclosed a space next to their shelter or between two shelters with canvas or corrugated sheets, as shown in Fig. 10. One of the main benefits of such a private area was for women residents to have access to an outside space. This provided safety, privacy and aligned to their cultural needs.

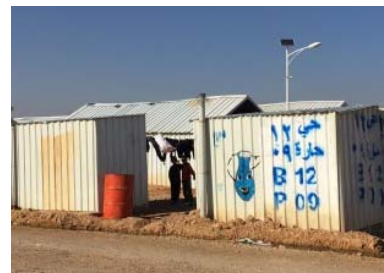
Fig. 19 Communal unit for toilet and shower [15]

- *Facilities:* Toilets are communal in Azraq camp and each unit (toilet and a shower) is used by approximately three families (Fig. 19). Residents had ceased to use the communal showers due to safety concerns and opted to shower in their own shelters using buckets of water. The shelters were not designed to have internal showers nor is their space provision. The main difficulties regarding using communal facilities are:

- hygiene problems: used by large numbers,
- distance problem: using the toilets in winter is problematic, especially for children, due to the distance and the harsh weather,
- ground turns into mud after raining, and
- lack of security and safety: specifically, for children and women at night.
