Beating Phenomenon of Multi-Harmonics Defect Frequencies in a Rolling Element Bearing: Case Study from Water Pumping Station

Fathi N. Mayoof

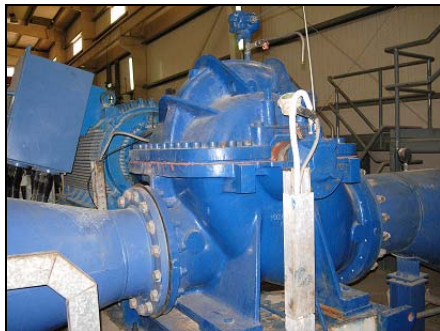
A double suction centrifugal pump running at 1480 rpm (24.67 Hz) is installed in West Riffa II water blending station in Bahrain water transmission network as shown in Fig. 2. The main duty of the pump is to pump water from a ground storage tanks to an elevated service reservoir (ESR). The last overhauling of the pump was on May 2008 after which the pump was running smoothly. Fig. 3 shows the vertical frequency spectrum of the Pump-drive end bearing which has an overall vibration of 0.6 mm/s only.

Fig. 2 West Riffa centrifugal pump

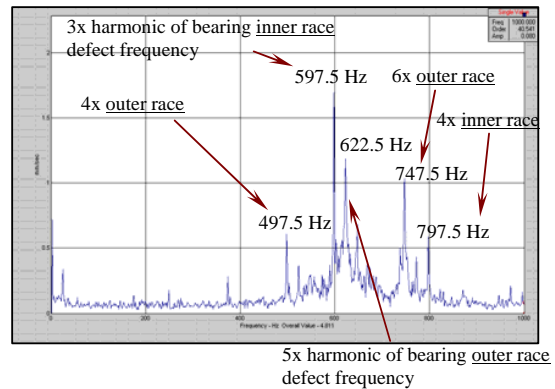
A quick inspection of the Table III shows that the 597.5 Hz is equivalent to the third harmonic (3X) of the inner race frequency, while the 622.5 Hz is equivalent to the fifth harmonic (5X) of the outer race frequency.

Moreover, several harmonics are appeared in the frequency spectrum. Fig. 11 shows the two frequencies of beating signal along with other harmonics. 4X and 6X of the outer race frequency are appeared at 497.5 Hz and 747.5 Hz respectively. The inner race frequency shows 4X at 797.5 Hz as well as the 3X at 597.5 Hz.

Fig. 11 Multi-harmonics of bearing defect frequencies

Hence, a recommendation of dismantling the pump and replace the bearings were sent to the maintenance group. Accordingly, the action was taken and the pump overhauled. We inspected the dismantled bearing to confirm the concluded results. Fig. 12 shows the bearing after dismantling. Clearly, dark marks appear inside the outer race and the rollers. A closer view on the roller is shown in Fig. 13. Several rollers were damaged and worn out.

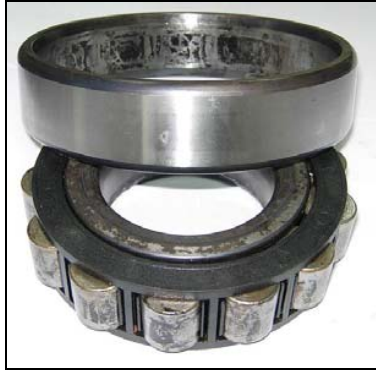
Fig. 12 The bearing after removal. Note the marks in the rollers and the outer race

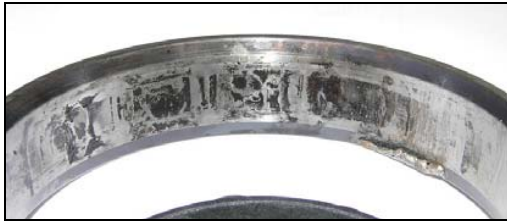
Both outer and inner races were defective as shown in Fig. 14 and Fig. 15. The outer race has a lot of scratches and wear. The same thing could be said about the inner race.

Fig. 14 The defects (dark marks) in the outer race of the bearing

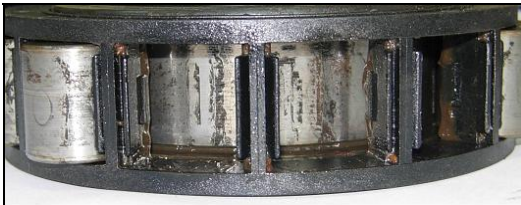
Fig. 15 The defects (dark marks) in the inner race of the bearing
