Comparing Repaired and Undamaged Specimens Test Results of Post-Tensioned Beam to Column Connections

Mustafa Kaya

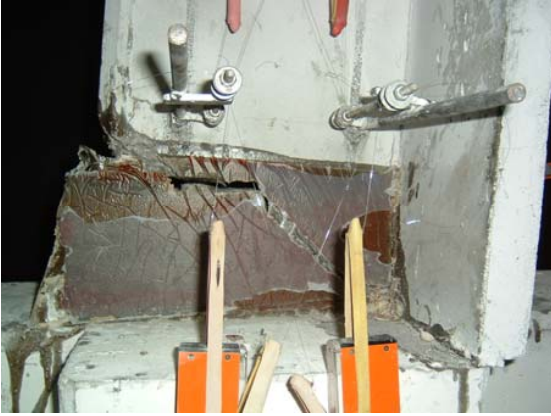
Fig. 2 A view of corbel and bottom side of the beam at the CP1R specimen after experiment

When the load applied to the specimen reached nearly 7.6 kN the loss of the initial stiffness of the specimen decreased due to the cracking of the epoxy resin at the bottom surface of the beam. In spite of observing a loss in the stiffness of the CP1R specimen, the test was completed without excessive damage at the connection (Fig. 2).

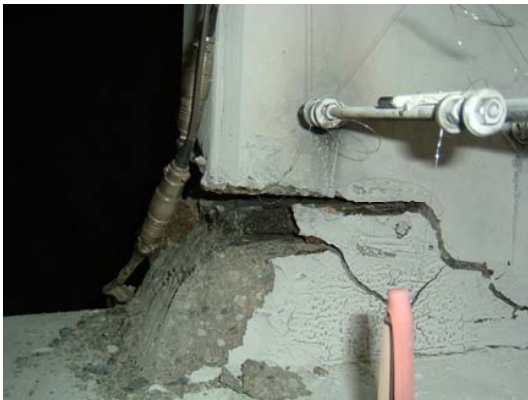
Fig. 3 Fallen state of the parts of the concrete at the upper corner of the corbel of the DP1R specimen

In repetitive loadings, the loading capacity of the DP1U specimen reached average 54 % of the loading capacity of the DP1 when a 1.5 % drift was applied, and a maximum loading capacity of the DP1R specimen reached average 77,00 of the loading capacity of the DP1 specimen. The initial stiffness of the DP1R specimen was seen to be higher than the initial stiffness of the reference specimen. After a nearly 7.5 kN load, the cracking of the epoxy resin caused a decrease in the stiffness of the specimen. The experimental specimen continued to carry the load during the later cycles at a lower stiffness. The bottom edge of the beam touching the corbel at the corbel side was crushed during the backward loading of the last cycle. The cracking of the concrete at the bottom part of the beam caused a 6 kN load loss of the specimen at this loading (Fig. 3).
