# Damage Assessment and Repair for Older Brick Buildings

Tim D. Sass

**Keywords**—Brick, damage, deterioration, facade.

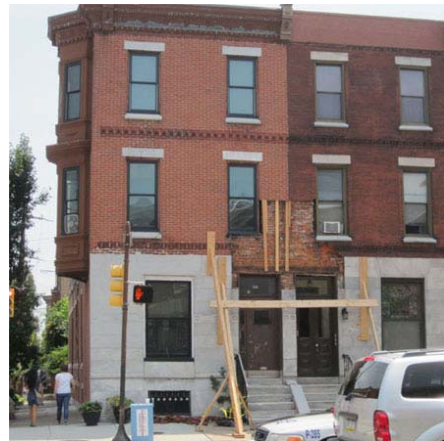
Fig. 1 Brick wall damage

When a brick wall suddenly collapses, the immediate cause is unknown. The collapse could be attributed to the weather or vibrations from nearby construction. A structural engineer called on to investigate many such collapses will learn to include an evaluation of the original construction as part of the forensic study.

Deficient original construction methods on older brick facades can result in brick facades that bulge out of alignment. When such deteriorated, weakened brickwork suddenly fails, the failure can be mistaken for seismic, storm or construction related damage.

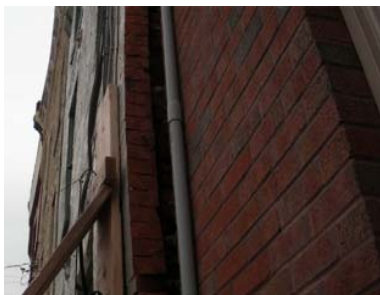
Fig. 2 New plumb wall next to old bulged brick

New construction can expose ongoing deterioration and bulging brickwork. Where bulging brickwork extends across multiple buildings, renovating the front façade of one of the buildings can expose the extent of movement on neighboring structures. A new, plumb front facade on a renovated building makes the extent of movement on a neighboring building's bulged front brick façade suddenly apparent. The sudden discovery of bulging brick may be incorrectly blamed on renovation efforts on the neighboring building.

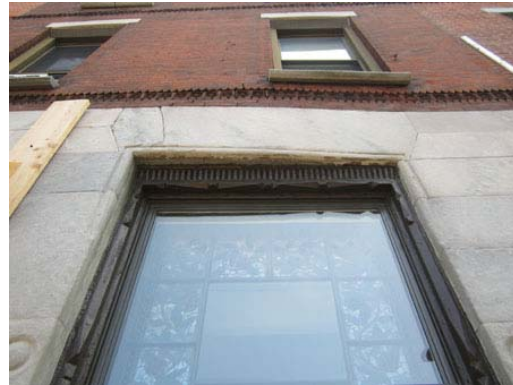
Fig. 3 Bulge at window opening

Structural brick walls often bulge around door and window openings. As brickwork bulges, gaps open up around windows and doors. These gaps are typically not uniform and taper down following the bulging brick. Over the years, patch repairs to the building will often include filling gaps in between the door and window openings and the bulging brick with mortar or caulk. Evidence of such previous repairs often remain even on collapsed brickwork and can be used to help determine whether a brick façade was bulging when it collapsed.
