Energy Systems and Crushing Behavior of Fiber Reinforced Composite Materials

Hakim S. Sultan Aljibori

Abstract—Effect of geometry on crushing behavior, energy absorption and failure mode of woven roving jute fiber/epoxy laminated composite tubes were experimentally studied. Investigations were carried out on three different geometrical types of composite tubes (circular, square and radial corrugated) subjected to axial compressive loading. It was observed in axial crushing study that the load bearing capability is significantly influenced by corrugation geometry. The influence of geometries of specimens was supported by the plotted load – displacement curves of the tests.

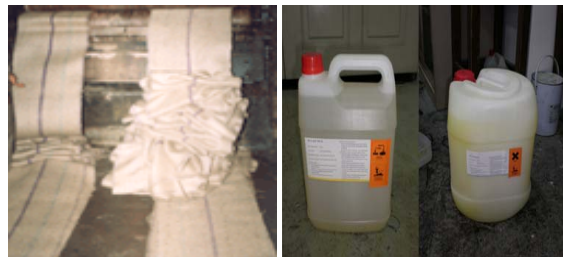
Fig. 4 Jute Fiber, Epoxy with hardener

Three types of specimen have been investigated, SJFT, CJFT and RCJFT. The entire structures are made of woven roving jute fiber/epoxy as shown in Figure 4. Three specimens were fabricated under the same conditions with a fixed fiber orientation angle of 0°/90° and epoxy resin (ZE-LAM 7892 A) with hardener (ZE-LAM 7892 B). All the specimens have inside diameter (d) 10 cm, height (h) 10 cm and wall thickness (t) 5mm. Three types of wooden mandrels have been manufactured in the workshop. The mandrels have the same length of 30 cm as shown in Fig 5.

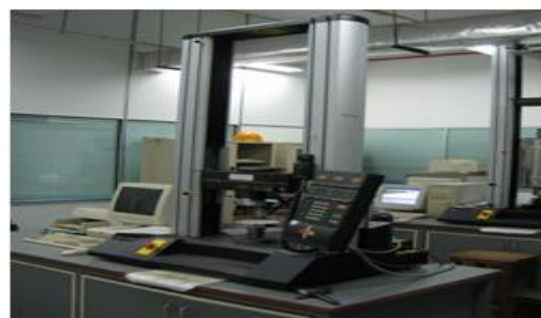
Fig. 7 Photograph of the INSTRON machine

The specimens were tested in quasi-static axial compression between two flat steel plates one is static and the other one moving with constant crushing speed. INSTRON 4469 digital testing machine (Figure. 7) with full scale load range of 50kN was used. Three specimens of each type of composite tubes were tested. Load platens were set parallel to each other before testing. All composite tubes were compressed at a loading rate of 15 mm/min until limited crush, which implies complete compaction of the tubes being tested. Load and displacement were recorded by an automatic data acquisition system. Progress and history of triangular crushing test of SJFT, CJFT and RCJFT are shown in Figures 8-10.

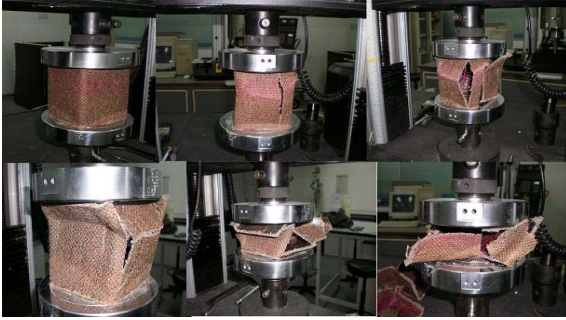
Fig. 8 Progress of Crashing Test of SQJFT

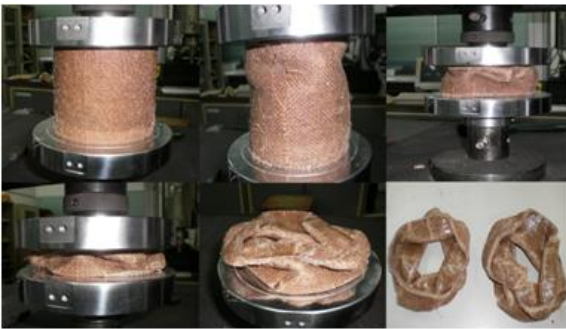
Fig. 9 Progress of Crashing Test of CJFT

Figure 12 (a) shows a typical crushing deformation of the CJFT subjected to quasi-static compressive load. Non-linearity is evident during the pre-crush-stage as shown in Figure 9b, where non-axisymmetric buckling is seen, which is characterized by unstable local tube wall buckling initiated the failure at the top end of the specimen as shown in Figure 12b. In this stage the tube resistance reaches its first and highest peak (45.35kN) at a deformation of 4.44 mm. On the other hand, the tube load-carrying capacity decreases gradually with the progress of crushing process. It is seen that the progressive folding in buckling is characterized by hinge formation and folding of the tube walls as in the case of ductile fiber-reinforced materials with the development of wrinkles. These wrinkles and buckles initiate and develop sequentially from one end of a tube under buckling process. The accumulation of the materials of the specimen caused the growth in the load/displacement curve at the end as shown in Figure 12c.

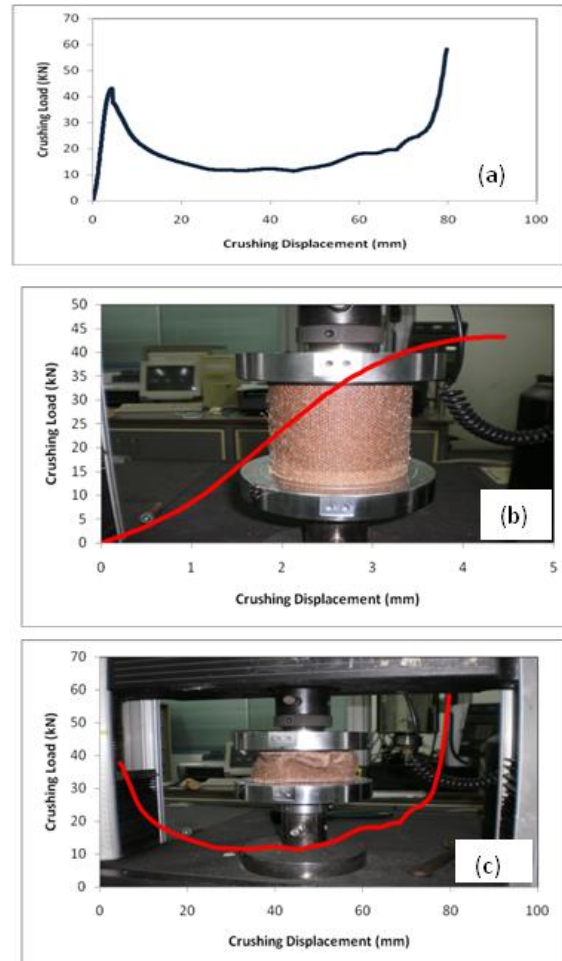
Fig. 12 Load-Displacement Curve of CJFT

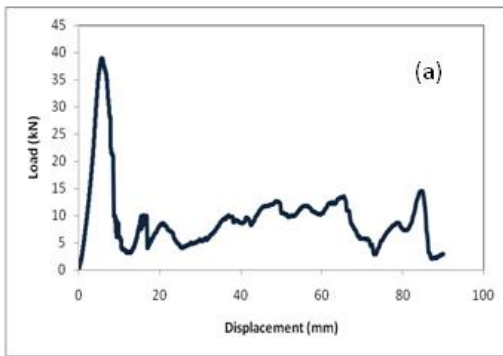
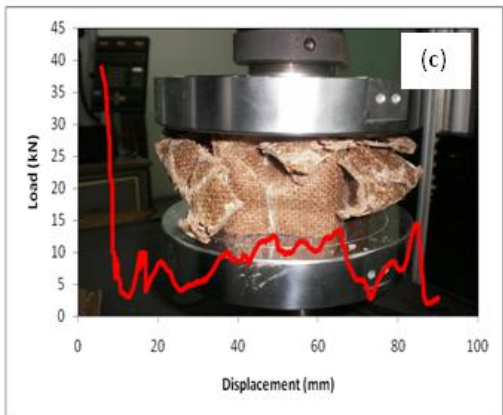
Fig. 13 Load-Displacement Curve of RCJFT

Figure 13 shows a crushing deformation of the RCJFT, subjected to quasi-static compressive load, which is characterized by longitudinal fracture, crack propagation and splitting of the tube walls transversely to the tube longitudinal axis. This is typically initiated at the top end of the compressed tube associated with low crash energy absorption compared to the stable progressive end-crushing mode. In this mode, the audible matrix cracking and fiber breakage occurred when the tube wall resistance reaches its peak magnitude of 38.84 kN at 5.77 mm as shown in Figure 13-a and 13-b. It is observed that the tube resistance sharply reduces with the progress of crushing and the tube walls were splitting transversely with rapid propagation of brittle fracture in the corrugated walls of the tube leading to a catastrophic failure as shown in Figure 13-c.

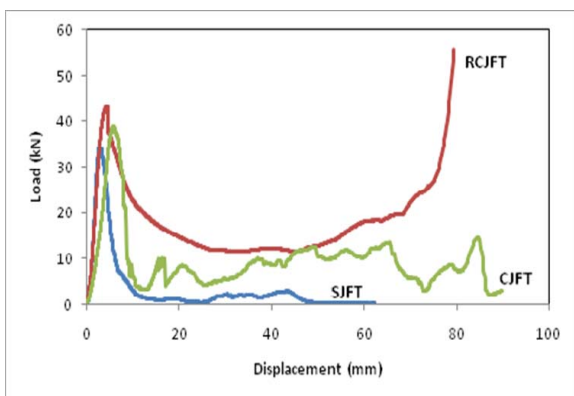
Fig. 14 Load Displacement Curves of Different Geometry

Figure 14 represent the load-displacement curves of three different geometries for comparison between three shapes. Crushing loads of the specimens listed are in Table 4.

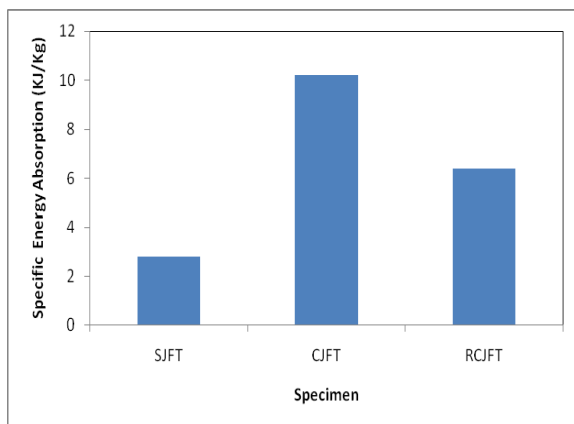
Fig. 17 Specific Energy Absorption (SEA)

Specific energy absorption (SEA) is the energy absorbed per unit mass of material, and the units of SEA are kJ/kg. Figure

17 depict that the circular tube CJFT produced the highest values of specific energy absorption. Therefore, the circular geometry is the best for the appliances designed with the jute fiber/epoxy resin.
