Experimental Testing of Composite Tubes with Different Corrugation Profile Subjected to Lateral Compression Load

Elfetori F. Abdewi

Abstract—This paper presents the effect of corrugation profile geometry on the crushing behavior, energy absorption, failure mechanism, and failure mode of woven roving glass fibre/epoxy laminated composite tube. Experimental investigations were carried out on composite tubes with three different profile shapes: sinusoidal, triangular and trapezoidal. The tubes were subjected to lateral compressive loading. On the addition to a radial corrugated composite tube, cylindrical composite tube, were fabricated and tested under the same condition in order to know the effect of corrugation geometry. Typical histories of their deformation are presented. Behavior of tubes as regards the peak crushing load, energy absorbed and mode of crushing has been discussed. The results show that the behavior of the tube under lateral compression load is influenced by the geometry of the tube itself.

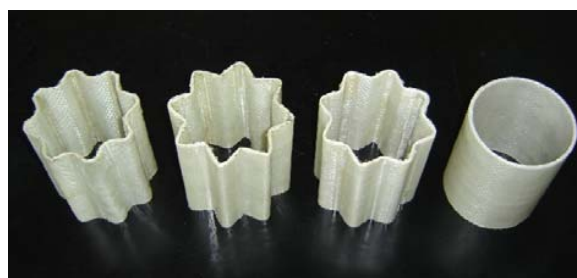
Fig. 1 Tested specimens
(Right to left CCT, RCCT, TRCT, TZCT)

Three radial corrugated composite tubes with different profiles have been tested; Sinusoidal, Triangular, and Trapezoidal profile. They were referred in this paper as: RCCT, TRCT, and TZCT respectively. On addition to that, cylindrical composite tube CCT, were fabricated and tested under the same condition in order to know the effect of corrugation geometry (see Fig. 1). The specimens are made of woven roving glass fibre/epoxy 600 g/sqm. All specimens fabricated under the same conditions with a fixed number of layers equal to six.

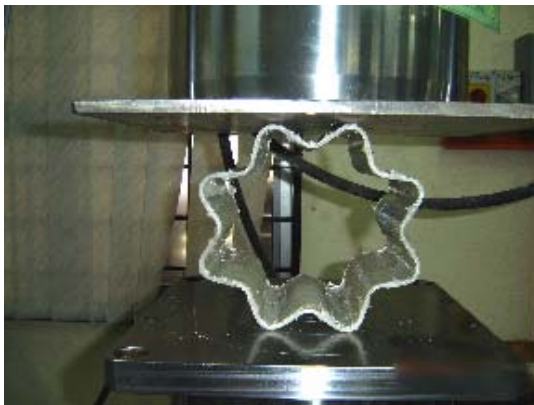
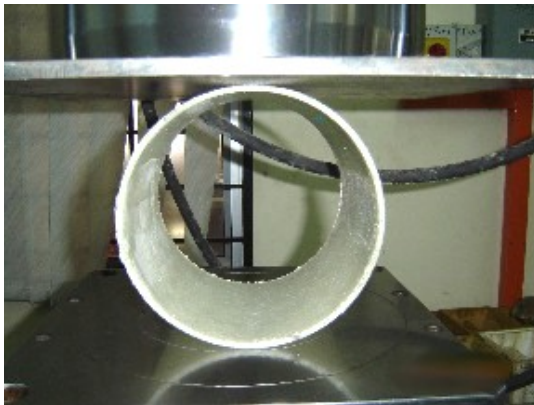
Fig. 2 (a) Corrugated specimen (RCCT) under lateral compression load, (b) Cylindrical specimen (CCT) under lateral compression load

Test was carried out under the same condition for all types of specimens. Quasi-static tests were conducted by laterally compressed of specimens between parallel, flat steel platens (see Fig. 2), one static and one moving at a constant cross-head speed. Load platens were set parallel to each other prior to the initiation of the test. From three to five replicate tests were conducted for each specimen. The tests were carried out at a speed of 15 mm/min. Load and displacement were recorded by an automatic data acquisition system.

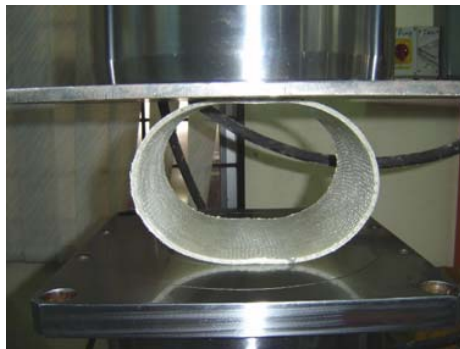
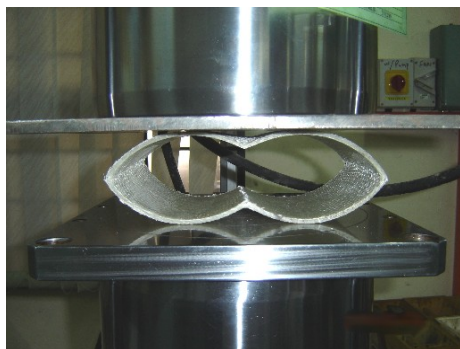
Fig. 3 Crushing of cylindrical composite tube subjected to lateral compression load

For cylindrical tubes (CCT), as shown in Fig. 3(a), as the crushing load increases, the model becomes elliptical shape, and at this stage resistant load achieved its maximum value before cracks takes place. Immediately after this stage four longitudinal fracture lines are observed to have developed. The fracture lines are formed diametrically opposite to each other at about 90° angle as seen in Fig. 3(b). Further deformation leads the model to form a shape of two similar adjacent eyes. This leads to gradual increase of load. This behavior seems to continue until complete crushing when the specimen forming two flat sheets.

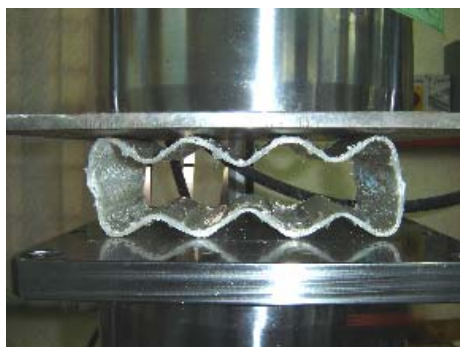
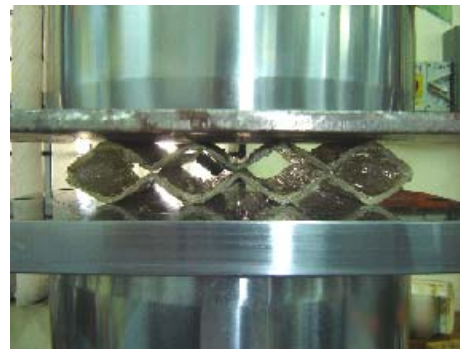
Fig. 4 Crushing of corrugated composite tube subjected to lateral compression load

However, for radial corrugated tubes all kinds of specimens with different profiles (RCCT, TRCT, TZCT) have the same behavior under the effect of lateral compression load. As the load increases gradually the specimen reforming its shape to become a rectangular with dissimilar sides in Fig. 4(a). Increasing of compression load reforming the radial corrugated tube to become approximately a rectangular shape with a corresponding straight sides and a profile sides which in contact with the flat platens. Further increases of compression load causes two longitudinal fracture lines at the specimen sides. Consequently the upper and lower profile formed parts contact each other at the bottom and top points of the parts respectively in Fig. 4(b).

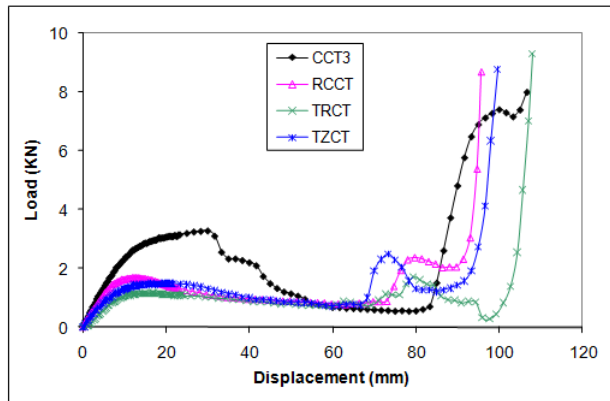
Fig. 5 Load-Displacement curve
CCT, RCCT, TRCT, TZCT

Typical load-displacement curves were presented to exemplify the effect of corrugation profile on the crushing behaviour and energy absorption capability of CCT, RCCT, TRCT and TZCT models when subjected to lateral compression load as shown in Fig. 5. Lateral crushing exhibits minimum fluctuating load specimens crushing length.

The behaviour of lateral crushing of TRCT and TZCT models was exactly like the behaviour of RCCT model. This can be easily understood from load-displacement curve. The three curves of corrugated tubes (RCCT, TRCT, and TZCT) were mostly coincides each other. However there was a valuable difference between the results of these three corrugated tubes and the cylindrical tube (CCT). The CCT mode recorded much higher initial failure load than corrugated tubes. It is about two to three times higher. Changing of corrugation profile did not affect much the crushing behaviour and energy absorption of composite tubes when subjected to lateral compression load. In spite of corrugation shape, radial corrugation allows the tube to deform elastically with a minimum resisting force at early stages of crushing. This stage followed by forming of two

longitudinal fracture lines at the tube sides that leads to separate the tube to two corrugated sheets. When these sheets meet each other, here a slight difference was existed (if any), due to the difference in corrugation profile. At this stage, the structures form a shape of serious of honeycombs in case of trapezoidal profile, and a serious of parallelograms in the case of triangular profile. But for any case, it was observed that at this stage load increases sharply until the end of crush.
