# Flow Measurement Using Magnetic Meters in Large Underground Cooling Water Pipelines

**Abstract**—This paper outlines the basic installation and operation of magnetic inductive flow velocity sensors on large underground cooling water pipelines. Research on the effects of cathodic protection as well as into other factors that might influence the overall performance of the meter is presented in this paper. The experiments were carried out on an immersion type magnetic meter specially used for flow measurement of cooling water pipeline. An attempt has been made in this paper to outline guidelines that can ensure accurate measurement related to immersion type magnetic meters on underground pipelines.

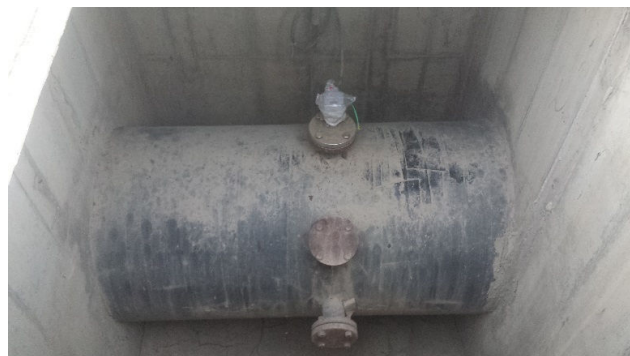
As shown in Fig. 7 the transmitter is top mounted and thus naturally the possibility of air bubbles flowing on the top portion of the pipe might pose a problem. As the sensor has both electrodes and magnetic field generating coils in very close proximity, large air bubbles passing in front of the sensor will change the magnetic inductance of the liquid and hence change the flow value.

Furthermore this phenomenon is made worse because of the much smaller area over which the magnetic field is able to pass through compared to the much larger pipe and to further complicate matters the EMF value is very small and thence easily affected. However even though this is a very probable reason but pipe pressure helps determine the possibility of air bubbles. The pipeline under consideration was pressurized at 8 bar and thence the possibility was very low [4]. Furthermore the flow sensor was immersed 5 inches into the pipeline.

Fig. 8 Mounting position of sensor

However on examining the water sample it was found that along with the water, solid particles and sometimes even plastic wrappers flowed through the pipe line. This helped identify the problem, instead of air bubbles it were solid particles flowing through the water that when flowed in front of the pipeline changed the liquids magnetic inductance. This phenomenon is not observed in normal magnetic meter which have electrodes at each diametric end of the pipeline and

magnetic coils wrap the entire flow tube section. Thus the passing of these solid particles resulted in change in the inductance of our fluid and caused our very small EMF signal to be affected. Two solutions were proposed for this problem:

- 1) The installation of a filter to clean the fluid however the filter would require cleaning and could get clogged. Such high maintenance was not possible at a cooling water pipeline and thus the proposition was dismissed.
- 2) The installation of another sensor and both acting in 2 out of 2 logic was considered. Steps were also taken on this proposition and as Fig. 7 depicts arrangements for the installation of the sensor are already available. This proposition is being acted upon
