# Fundamental Research on Factors Affecting the Under-Film Corrosion Behavior of Coated Steel Members

T. Sakamoto, S. Kainuma

**Keywords**—Accelerated deterioration test, Coating durability, Environmental factor, Under-film corrosion.

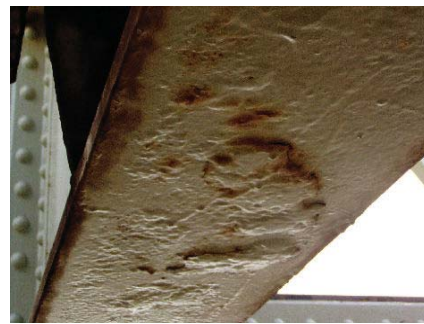
Fig. 1 Appearance of Under-film Corrosion

impossible to completely protect the environmental factors such as water vapor and oxygen; therefore, the coating film covered on the rust is degraded by the progress the under-film corrosion due to various corrosive factors. Thus, in order to inhibit the under-film corrosion, it is important to understand the relationship among corrosive factors, remaining amounts of the rust and coating durability. Fig. 1 shows under-film corrosion of a steel structure.

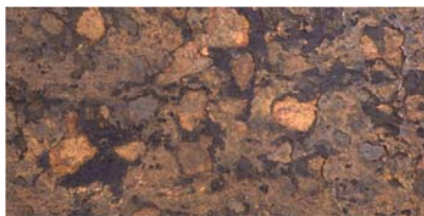
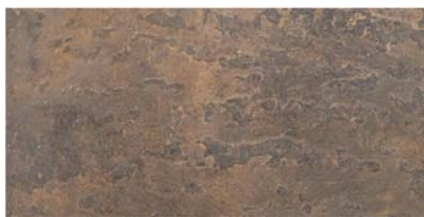
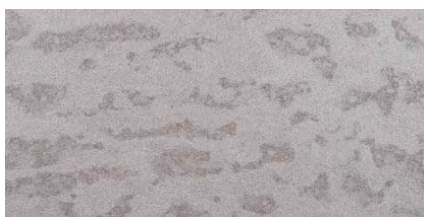
- Wire Brushing was applied to the steel surface to remove rust particles. The rust layer adhering tightly to the steel substrate was not removed by wire brushing.
- Wire Brushing + Cup Wire Treatment: After a) Wire brushing, the rust layer adhering tightly to the steel substrate was removed by cup-wire which was driven by electric motor. Cup-wire treatment was continued until any more rust particles are not removed. The rust layer was slightly remaining on the steel substrate.
- Wire Brushing + Cup Wire Treatment + Blast Treatment: After b) Wire brushing and cup wire treatment, the rust remaining on the steel substrate was almost removed by blast treatment. A preparation grade is Sa 2 according to the instructions prescribed in ISO 8501-1.

(a) Wire Brushing

(b) Cup Wire Treatment

(c) Blast Treatment

Fig. 2 Appearance of Corroded Surface after Each Surface Preparation

Three methods of the surface preparation on corroded surface are selected as follows. Fig. 2 shows the corroded surface after each surface preparation.

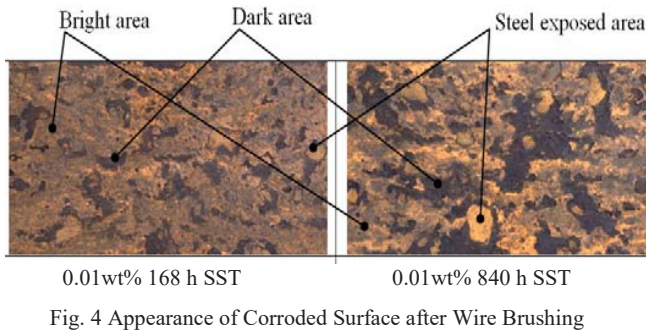
The surface appearance after removal by wire blushing was shown in Fig. 4. The rust layer tightly adhering to the steel substrate roughly distinguished two images: a bright area and a dark area. In addition, some surface areas had an exposed steel substrate. In Fig. 4, it is also find that dark areas and the exposed steel substrate tended to increase by prolonging the SST time duration.

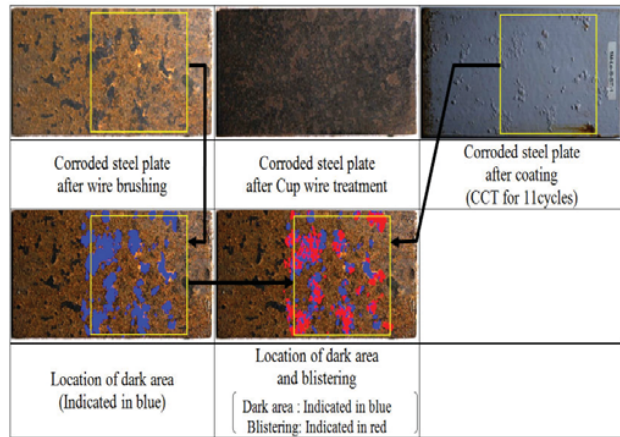
Fig. 5 Relationship of dark area and blistering of coating (Corroded steel plate by SST for 168 h)

Fig. 5 shows appearances of 168 h SST and cup wire treatment specimens after 11 CCT cycles. The blistering tended to develop around the dark area detected after preliminary wire brushing. It was reported that the dark area of the surface image corresponded to the area with enriched  $Fe_3O_4$  as a consequence of reduction of  $\beta$ -FeOOH and the amorphous constituent measured by XRD (X-ray diffraction). As well, due to localized enrichment of chloride ion in such area, macro cell corrosion must have been promoted with the steel substrate/rust interface as the anode and the top surface of rust as the cathode [5].

Taking into account this result, the dark area must refer to the anodic zone with enriched chloride ion. The volume of the rust increase based on the conversion of  $\beta$ -FeOOH and the XRD amorphous rust constituent to  $Fe_3O_4$  by the reduction reaction. Thus, the  $Fe_3O_4$  formed by the reductive reaction becomes porous. When the steel surface coated over remaining  $Fe_3O_4$ , moisture penetrates into the rust through the coating film by the osmotic pressure. Therefore, it was estimated that the dark area was highly vulnerable to under-film corrosion.

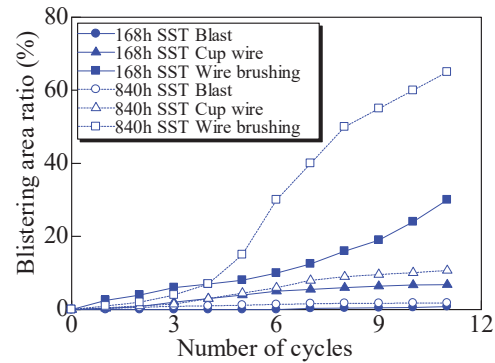
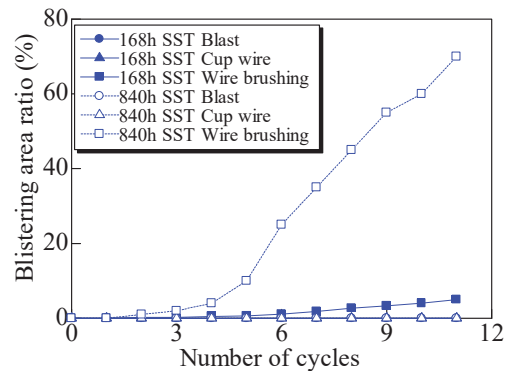
Fig. 6 and Table III show the relationship between the measured blistering area ratio during the CCT and the number of cycles. For most of the specimens, it is seen that the blistering area ratio tended to increase with increasing number of cycles. On the other hand, the blistering was little formed on the specimens to which T-7 type was applied after cup wire or blast treatment.

(a) B-7 type

(b) T-7 type

Fig. 6 Blistering Area Ratio during the CCT as a Function of the Number of Cycles

In the case of B-7 type applied specimen, the blistering was most formed on the specimens painted after wire brushing, and

The blistering was more formed on the specimens of B-7 type application than those of T-7 type application. The result was attributed to the durability of each coating system. On the other hand, the same degree of blistering was formed on the 840 h SST specimens painted either coating system after wire brushing, then it was confirmed that the durability of each coating film had drastically degraded. Furthermore, in the case of comparing for the same number of cycles, the blistering degree appeared to be more severe for specimens after 840 h SST than 168 h SST. It is reported that the longer the SST duration, the higher the chloride ion content in the rust [6]. Thus, it is suggested that salt in the rust yielded by undercoat corrosion is harmful to the durability of the coating.

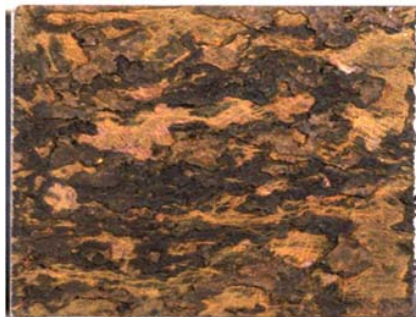
Fig. 7 Appearance of Corroded Surface before Painting (840 h SST, wire brushing)
