# Incessant Collapse of Buildings in Nigeria: The Possible Role of the Use of Inappropriate Cement Grade/Strength Class

Kazeem K. Adewole, Joy-Felicia O. Oladejo, Wasiu O. Ajagbe

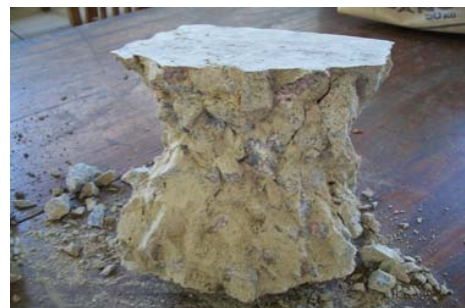
(a) Fractured experimental specimen

(b) Acceptable cube fracture shape

Fig. 2 Fractured concrete cube

The particle size distribution curve for the sand used for this work and the typical fracture or failure shape exhibited by all the concrete cubes are shown in Figs. 1 and 2 (a) respectively. The average compressive strengths for the concrete cubes made with cement grades 32.5 and 42.5 for all the three mix ratios are presented in Table I.

The shape of the fractured experimental cubes shown in Fig. 2 (a) agrees with the acceptable fracture shape specified in [27] shown in Fig. 2 (b). The good agreement between the fracture shape of the experimental cubes and the acceptable fracture shape establishes the validity of the compressive strength tests conducted in this work as it demonstrates that the compressive strength tests conducted in this work proceeded satisfactorily as specified in [27].
