Influence and Interaction of Temperature, H₂S and pH on Concrete Sewer Pipe Corrosion

Anna Romanova, Mojtaba Mahmoodian, Morteza A. Alani

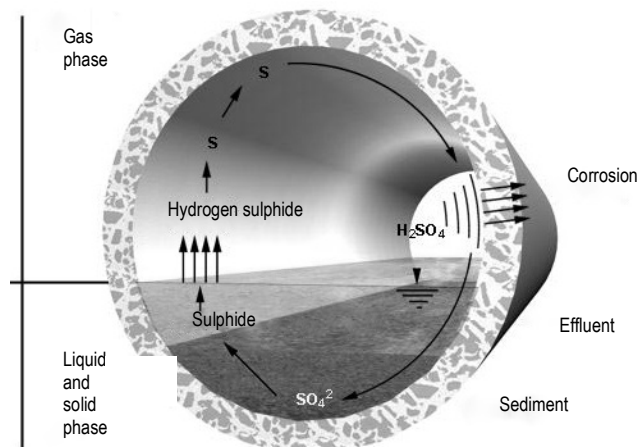
Fig. 1 Microbially induced concrete corrosion in sewer [19]

The process of sewer pipe corrosion has been studied since 1940th and a set of representative knowledge has been gained over years, which are referred to as microbially induced concrete corrosion (MICC) [12]. The bacteria class *Acidithiobacillus thiooxidans* [12]-[14] which are active in the effluent biofilm [15] convert sulphate to sulphide [16]. Some part of sulphide is released in atmosphere as gaseous hydrogen sulphide (H₂S) [16]. Further, the hydrogen sulphide is oxidised [17] to sulphuric acid (H₂SO₄), which subsequently attacks susceptible pipeline materials [18]. Fig. 1 demonstrates the chemical reaction of microbially induced concrete corrosion process in sewer pipe.

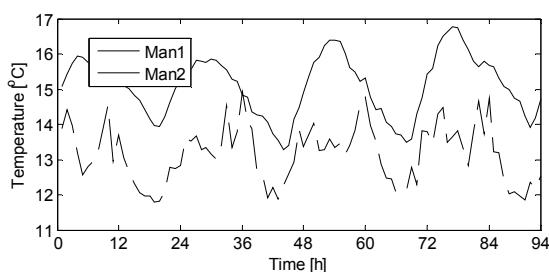
Fig. 1 Effluent temperature for Manhole 1 and Manhole 2 for a period of 4 days in the beginning of April shown in hours

The effluent temperatures for both manholes were found to follow very similar daily trend, however each of them has individual hourly pattern. Fig. 1 represents the data of effluent temperature recorded at a manhole 1 and manhole 2 in 5 days period in the beginning of April, where zero is set at 10am.

The data on Fig. 1 and for all other graphs was resampled to represent an average value for each given hour. Overall, in Feb-Apr the temperatures measurements minimum, maximum and mean for Man1 and Man2 were, 10.8°C, 17.1°C, 13.2°C and 11.6°C, 17.6°C, 15.1°C, respectively. In general the temperatures in Man2 are found to be higher and this is thought to be influenced by a closer location to the rising main, pumping station and generally the industrial sector which have larger use of hot water.

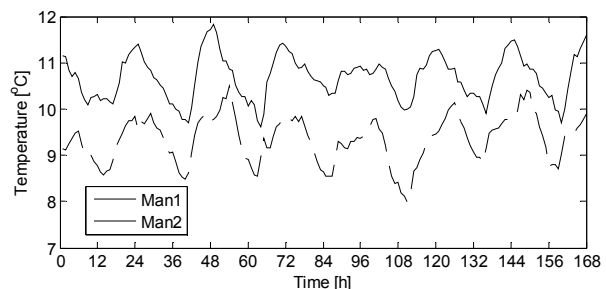
Fig. 2 Ambient temperature for Manhole 1 and Manhole 2 for a period of 1 week in the beginning of March shown in hours

The ambient temperatures for both manholes were found to follow overall an identical pattern. The general pattern of this behavior for both manholes is illustrated in Fig. 2, with zero set at midnight. From Fig. 2 it can be noted that the temperature in Man 1 is generally slightly lower for that compared with Man 2, with mean temperature values of 9.3°C and 10.6°C, respectively. Overall, in Feb-Apr the temperatures measurements minimum, maximum and mean for Man1 and Man2 were, 7.6°C, 12.9°C, 10°C and 8.7°C, 13.8°C, 11.2°C, respectively. The temperatures increased over the day with peak times at 11pm-4am after which they declined. This coincided with the discharge of overflow in the pumping station which generally takes place at midnight or when the chamber is full. However each manhole had manhole-specific minor pattern which is thought to be governed by house hold and industry activity in the area.

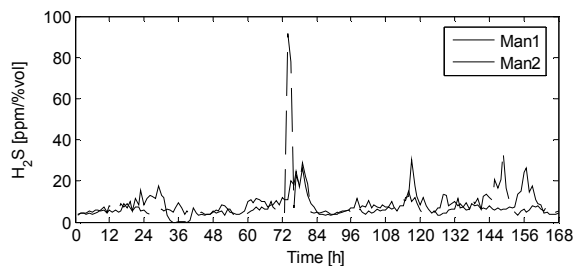
Fig. 3 Hydrogen sulphide concentration for Manhole 1 and Manhole 2 for a period of 1 week in the beginning of March shown in hours

The concentration of hydrogen sulphide for both of the manholes was measured with the sensor being placed in the middle of the manhole at 600mm above the effluent. The measurements of H_2S are presented on Fig. 3, where the data is shown for the same time period as in Fig. 2. From the figure it can be noted that the pattern of H_2S concentration is similar for both manholes even though they were located far apart and governed by different rising mains and pumping station conditions. Although, it should be noted that the operational time for all pumping stations in experimental area is the same. Graph identified large peak of H_2S at Manhole 1 at 91ppm/ % vol, where manhole 2 identifies only 29ppm/%vol. A similar peak tends to appear app. every 48h closer to midnight.

Overall, in Feb-Apr the measurements of the H_2S concentration minimum, maximum and mean for Man1 and Man2 were, 3, 134, 12 and 0, 168, 12, respectively. Even though the minimum and maximum values of both of the manholes varied, the mean of 12ppm/%vol was observed in both, whereas in most of the times a value of 3-5ppm/%vol was recorded.

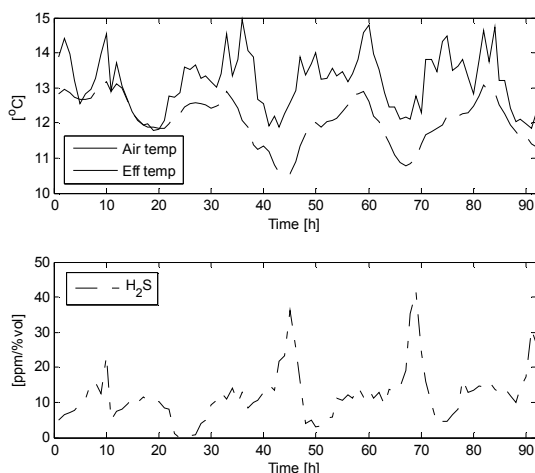
Fig. 4 Temperatures and hydrogen sulphide concentration for Manhole 1 for a period of 4days in April shown in hours

The interaction between parameters of ambient temperature, effluent temperature and concentrations of hydrogen sulphide was investigated. Fig. 4 demonstrates the recorded data for the above for first four days in April for Manhole 1, with zero starting at 10am.

The data suggests that there is a relation between the ambient and effluent temperatures as they follow the same hourly pattern (which is governed by the effluent temperature, which in turn is related to domestic and industrial activities) and daily trend (governed by effluent temperature and general temperature of air outside the manhole). Furthermore, it can be noted that the H_2S level peaks together with the general decrease in temperature inside the manhole in late evening and early morning hours (during this time the general household and industrial activity is minimal, the flow levels are low to

moderate which allows for gas build-up). Furthermore, there is an apparent 10h shift in H_2S level increase and decrease behavior compared to temperatures. The above findings were confirmed for both of the manholes during Feb-Apr period.
