Investigation of Rehabilitation Effects on Fire Damaged High Strength Concrete Beams

Eun Mi Ryu, Ah Young An, Ji Yeon Kang, Yeong Soo Shin, Hee Sun Kim

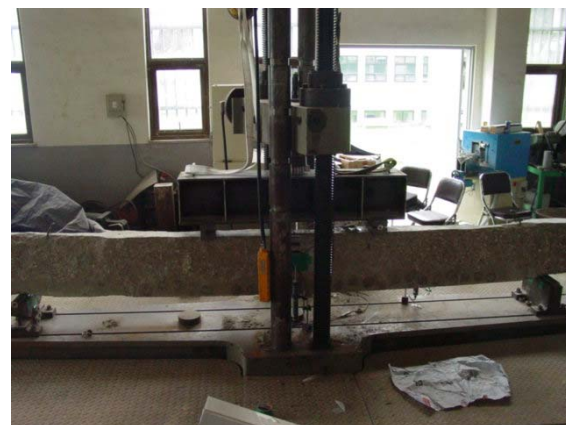
Fig. 5 Four-point loading test of rehabilitated beam

Specimens are simply supported with an effective span of 3750mm and subject to four-point loading. The vertical deflection of the specimen is measured at midspan using a linear variable displacement transducer (LVDT). And the load increases with a gradual rate and is recorded through a data logger. Figs. 3 and 5 illustrate the instrumentation used for the test.

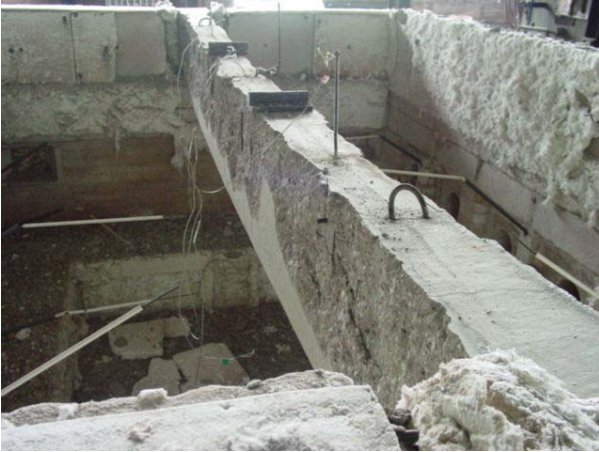
Fig. 6 Specimen on the horizontal heating furnace after fire test

After fire test, the specimens are damaged as shown in Fig. 6 and are left during one month. For comparing residual strength and strength of rehabilitated beam, rehabilitation is performed. Fire damaged U-shaped concrete cover is removed. And, removed part is filled with polymeric cement mortar.
