Protection of Floating Roof Petroleum Storage Tanks against Lightning Strokes

F. M. Mohamed, A. Y. Abdelaziz

Keywords—Crude oil, fire, floating roof tank, lightning protection system.

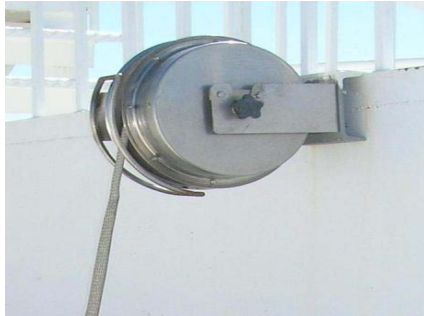
Fig. 3 LEC Retractable Grounding Assembly (RGA) on Floating Roof Tank [1]

- 3) It is also common practice to install bypass conductors between the roof and the tank spaced at intervals no more than 30 m around the circumference of the floating roof. For the new floating roof tank that shall be under our case study, it has a length of at least 49 m because the dimension of the tank (90 m diameter and 18 m in height). The installation of the bypass conductors is easy, inexpensive, and can be installed on both new and existing tanks. The bypass conductors shall have an impedance that is less than that of presented by shunts, so it shall attract the intermediate and long-duration component of the lightning-stroke current to pass through it rather than the shunts. However, the bypass conductor end-to-end voltage may be so high as to cause a dielectric breakdown of the insulating surrounding air. This lead the tank owners to use a retractable conductor wound on a spring-tensioned reel (RGA), instead of the standard conductor. Lightning Eliminators & Consultants (LEC) [1], has developed a roof-shell bonding mechanism (RGA) which is better than the conventional type of bypass conductor. RGA is complete with a spring to retract the conductors on the wheel. The length of the bypass conductor is always keeping the minimum length regarding the location of the floating roof at the top or the bottom of the tank. Also, a typical retractable grounding assembly (RGA) of floating roof tank is shown in Fig. 3. Due to the large diameter of the floating roof tanks (FRT's), and order to increase the electrical connection between the roof and the shell of the FRT, it is recommended to install multiple RGA's on the floating roof tank. The RGA should be installed at intervals no more than 30 m around the circumference of the floating roof [1]: so, in our case, the recommended number of RGA's shall be not less than 10 m, as the tank diameter is 90 m, and the circumference is about 285 m. Although RGA is better than conventional cables, it provides optimal solution for the tank protection against lightning

- 4) Installation of the retractable bypass conductor (RGA's), in addition to the existing shunt straps system, can be installed to existing and new tanks in the future.
- 5) Checking that all the tanks in the zone of the tank fire are connected to the earthing network, as per the applicable code.
- 6) Installation of an Early Streamer Emission (ESE) air terminal system on the tank shell according to the tank diameter.
- 7) Performing lightning risk assessment analysis for the new floating roof tanks that shall be installed in areas subjected to frequent lightning activity.
