Reinforced Concrete Bridge Deck Condition Assessment Methods Using Ground Penetrating Radar and Infrared Thermography

Nicole M. Martino

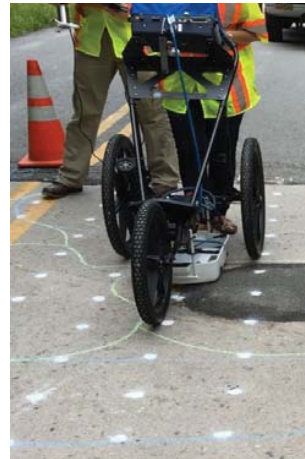
Fig. 1 Picture one of GPR data collection

Ground penetrating radar works by sending electromagnetic pulses through the subsurface of the deck with a high frequency antenna that travels over the deck, and in the direction of vehicular traffic. When those pulses come into contact with a material of differing dielectric property, like the concrete rebar interface, some of the signal is scattered and captured by the antenna’s receiver. Two examples of data collection using this method can be seen in Figs. 1 and 2.

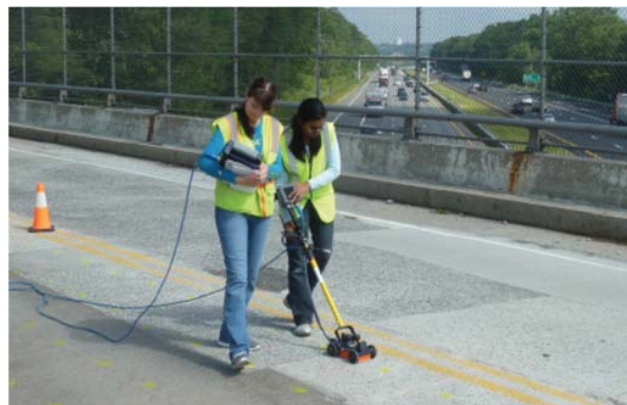
Fig. 2 Picture two of GPR data collection

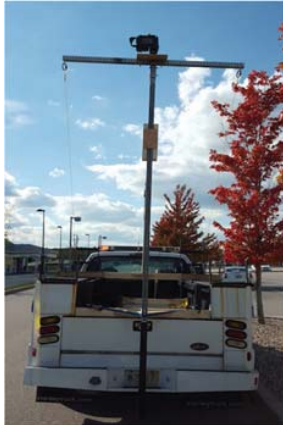
Infrared thermography works by collecting emitted infrared energy, in the form of temperatures (degrees F), from the surface of the deck using an infrared camera mounted onto a vehicle, about 12-13ft above the surface (Fig. 4). The surface temperatures vary when a delamination is present within the subsurface. Since a delamination is an air pocket, it acts as an insulator for that location of the deck. So as the ambient air temperature rises early in the day, the delaminated area will heat up quicker than an area free from damage and appear as a hot spot.

Fig. 4 IR Setup
