Self-Help Adaptation to Flooding in Low-Income Settlements in Chiang Mai, Thailand

Nachawit Tikul

Abstract—This study aimed to determine low-income housing adaptations for flooding, which causes living problems and housing damage, and the results from improvement. Three low-income settlements in Chiang Mai which experienced different flood types, i.e. flash floods in Samukeepattana, drainage floods in Bansanku, and river floods in Kampangam, were chosen for the study. Almost all of the residents improved their houses to protect the property from flood damage by changing building materials to flood damage resistant materials for walls, floors, and other parts of the structure that were below the base of annual flood elevation. They could only build some parts of their own homes, so hiring skilled workers or contractors was still important. Building materials which have no need for any special tools and are easy to access and use for construction, as well as low cost, are selected for construction. The residents in the three slums faced living problems for only a short time and were able to cope with them. This may be due to the location of the three slums near the city where assis

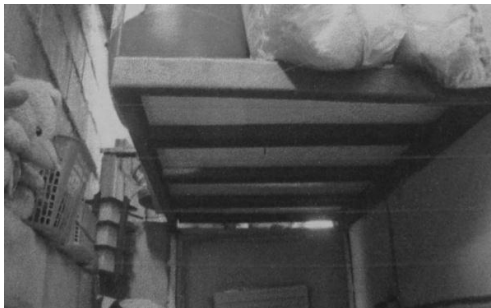
Fig. 2 Shelf preparation for protection of personal belongings

evacuate from the low-income settlements. Shortage of drinking water and food rarely occurred during floods with the three low-income settlements, because there were short flood duration and the residents could access retail stores around their houses or public assistance. This is an advantage of low-income settlements in urban areas. In the case of problems with the toilets, they solved the problem by using the neighbor's toilet or defecating into plastic bags. Even when they cannot use electricity, residence can normally still live in their houses since they have fewer home appliances. The strong furniture, such as beds, tables, cabinets, and shelves, were adapted to become the floor for living when 1-storey houses flooded less than 1.00 m. In addition, they prepared to protect things by lifting them above the water or put them on the shelves, which were built on the wall (Fig. 2). However, the shelves cannot be built in every house due to a lack of structural strength, and therefore in some cases, property and furniture remained in the flood waters.

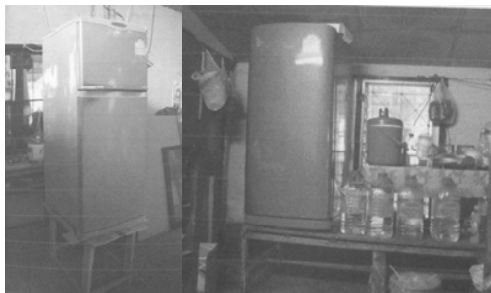
Fig. 3 Lifting the refrigerator above regular flood levels
