Site Inspection and Evaluation Behavior of Qing Shang Concrete Bridge

Keywords—Field investigation, prestressed concrete box girder, maintenance, Qing Shan Bridge

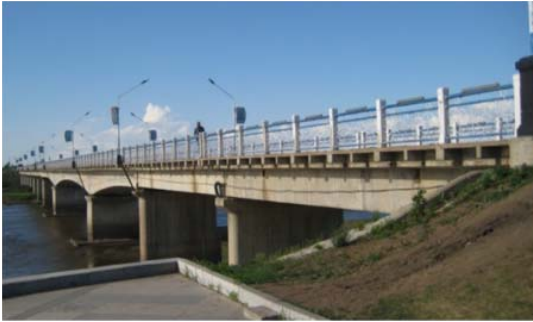
Qing Shan Bridge shown Fig. (1.1) is located in He Gang – Nenjiang 303 provincial highway lane, Heilongjiang Province, China; an important bridge in the urban areas of Wu Dalian Chi. The bridge has been operating for more than 29 years since August 1982. Bridge length is 314.0 meters, including 13 Span; the bridge consists of the left approach, right approach and the main bridge span. among them, the left approach abutment no. 1- Pier no. 2 (A1 ~ P2) has two span, 20 meter of reinforced concrete simply supported T beam; the main bridge pier no. 2 – pier no. 5 (P2 - P5) has three-span in total, overall prestressed concrete box girder, spans arrangement are (30m +50 m +30 m); the right (P5 ~ A2) Approach has eight spans, 20 meter of reinforced concrete simply supported T beam, the horizontal section consists of five simply supported T beam, jointed together.

Fig.1 is located in He Gang – Nenjiang 303 provincial highway lane, Heilongjiang Province, China

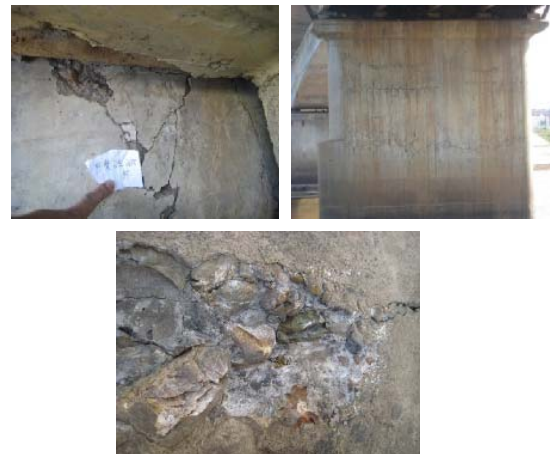
Fig. 4 Damage of concrete bridge abutment #14 and pier No. 5

After checking the abutment joints, the joints were filled with sand and small stones and other debris; the result will be the abutment expansion joints lose functionality. The beams were close to the abutment wall, and the reasons for these

defects include the following :(1) elongation due to heated up beam contract the concrete of back wall. (2). soil pressure behind the abutment makes the abutment move or tilt forward. In other word, the pressure between the beam and the back wall directly causes the damage and defect of concrete as shown in Fig. (4).

The cracked part of the back wall, affecting the durability of the bridge, also if the abutment is damaged to certain degree, the stability of the bridge will be worse.

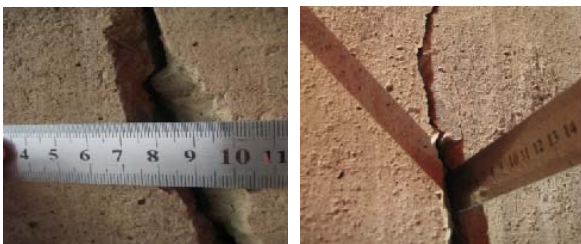
There are 12 bridge piers; all have different defects in certain degree, detailed as followings: first : Pier overall had a good condition, there is no damage of concrete bridge surface, no apparently cracks, only in the center of the piers, at upper part that has a micro-crack, width about 0.2mm, length about 2m. Reason for cracking was degradation of temperature or mass concrete dried, rather than structural joints. Second : the piers # 5 have the most seriously damaged, it's the transition pier between main bridge and approach bridge span , which have a large cracks, described as follows:(1) large crack with maximum width of about (1mm - 2mm) as shown in Fig. (5). There is a crack located in the middle area of the pier had not extended to the top of pier. The inside crack width about 5mm, the depth was more than 60mm.The vertical crack about 3mm, all were beyond the bridge regulatory require, were overtake the bridge specifications. The main reasons caused the cracks was temperature or big concentrate during construction. There was no doubt about that, during the recent years, the cracks lost their function, leading to the rain or the melt ice flew onto the pier surface, and the course of melt and freeze had accelerated the speed of the crack expanding. (2) The horizontal crack in the pier root was caused by temperature (heat) produced, in the winter as it is also subject to the freeze-thaw cycle. (3) There are many different reasons for cracks of the pier #5, mainly includes the melted ice lead penetrated through concrete to the aggregate lead to improper reaction and negative affection, as a result, the water flew directly pier surface. Winter freeze-thaw cycles are aggravated by the net crack growth.

Fig. 5 5 Pier # 5 crack depth

- (7) The extent of serious damages in piers #5 and # 11 the maintenance and reinforcement must be carrying out for piers. The extent of other minor damage should also apply maintenance process.

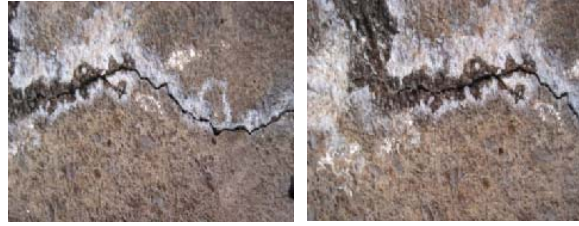
Pier #5 conditions is worse, badly influence on carrying capacity and the durability of the bridge. Some cracks there have white lime precipitation, crack width about 0.6mm, as shown in Fig. (6).

Fig. 6 South side of the pier # 5 surface cracks whitening

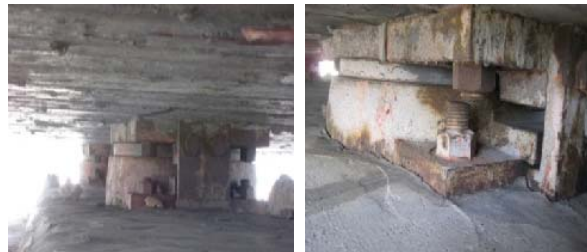
Simply supported reinforced concrete T beam was used steel bearing, bearing dose not showing damage reduction activities, Capping beam have no any obvious damage.

Fig. 8 Bearing steel plate

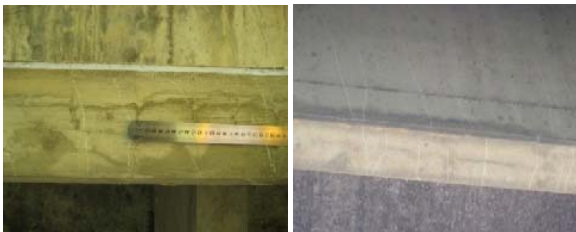
The T beam of all 10 spans were investigated, the occurrence of most T beams have cracking phenomenon occurred. T Beam crack region appears at the bottom under bent beam, crack extended upward along the ribbed T beam, the individual extends to the T beam flange crack, crack width distributed over 0.1mm to 0.4mm, the maximum was about 0.4mm, and crack spacing was about 10 to 15cm. The bridge needs to be improved the flexural bending strength. T beam support region have shear cracks, diagonal cracks were found there, but does not covered large area, crack width about 0.2mm. Cracks generated by the structural force and that

reflect the possible consequences of inadequate carrying capacity of the bridge, which effect on bridge safety and durability. Fig. (9) show the cracks types.

Fig. 9 (c) T beam cross-cracks in the region

- (1) The active implementation of the Qing Shan Bridge, detailed investigation, the static load test, designed must be carried out to provide the necessary technical basis for the maintenance.
- (2) Approach spans of reinforced concrete T-beam should provide design of the implementation reinforcement to increase the carrying capacity of the bridge.
- (3) Replacement of expansion joints. However, in order to improve driving conditions and improve the bridge level of service, while reducing the workload

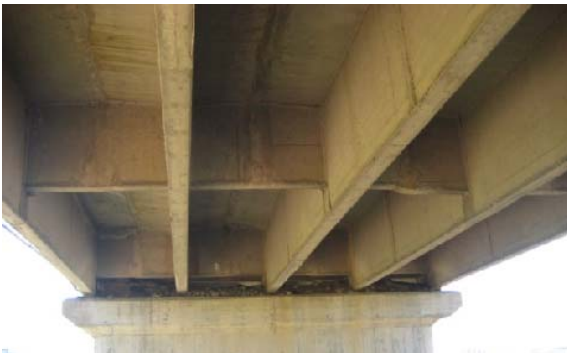
All lateral connections on the bridge observed in detail, simply supported T beam horizontal connections in good condition and the occurrence of cracking was apparent, diaphragm locally have crack, but crack width was small, about 0.1mm.

Fig. 9 (d) T Beam connections is good, no obvious damage (diaphragm)

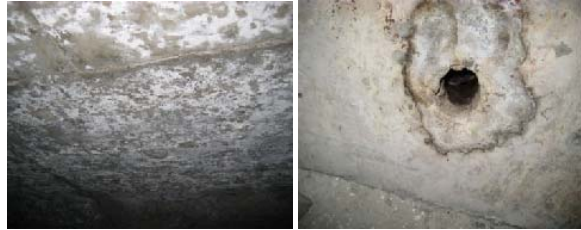
The continuous beam span for the whole box girder and the concrete surface was in a good condition, no obvious damage and cracks. Climb from the box at pier 2 internal inspection of the box found within the surface of structural cracks, top of the local area (especially the original hanging holes of hanging span) the concrete take off, tendons exposed and leaking.

Bridge deck waterproofing was in bad condition, box

leakage, closed hole wasn't dense construction which effect on the durability of the bridge

Fig. 9 (a) the internal box water drainage damage

- (4) Provide appropriate repairs for steel corrosion, concrete cracking and falling concrete parts.
- (5) Completely replace the waterproof layer, re-set the road vent pipe (vent pipe should be guaranteed about 20cm below the main beam);
- (6) Re-laying of pavement, to resolve technical issues such as Bump;

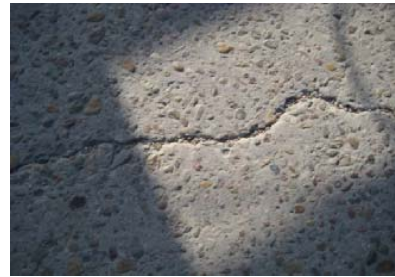
Cement concrete pavement deck with less smoothness, spots potholes, and cracks. Cracking phenomenon effect on carrying capacity of the bridge, functionality, durability,etc, as shown in Fig. (10)

Fig. 10 Deck Damage

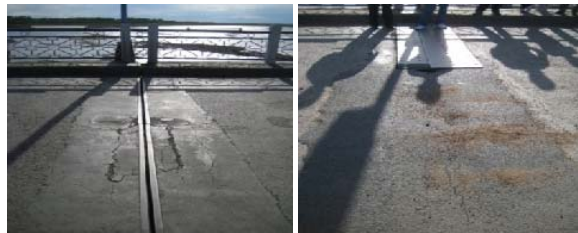
There are severely damaged expansion joints shown in Fig. (11), basically loss of functionality, overloading rolling, improper maintenance witch effect on durability.

Fig. 11 Serious damaged bridge deck expansion joint

of the daily maintenance and management, proposed a continuous deck structure, to minimize the number of joints.

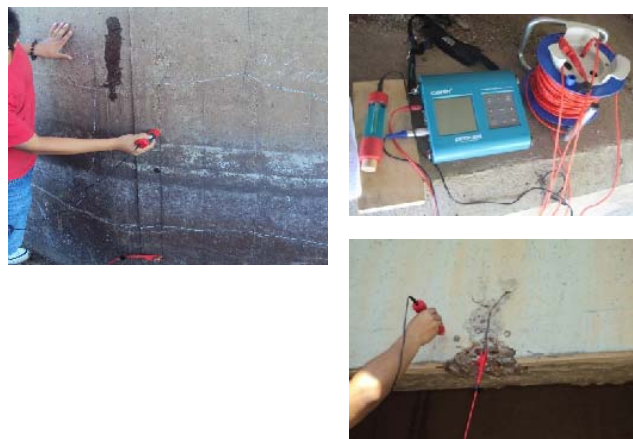
Test results showed that: According to the relationship between steel potential values and the steel corrosion, that the main reinforced concrete cover layer has serious damage, the other side layers had no visual cracks. The damage of concrete layer shows the seriously steel corrosion as shown in Fig. (12).

Fig. (12) Steel corrosion detectors
