# Study of Ageing Deterioration of Silicone Rubber Housing Material for Outdoor Polymer Insulators

S. Thong-om, W. Payakcho, J. Grasoam and B. Marungsri\*

**Abstract**— This paper presents the experimental results of salt fog ageing test of silicone rubber housing material for outdoor polymer insulator based on IEC 61109. Four types of HTV silicone rubber sheet with different amount of ATH were tested continuously 1000 hours in salt fog chamber. By visual observation after tested, slightly surface erosion was observed on tested specimen surface near the energized end. Furthermore, increasing in hardness and reduction in hydrophobicity were measured on tested specimen comparing with new specimen. In addition, chemical analysis by ATR-FTIR was conducted in order to elucidate the chemical change of tested specimens comparing with new specimen. Physical and chemical results confirmed the experimental results as well.

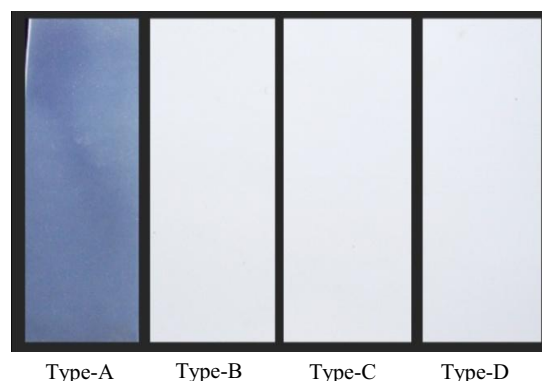
Fig. 1 specimens

Specimens made of high-temperature vulcanized silicone rubber (HTV SiR) with/without alumina trihydrate (ATH:  $\text{Al}_2\text{O}_3 \cdot 3\text{H}_2\text{O}$ ) having content 0%, 50%, 100% and 150% by weight were used in this experimental, as shown in Table I and Fig. 1. Configuration of tested specimen illustrated in Fig. 2. All specimen having 2 mm in thickness, 30 mm in width and 200 mm in length attached with metal electrodes on the both ends of each specimen were hung vertically in test chamber during test.

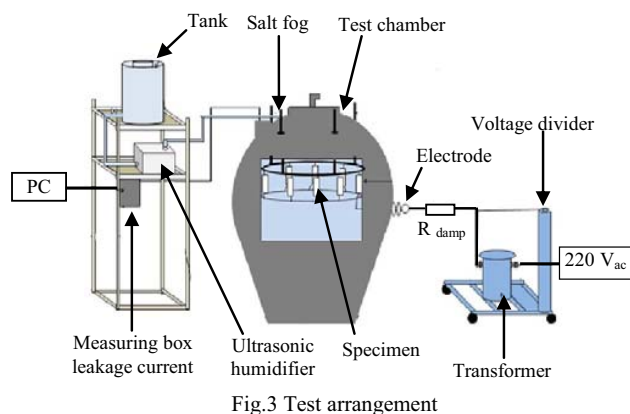
Fig.3 Test arrangement

A polyethylene tank having the volume 4.0 m<sup>3</sup> was used as the salt fog test chamber. During salt fog ageing tests, specimens were hung vertically in the test chamber. An ultrasonic humidifier was used as salt fog generation and salt fog was injected from the top of the test chamber. Fig. 3 shows the test arrangement and Fig. 4 shows the actual test chamber.

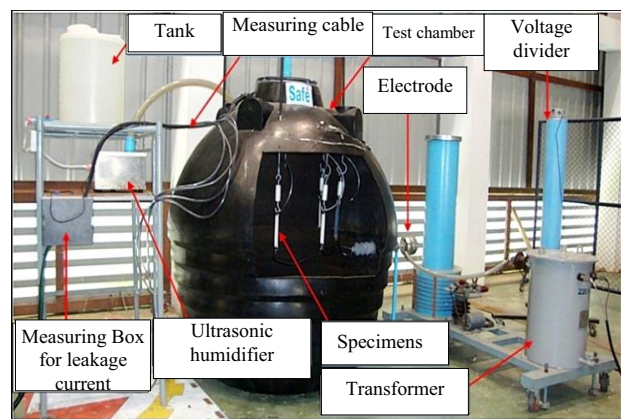
Fig. 4 Test chamber

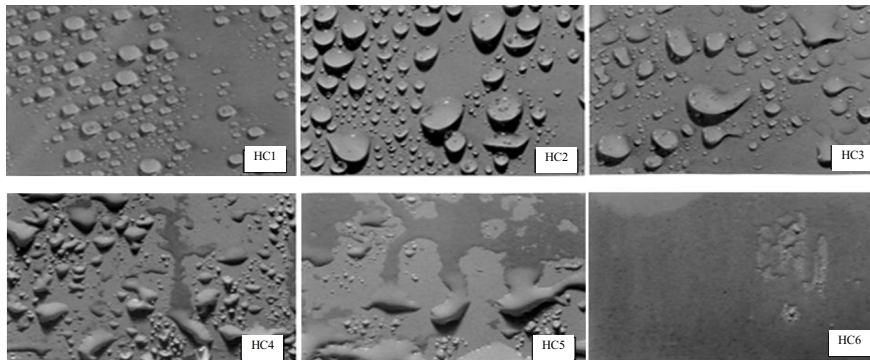
Fig. 7 Characteristics of the sample surface HC1-HC6

reduction in hydrophobicity and/or may be related to the amount of ATH. Reduction in hydrophobicity was evaluated by STRI criteria, as shown in Fig.7 [9,10]. Characteristics of hydrophobicity on tested specimen surface are shown in Fig.8. Hydrophobicity measurement results are shown in Table III.

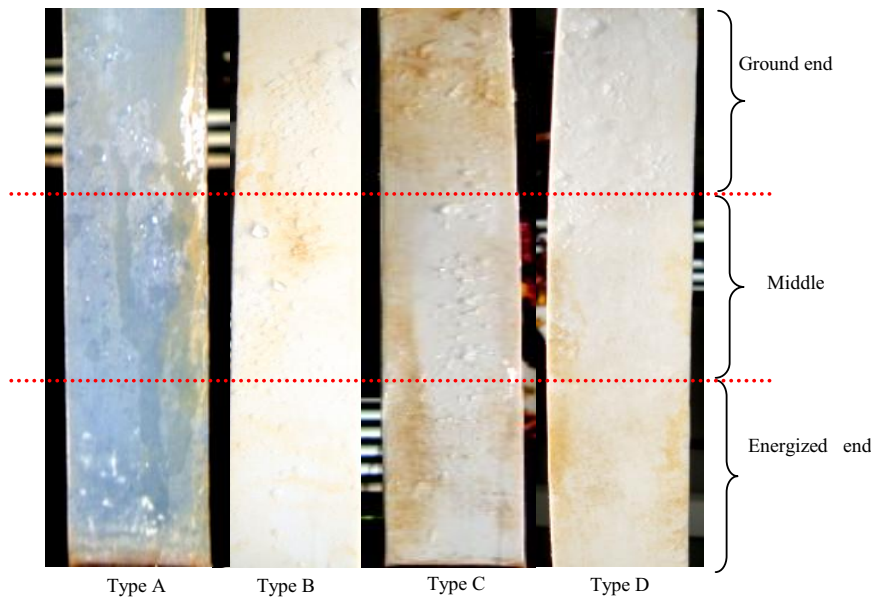
Fig. 8 Characteristics of hydrophobicity on surface

Significant decreasing in hydrophobicity can be observed on thoroughly surface of the specimens. Extremely loss of hydrophobicity (HC 6) was observed on thoroughly surface of specimen type A. In the case of the specimen without ATH and without filler surface treatment, a larger reduction in hydrophobicity can be seen compared with the other specimens having ATH. Such results indicate that ATH filler and filler surface treatment can delay the reduction of hydrophobicity on silicone rubber surface. Also, extremely loss of hydrophobicity (HC 6) at energized end was observed on all specimen surfaces. Such results indicate that high electric field stress can accelerate the reduction of hydrophobicity on the specimen surface.

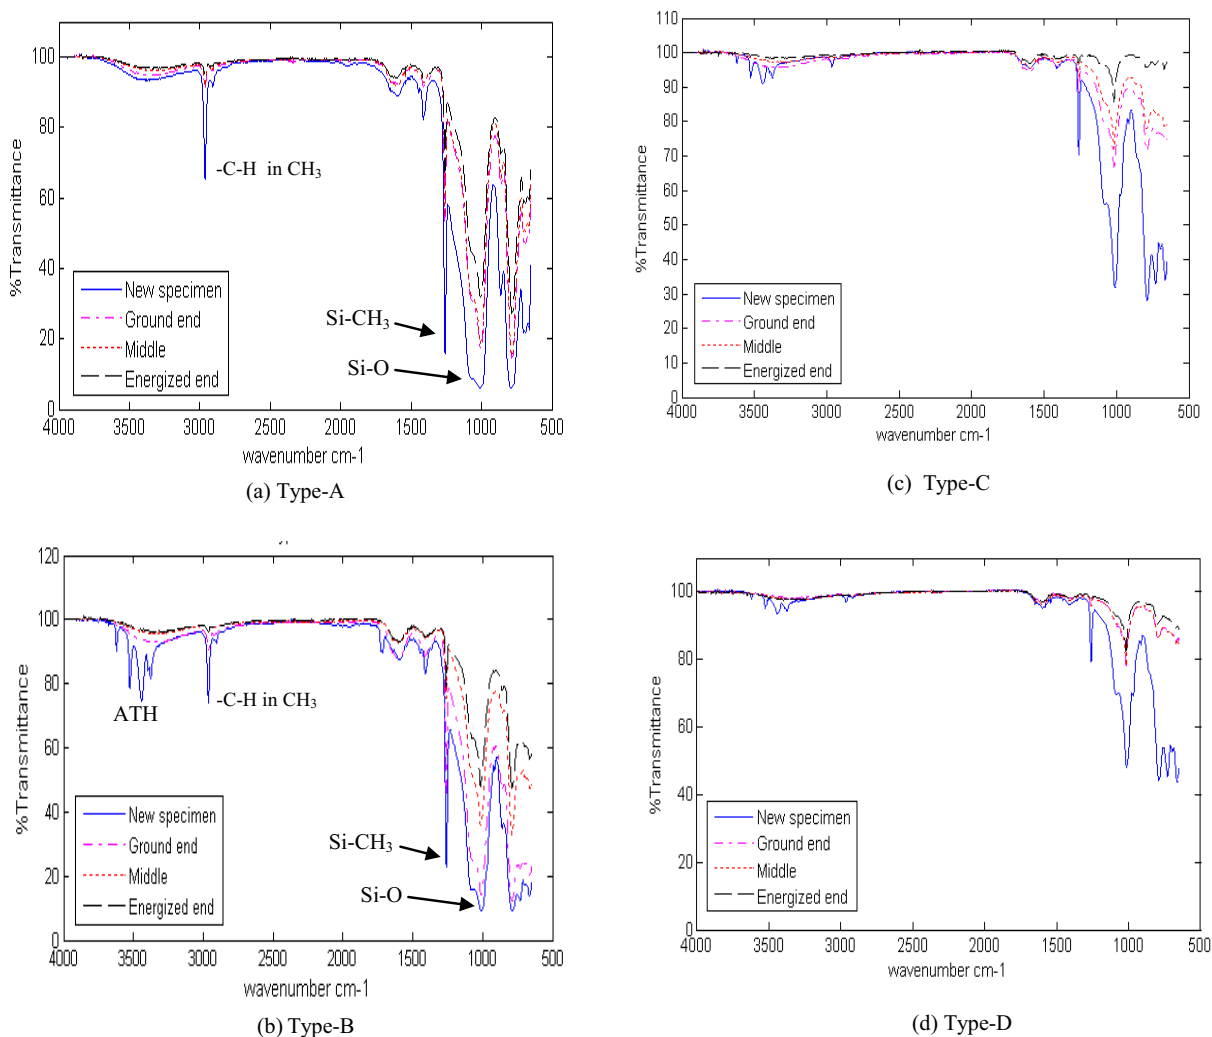
Fig. 9 FTIR spectra of test specimens

The chemical bonds of interested chemical structure are bonding side chain (Si-CH<sub>3</sub>) with wave number 1261 cm<sup>-1</sup>, backbone (Si-O) with wave number 1041 cm<sup>-1</sup>. Decreasing of Si-CH<sub>3</sub> means separation of side chain and decreasing of Si-O refers to the separation of the back bone of polydimethylsiloxane bonding changes. The changes in the absorption peak of Si-CH<sub>3</sub> and Si-O bonds show degree of specimen surface deterioration. FTIR spectra of specimens and %Transmittance of specimens after 1000 hrs salt fog test are shown in Fig.9 and Table IV.

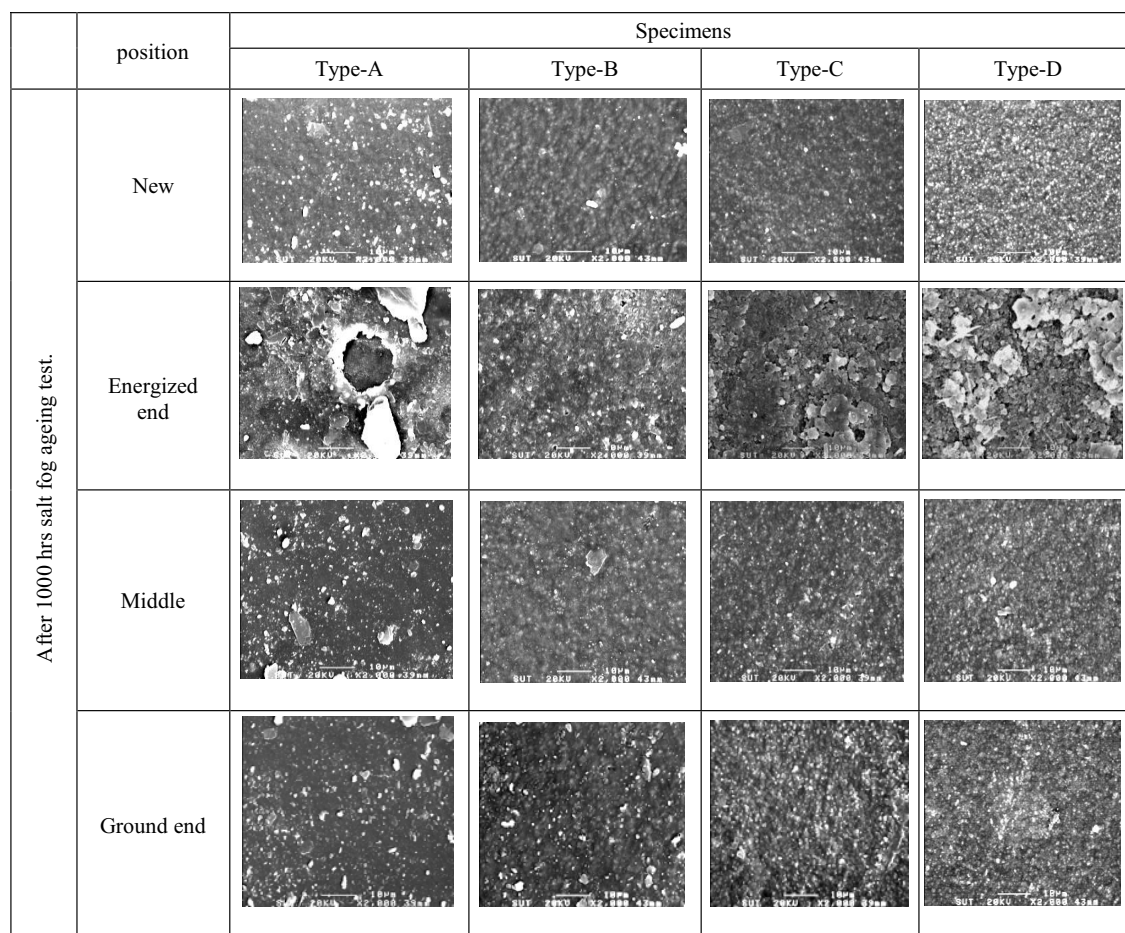
Fig. 10 SEM analyzes of the specimens surface.

A comparison of the photo-micrographs between the aged and new specimen can provide a comparative indication of the surface conditions. Specimens were gold coated prior to examination [11]. Severe micro-erosion was observed on the energized end of tested specimen type-A comparing with the other type, as shown in Fig. 10.

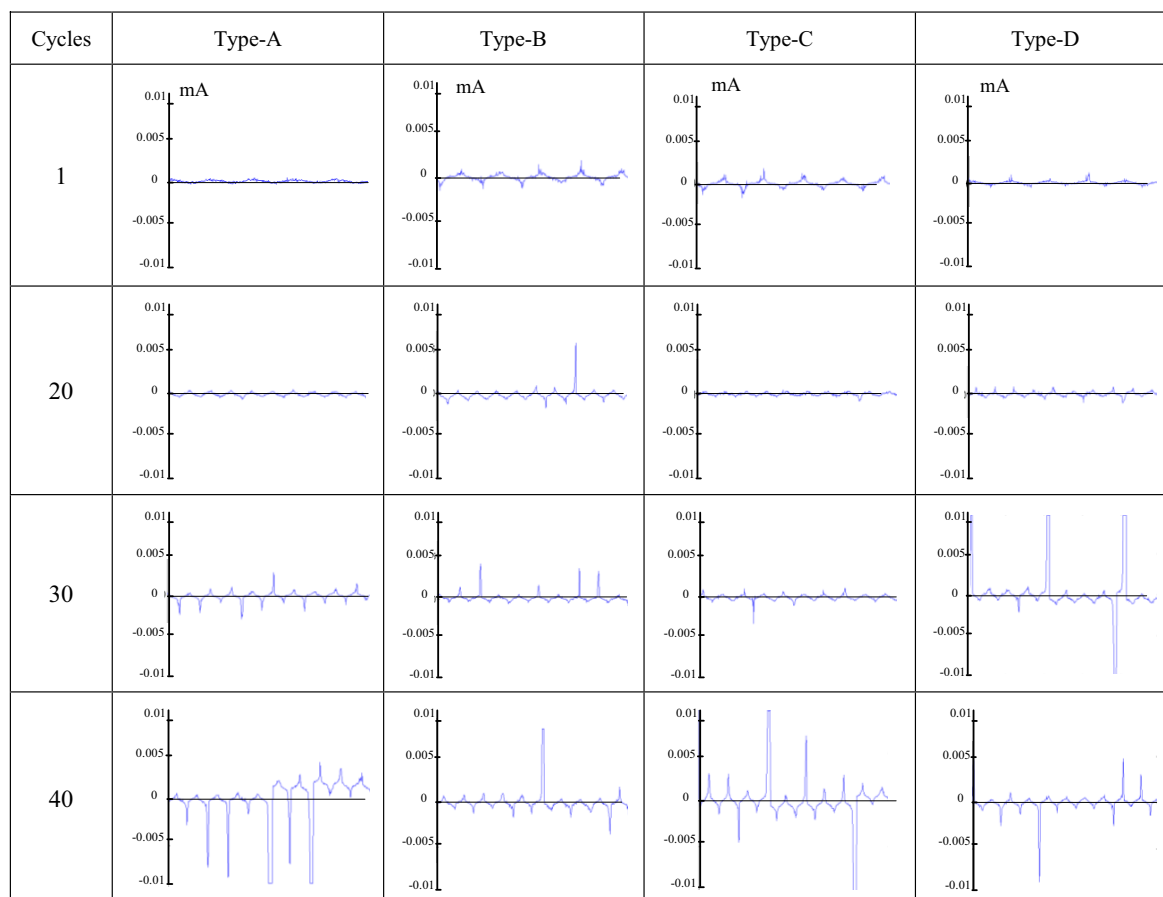
Fig. 11 Leakage current waveform (1 cycle is 24 hrs).

Leakage current flowing along the specimen surface was continuously measured and was recorded every 1 minute by leakage measuring software via LabView. Typical leakage current waveforms in each test cycle during salt fog injection are shown in Fig.11. The magnitudes of the leakage current increased gradually as the number of test cycles increased. The degree of the surface deterioration correlated with magnitudes of the leakage current.
