The Fracture Resistance of Zirconia Based Dental Crowns from Cyclic Loading: A Function of Relative Wear Depth

T. Qasim, B. El Masoud, D. Ailabouni

Abstract—This *in vitro* study focused on investigating the fatigue resistance of veneered zirconia molar crowns with different veneering ceramic thicknesses, simulating the relative wear depths under simulated cyclic loading. A mandibular first molar was prepared and then scanned using computer-aided design/computer-aided manufacturing (CAD/CAM) technology to fabricate 32 zirconia copings of uniform 0.5 mm thickness. The manufactured copings then veneered with 1.5 mm, 1.0 mm, 0.5 mm, and 0.0 mm representing 0%, 33%, 66%, and 100% relative wear of a normal ceramic thickness of 1.5 mm. All samples were thermally aged to 6000 thermo-cycles for 2 minutes with distilled water between 5 °C and 55 °C. The samples subjected to cyclic fatigue and fracture testing using SD Mechatronik chewing simulator. These samples are loaded up to 1.25×10^6 cycles or until they fail. During fatigue testing, extensive cracks were observed in samples with 0.5 mm veneering layer thickness. Veneering layer thickness 1.5-mm group and 1.0-mm group were not differ

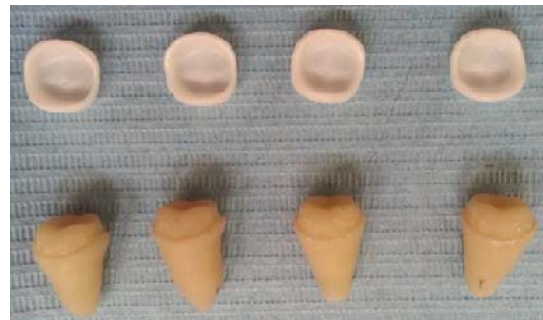
Fig. 2 Lateral view of fabricated abutments

To reduce shrinkage stress and cuspal deflection, the crown-fitting surface was filled with resin-based composites using the incremental layering technique buildup, and consequently, optimal adaptation to the crown can be achieved [17]. Each layer (about 2 mm thickness) was light cured for 40 seconds according to manufacturer's instructions using light curing device at 450 nm. The dies had a length not less than 8 mm below the gingival line to be able to embed them in the acrylic resin, and were checked visually to determine whether voids and defects are present, as shown in Fig. 2.

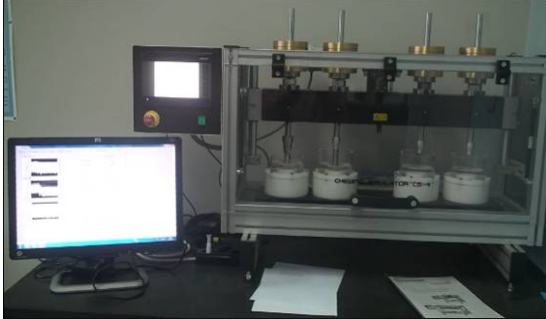
Fig. 3 Chewing simulator with the testing system's computer monitoring software

Specimens were subjected to cyclic fatigue and fracture testing using CS-4.2 SD Mechatronik chewing simulator (SD Mechatronik, Germany) as shown in Fig 3. The chewing simulator contains four test chambers, each chamber having an individual weight with a loading bar. A transverse bar that is mechanically driven by a stepping motor controls the horizontal and vertical movement links all bars. All chambers were filled with room temperature distilled water. To simulate the excursive movement of the human jaw, the sample's

buccal surface was mounted facing forward with the direction of the lateral. The simulator's movement is normally based on four biaxial movements: downward movement of the antagonist, lateral movement of the X-axis, upward movement and then movement of the X axis back to the starting point.

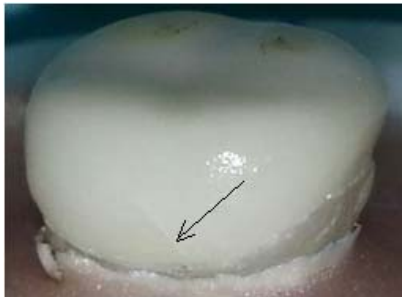
Fig. 6 Lingual surface of sample no.1 of 0.5 mm group after mouth-motion fatigue testing indicating its crack pattern

Extensive crack was observed in one sample in the 0.5-mm

veneering layer thickness group. This crack was observed first at 250×10^3 cycles with one cracking behavior. This crack occurred on the crown's lingual surface starting at the surface's margin and extended occlusally indicating the presence of a radial crack, shown in Fig. 6 with arrow pointing to radial cracks.
