The Performance and the Induced Rebar Corrosion of Acrylic Resins for Injection Systems in Concrete Structures

C. S. Paglia, E. Pesenti, A. Krattiger

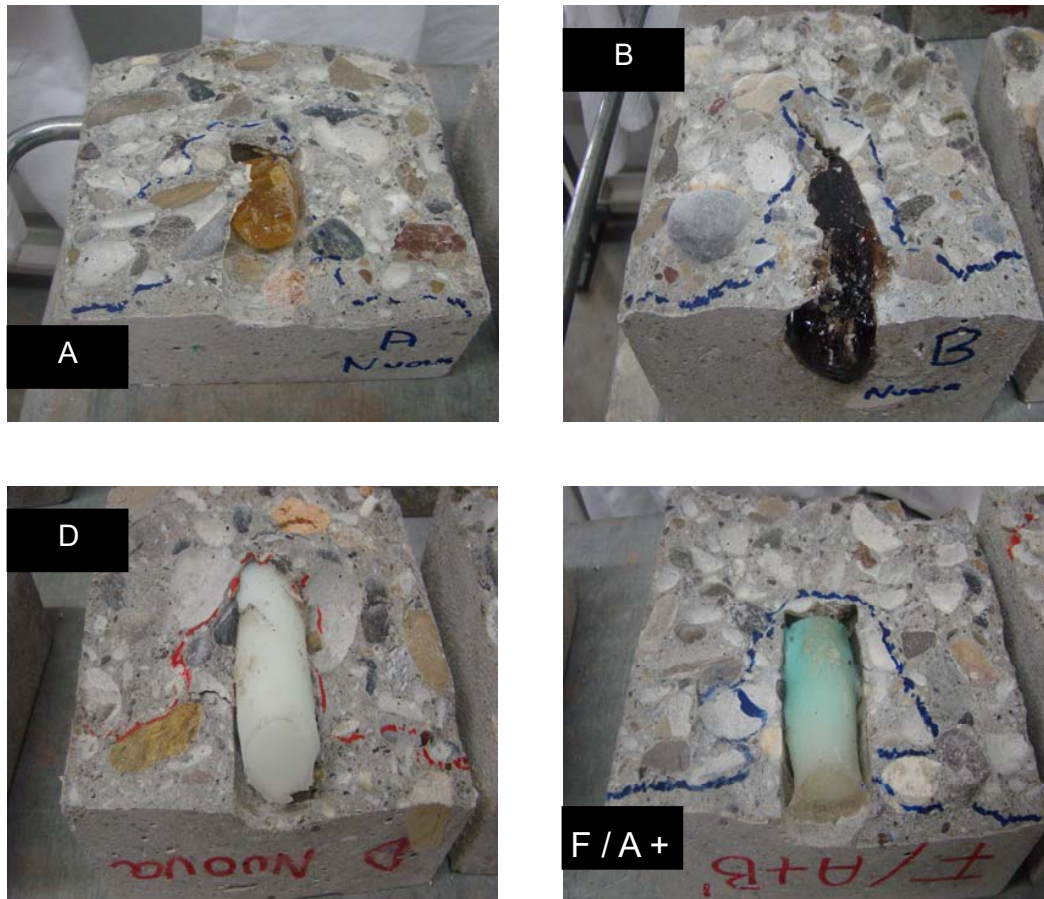
Fig. 3 Water penetration fronts measured according to the norm EN 12390-8 of the halves of concrete cube holes filled with the resins

The water penetration profiles for the cubes filled with the freshly mixed resins and broken in two halves exhibit a wide and deep penetration front along the hole filled with resin A. A relative reduction of the water penetration depth and width is observed for resins B, D and F/A+BI (Fig. 3).

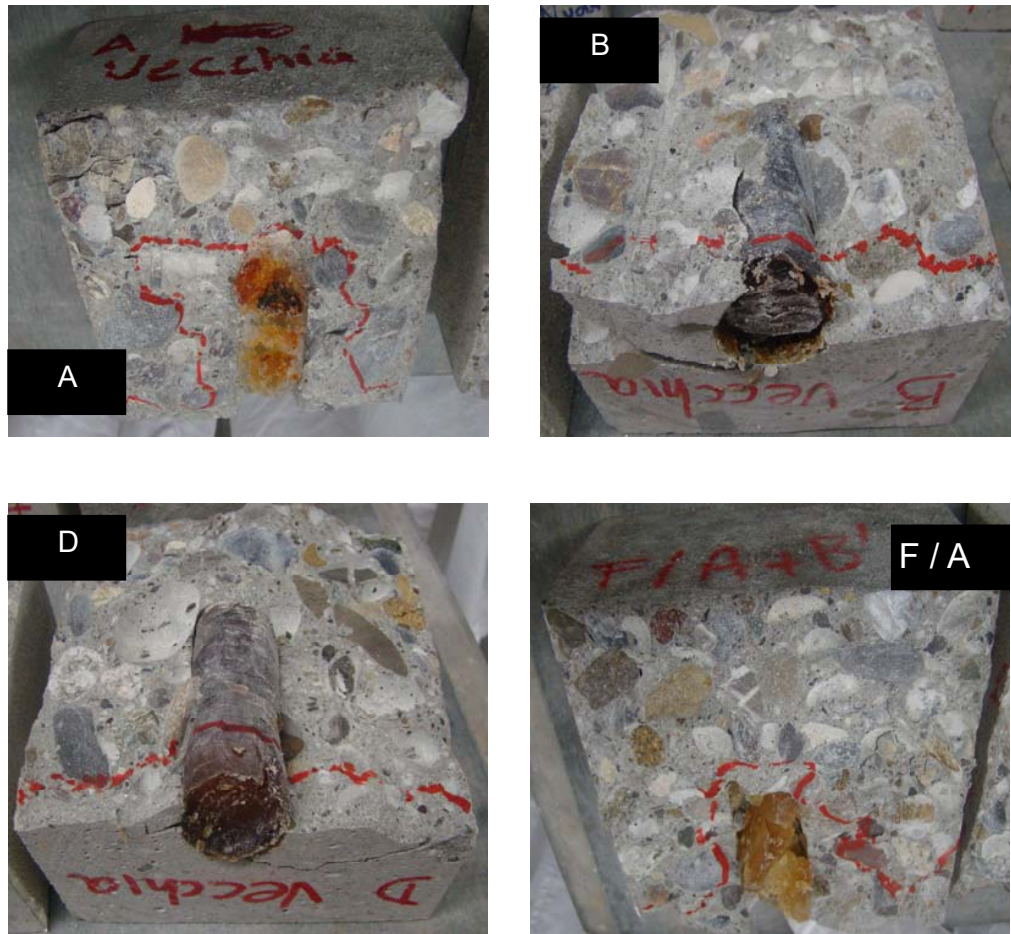
Fig. 4 Water penetration fronts measured according to the norm EN 12390-8 of the halves of concrete cube holes filled with the resins previously exposed to the durability cycles according to the norm EN 13687-3

interface resin-concrete. The weaker is the sealing along this latter interface, the wider is the penetration front line, as for instance for resin A. Interestingly, the depth and width of the water penetration front of the resin A and F/A+ BI, previously exposed to the durability cycles, increases or remain almost the same as compared to the holes filled with the same resins, but not subjected to the durability cycles (Figs. 3, 4 B, F/A+BI). On the contrary, resin B (acrylamide-based) and resin D (methacrylate-based) exhibit, after the exposure to the durability cycles and placing in the concrete holes, a significant reduction in the water penetration front lines. In fact, for these latter resins, a maximum water penetration depth of 32 mm and 24 mm, respectively, is observed (Table

III). In these latter cases, the interface resins-concrete appears to be almost completely sealed by the resins.

The penetration fronts are almost horizontal and are generally controlled by the concrete permeability itself and not by a lack of sealing along the interface resin-concrete. Thus, for these latter resins, ageing processes taking place over time do not significantly modify the relatively good water sealing performance.

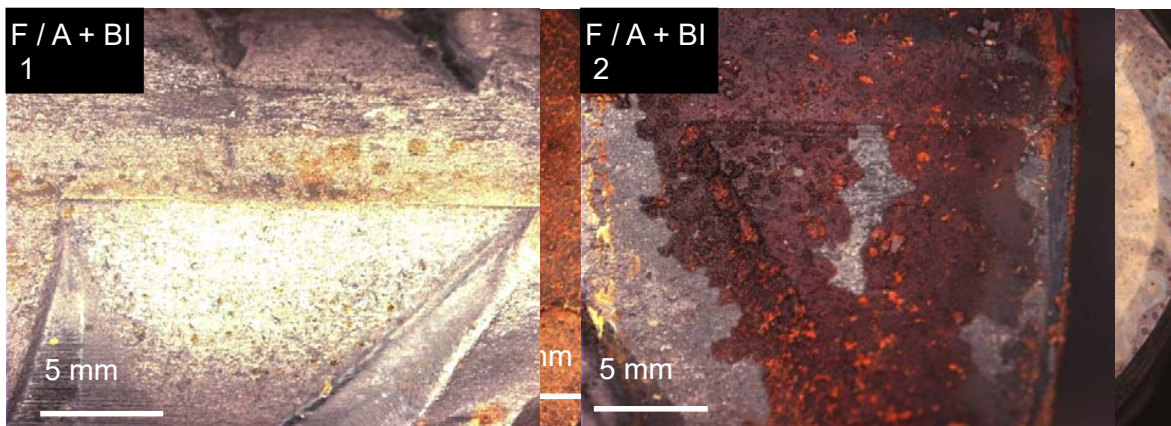
Fig. 9 Detailed view of the rebar in contact with resin F/A+BI. F/A+BI 1: slight presence of corrosion products for the rebar immersed in the resin. F/A+BI 2: corrosion of the rebar immersed in the aqueous solution F/A+BI. F/A+BI 3 Slight formation of corrosion products on the lower surface of the rebar immersed in resin F/A+BI. F/A+BI 4 Layers of corrosion products on the upper rebar surface in contact with the aqueous solution F/A+BI

On the other hand, the methacrylate-based resin F/A+ BI exhibits similar corrosion features as resin A and resin B (Fig. 9).

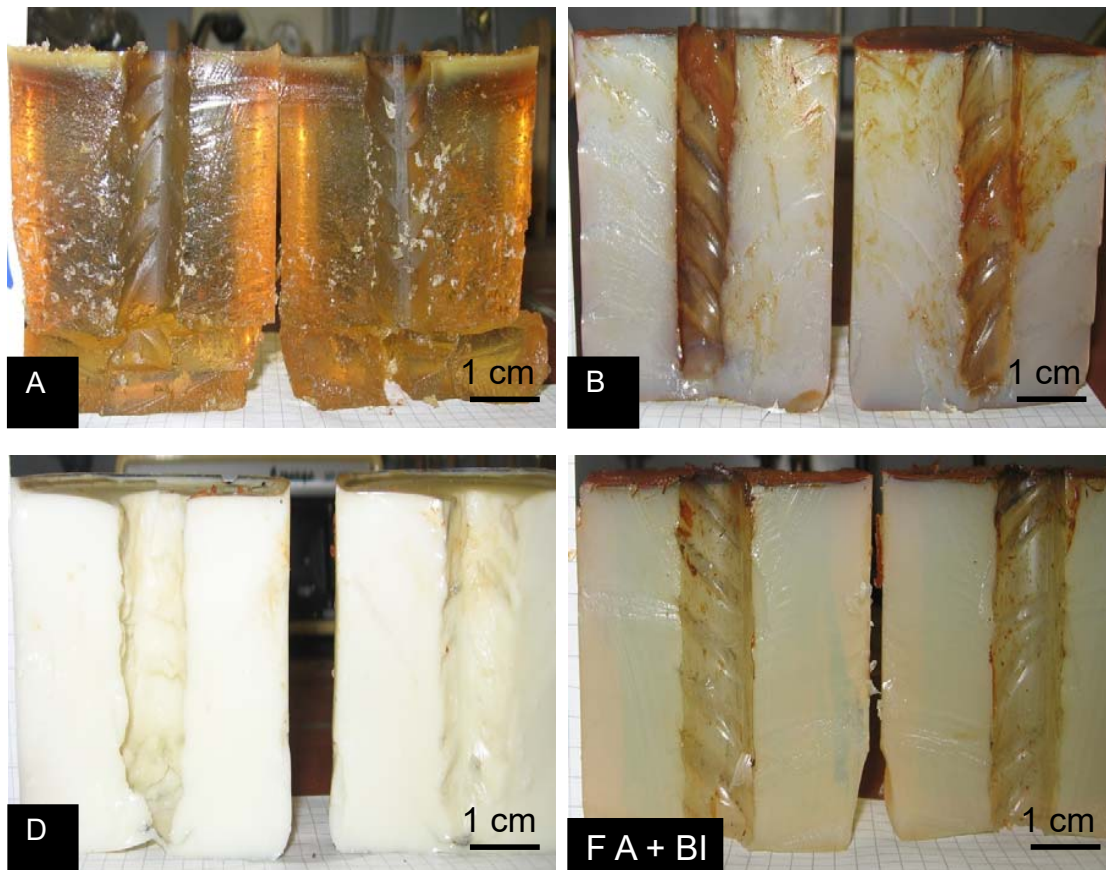
Fig. 10 Resin A: slight presence of corrosion products, in particular in the upper part of the resin (red-black colour) close to the aqueous solution. Resin B: uniform presence of corrosion products along the rebar region. Resin D: almost total absence of colouring effects due to the formation of corrosion products. Resin F/A+BI: uniform presence of corrosion products along the rebar region, in particular in the upper region close to the aqueous solution

In order to further clarify the presence of corrosion products, the resins were cut in two halves and examined with respect to the colour change along the regions where the rebars were placed. In this concern, it is clear that the resin D did not generally exhibit corrosion products along the rebar region, while the other resins indicate a presence of corrosion products, which contributed to the colouring of the resin along the rebar regions (Fig. 10).
