# Tool Damage and Adhesion Effects in Turning and Drilling of Hardened Steels

**Abstract**—Noteworthy results have been obtained in the turning and drilling of hardened high-strength steels using tungsten carbide based cutting tools. In a finish turning process, it was seen that surface roughness and tool flank wear followed very different trends against cutting time. The suggested explanation for this behaviour is that the profile cut into the workpiece surface is determined by the tool's cutting edge profile. It is shown that the profile appearing on the cut surface changes rapidly over time, so the profile of the tool cutting edge should also be changing rapidly. Workpiece material adhered onto the cutting tool, which is also known as a built-up edge, is a phenomenon which could explain the observations made. In terms of tool damage modes, workpiece material adhesion is believed to have contributed to tool wear in examples provided from finish turning, thread turning and drilling. Additionally, evidence of tool fracture and tool abrasion were recorded.

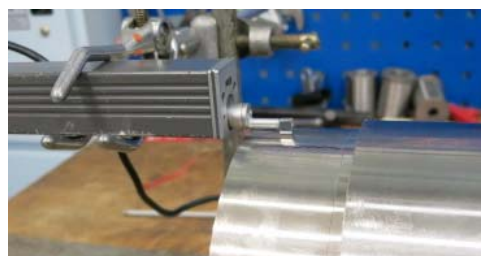
Fig. 1 Measuring roughness on turned bar surface

A standard toolmaker's microscope was used to gather images of the rake and flank faces of each tool for wear measurement and analysis. A Mitutoyo SJ-301 device was used to measure surface roughness in the direction of the bar's axis, applying a fixed cutoff wavelength of 0.8 mm (refer to Fig. 1 for a picture of the roughness measurement arrangement). InfiniteFocus G4 and SL devices from Alicona were used to create high resolution 3D scans of the turned surface and of damaged cutting tools.

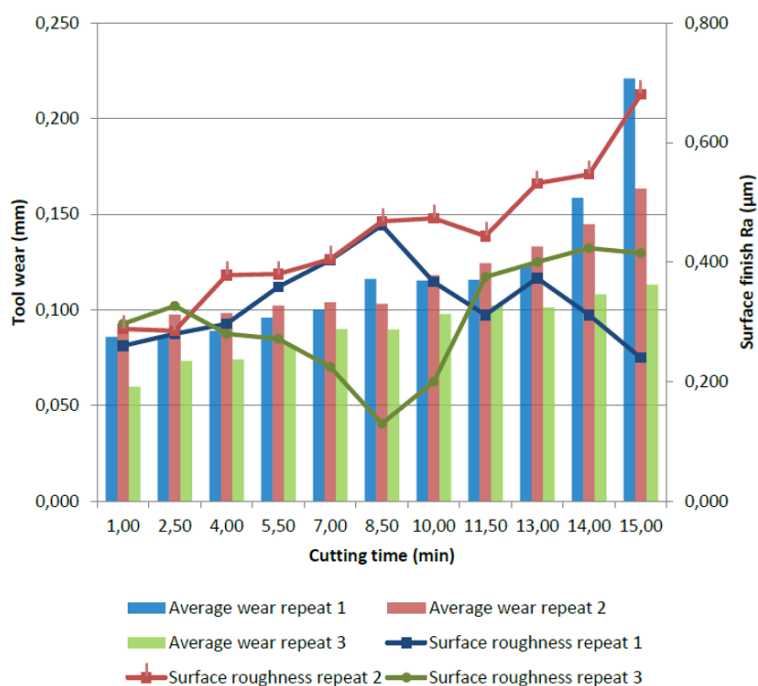
Fig. 2 Tool flank wear and surface roughness progression against time for repeat finish turning cuts. Surface finish in micrometres

For the results which are relevant to the following discussion see Figs. 2-4. Referring to Fig. 2 first, turning tool wear tests were run in an identical fashion three times over. Each repeat test began with a brand new cutting edge: the edge progressively wore during the cutting process. The measured average surface roughness ( $R_a$ ) is seen to increase and decrease over time. In repeat 2, there is an almost-monotonic upward trend in surface roughness from 0 to 15 minutes of insert cutting time, in repeat 3 there is an overall upward trend in roughness over time with large fluctuation, whilst in repeat 1 the roughness returns to very near the starting value after 15 minutes of cutting. However, over the same time period, the

measured average tool flank wear increases monotonically in all three cases.

The hypothesis to explain this behaviour is that the geometrical effect of adhered workpiece material superimposed onto wear on the cutting edge is what is creating the variable profile cut into the bar's surface and causing the variation in surface roughness. This is borne out by the way in which surface roughness fluctuates independently of the size of the wear scar (Fig. 2), and by the cross-sectional profile measured on the turned surface (Fig. 3). Adhesion causes short-term fluctuations in the surface roughness, whilst tool wear leads to a long-term upward trend in surface roughness (only seen in 2 out of 3 repeat tests). From examination of the turned surface data in Fig. 3, the cross-sectional profile of the surface in the direction of tool feed can be observed to have a cyclic wave-type pattern with a wavelength of 0.088 mm. Note that the tool feed and workpiece rotation combine to create a helical cutting pattern. 0.088mm is the feed per revolution of the turning operation, equivalent to the pitch of the cut helix. However, the exact appearance of each wave profile varies noticeably at each revolution of the bar. Fig. 3 is a scan of the surface created at the end of repeat wear test number 2, where the highest surface roughness was measured. The cut wave profile corresponds to the true profile (shape) of the cutting edge, similar to the case of a serrated knife moving through butter. The nominal shape of the cutting edge is a circle arc, as the tool insert was created with a 1.6 mm radius nose, but the true profile cut into the workpiece surface is far from a circle arc. The profile of the cutting edge has been modified by the joint effects of adhesion and wear. Each revolution of the bar occurs in less than one second, the tool wear occurring in this time period is minimal so the rapid change of profile observable from wave to wave in Fig. 3

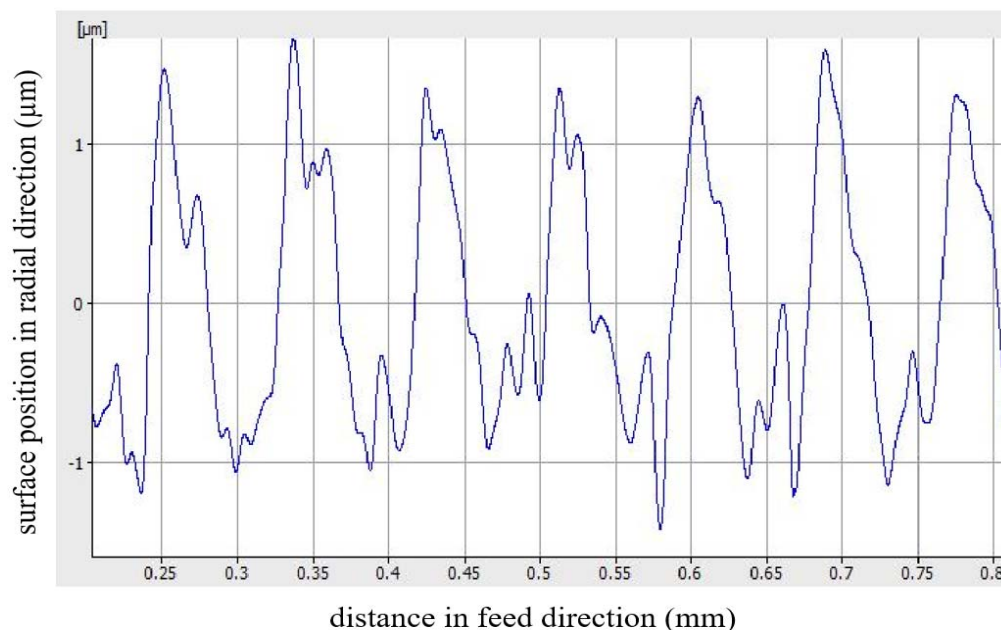
Fig. 3 Turned surface profile, in plane perpendicular to cutting speed direction

cannot be explained by tool wear. The proposal is that adhesion or BUE on the tool cutting edge has a large effect on the instantaneous surface finish of the turned bar.

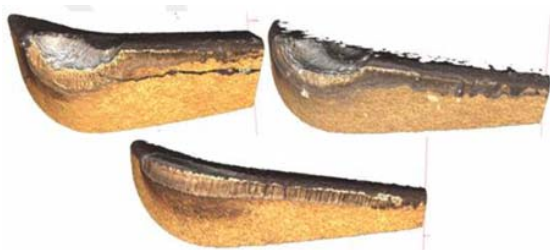
Fig. 4 High resolution 3D scans of tools after 15 minutes' turning

Fig. 4 displays high-resolution scans of the three turning inserts used in these trials. Moving clockwise from the top left, the inserts are from repeat trials 1, 2, and 3 as discussed. The rake face coating is black in colour; the insert flank coating is lighter in colour. The thin edges between the black surfaces and lighter-coloured surfaces are the cutting edges. The reflective silvery material visible in damaged areas along the cutting edges is adhered workpiece material. The uncoated tungsten carbide and cobalt substrate would appear as matt grey, but any areas where the coating has been removed are now covered in adhered material. Many thin “track” or “groove” damage features can be seen on the tool flanks, particularly visible for insert 3. These are orientated perpendicular to the cutting edges, and are the result of abrasive flank wear. Additionally, crater wear can be seen on the rake face in the case of inserts 1 and 2, this is due to the motion and heat resulting from cut chips (swarf) flowing over the rake face.

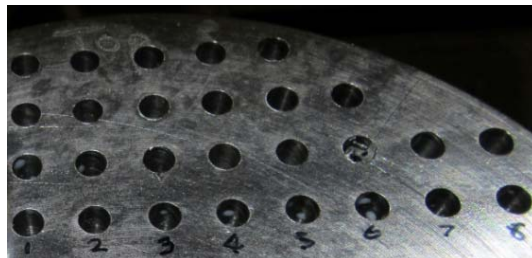
Fig. 5 Array of blind drilled holes in test piece surface

Drilling trials took place on a Starrag ZT1000 5-axis machining centre, which was chosen for its structurally-rigid machining head and a spindle speed of up to 24000 revolutions per minute. Blind holes were drilled to a depth of 50 mm with 4.5 mm diameter coated solid carbide 2-fluted drills. The hole depth is therefore 11 times the diameter. Fig. 5 shows an image of the drilled test holes. A shrink fit tool holder was used for all 4.5 mm drilling as shown in Fig. 6 (a). This holder provided a high grip force and low tool runout (or eccentricity), being less than 10 micrometres in all cases. The cutting fluid was a water-based emulsion supplied at 6-8% concentration. All 4.5 mm drills featured through-tool coolant holes, coolant was supplied through the machine spindle to the tool with 70 bar supply pressure.

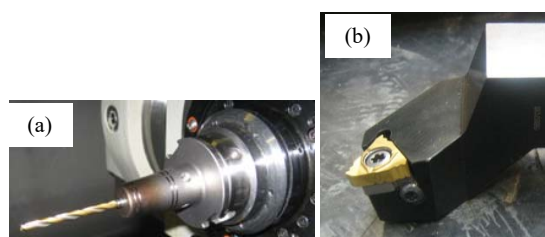
Fig. 6 Tool holding arrangements for (a) drilling and (b) thread turning

In the thread turning process, ISO standard threads were created with a 60-degree form and a pitch of 1.5 mm, equal to the programmed feed per revolution (refer to Fig. 7 for a picture of a finished thread). A shank tool was used to hold coated tungsten carbide based threading inserts as shown in Fig. 6 (b). The Hawk CNC lathe was used for thread turning, the same machine as described in Section II. Threads were

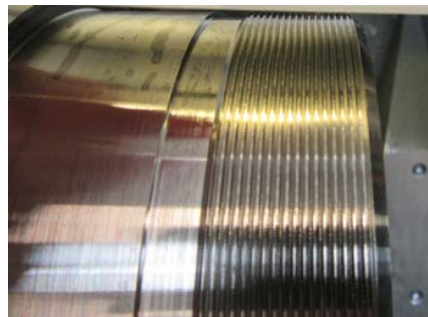
Fig. 7 Turned thread on cylindrical test piece

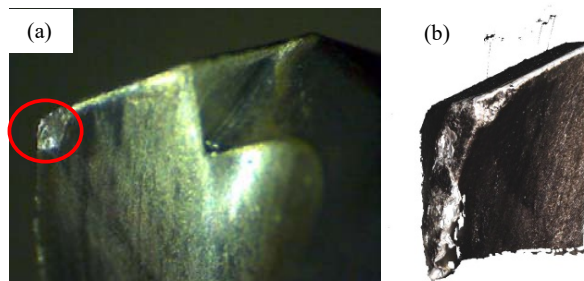
Fig. 8 Drilling failure images (a) microscope image of the end of flute 1; and (b) high-resolution 3D scan of failed drill corner, flute 2

The most common failure mode for drills was as shown in Fig. 8, involving loss of the corner region. This was the failure mode in around 70% of cases. In the remaining 30% of cases, fractures at the chisel edge (drill point) or fractures of the flutes (i.e. the drill broke into two or more large pieces) occurred. In threading, from 12 tests on various insert designs the worn-out cutting edges looked similar to Fig. 9 in every case.

Examining the drill images first: the appearance of the damage in Fig. 8 (a) suggests a “chip” or fracture on the drill corner, but from inspection of Fig. 8 (b), there is a great deal of adhesion around the area of missing tool material. There is no evidence of abrasion in this case. Three possible explanations are that: the drill corner fractured due to excessive cutting stresses imparted into the substrate; or that

adhesion wear plucked away the drill corners as observed by Nomani et al. [13]; or that the flow of cut material (swarf) has caused damage in the corner region, by jamming or abrasion. Both flutes had suffered the same type of damage simultaneously. An argument against stress-related fracture is made in a separate paragraph below. It is worth noting that the effective cutting speed on the end of the drill increases with distance from the centre point. At the centre point (also known as the chisel edge), fractures can occur due to high thrust and near-zero surface speed. The corner of each flute is a weak point structurally, meanwhile the surface speed is at its maximum value at the corner and periphery of the drill, which makes thermally-driven wear mechanisms more likely.

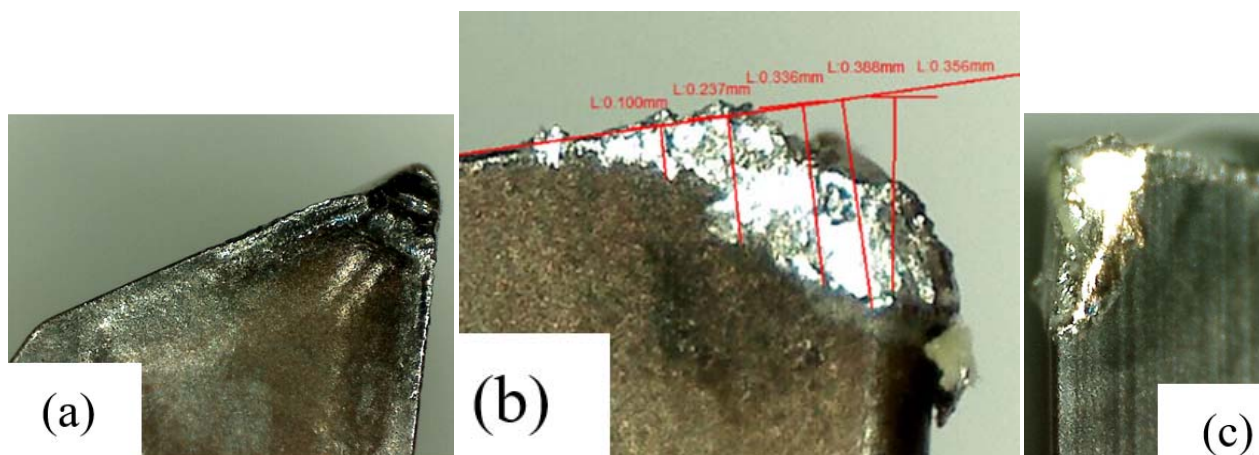
Fig. 9 Microscope images of failed thread turning inserts: (a) rake face view; (b) flank view 1; (c) flank view 2

When examining the threading insert (Fig. 9), adhered or “welded” material is present covering the entire damaged area of the cutting edge, which was also the case for the finish turning and drilling examples in this paper. A combination of adhesion and abrasion is the probable dominant cause of damage to the tool tip. Thread turning is a process where productivity is likely to be constrained by tool wear, because machining of the correct thread form requires a thin, sharp

insert geometry. The tip radius of the thread turning inserts used was 0.13 mm, which is required to create the correct thread root radius. The corner radius on the drills was around 0.2 mm, which may make the corner susceptible to damage. A blunter reinforced drill corner may survive better, if this is acceptable in terms of the hole geometrical requirements.
