Triplet Shear Tests on Retrofitted Brickwork Masonry Walls

Berna Istegun, Erkan Celebi

Abstract—The main objective of this experimental study is to assess the shear strength and the crack behavior of the triplets built of perforated brickwork masonry elements. In order to observe the influence of shear resistance and energy dissipating before and after retrofitting applications by using the reinforcing system, static-cyclic shear tests were employed in the structural mechanics laboratory of Sakarya University. The reinforcing system is composed of hybrid multi-axial seismic fabric consisting of alkali-resistant glass and polypropylene fibers. The plaster as bonding material used in the specimen's retrofitting consists of expanded glass granular. In order to acquire exact measuring data about the failure behavior of the two mortar joints under shear stressing, vertical load-controlled cylinder having force capacity of 50 kN and loading rate of 1.5 mm/min. with an internal inductive displacement transducers is carried out perpendicular to the triplet specimens. In this study, a total of six triplet specimens with textile reinforcement were prepared for these shear bond tests. The t

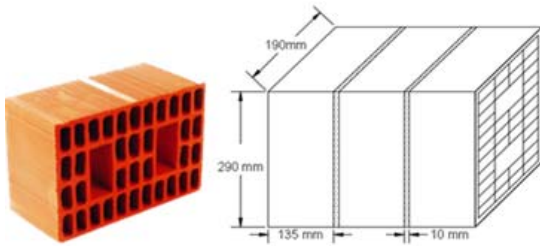
Fig. 1 Brick block and triplet specimen

Technical features of perforated bricks are given in the Table I. Each produced test set consists of a triplet of perforated brick blocks with three identical specimens (Fig. 1). Moreover, there are three sets of triplet specimens of which two of them were strengthened by using seismic fabric and its special plaster. The remaining one set of non-strengthening

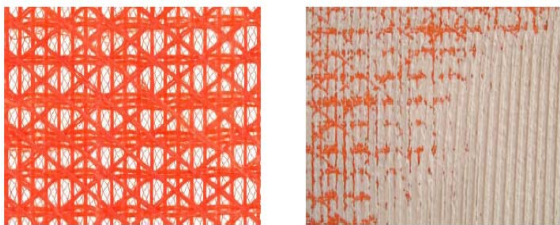
Fig. 2 The hybrid multiaxial seismic textile

The plaster and seismic fabric are implemented in two forms: Unilateral (D1G03) and bilateral (D1G04-T). Additionally, the thickness of plaster layer is equal to 2 cm for D1G03 and 1 cm (on each surface) for D1G04-T. The strengthening process is a combination of multi-axis hybrid seismic textile and special adhesive plaster (Fig. 2). This textile material comprises of alkali-resistant glass and polypropylene fibers.

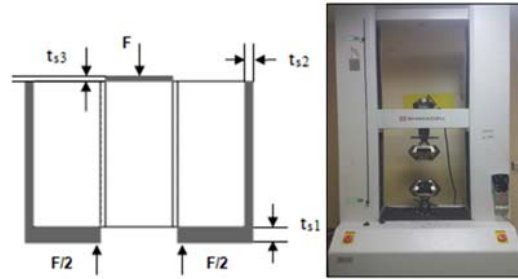
Fig. 3 Scheme of triplet shear test and test device

A steel plate with a thickness of 12 mm was situated on the middle brick of the triplet specimen in order to reduce the influence of the bending moment and transmit the load properly to the mortar. For providing the stability of the test setup, the outer two bricks were also supported by two steel L profiles. The results of the experimental study are recorded by a displacement sensor integrated into the load cylinder.

Test device in which all experiments conducted and the scheme of triplet test are illustrated in Fig. 3. The relevant thickness parameters (t_s) used in the triplet shear test are $t_{s1}=30$ mm, $t_{s2}=12$ mm and $t_{s3}=12$ mm, respectively.

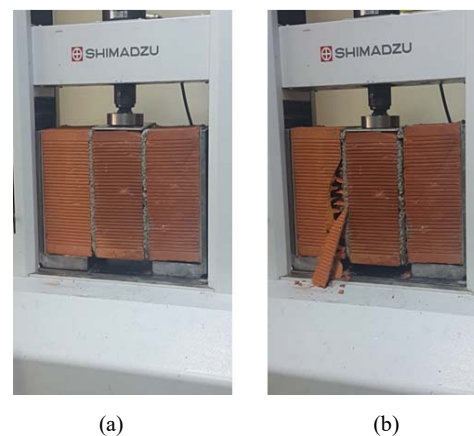
Fig. 4 (a) Initial state and (b) final state of D1R00-1

Firstly, the shear capacity was investigated without applying any plaster which was defined as the reference sample of the non-retrofitted masonry specimen. To describe this case, the non-strengthened control specimens are called as D1R00. Due to the fact that there are three specimens for each experiment set, each sample in the set is designated as D1R00-1, D1R00-2, and D1R00-3, respectively. Both initial and final states of failure under triplet shear test for D1R00-1 are given in Fig. 4.

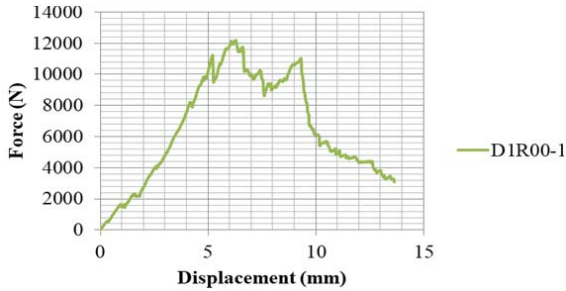
Fig. 5 Force-displacement diagram of the D1R00-1

The maximum shear force F_{max} for this sample is obtained as 12200 N. The attained force-displacement relationship is illustrated in Fig. 5.

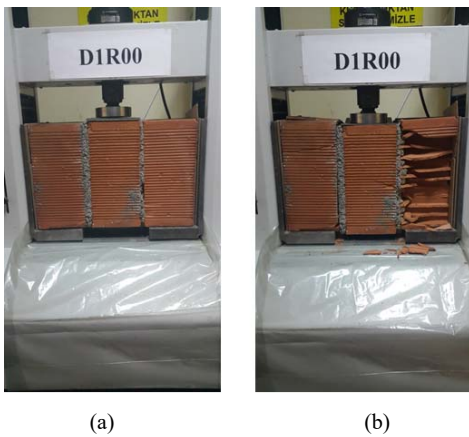
Fig. 6 (a) Initial state and (b) final state of D1R00-2

Similarly, triplet shear tests were performed for the D1R00-2 and D1R00-3 and the resulting crack forms are shown in Figs. 6 and 8, respectively.

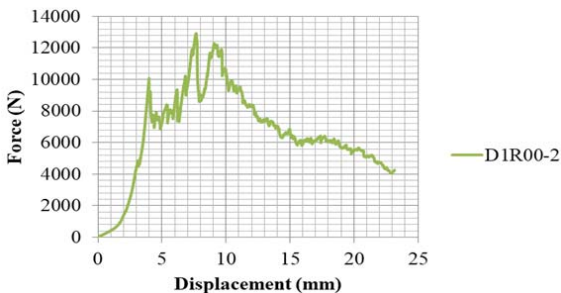
Fig. 7 Force-displacement diagram of the D1R00-2

As can be seen from Figs. 7 and 9, due to lack of ductility, the shear strength of the brick units suddenly decreased and brittle fractures occurred rapidly under stress. These damages are abrupt. The failure surface of specimen exhibits little degradation before the fracture occurs.

In this case, the shear strength, f_v are calculated as 0.117 MPa and 0.138 MPa by considering the experimentally

obtained maximum force of 12920 N and 15316 N, respectively.

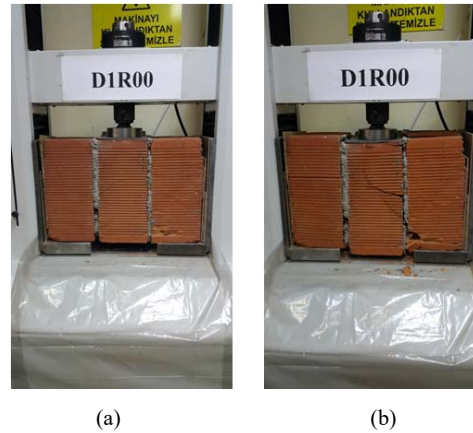
Fig. 8 (a) Initial state and (b) final state of D1R00-3

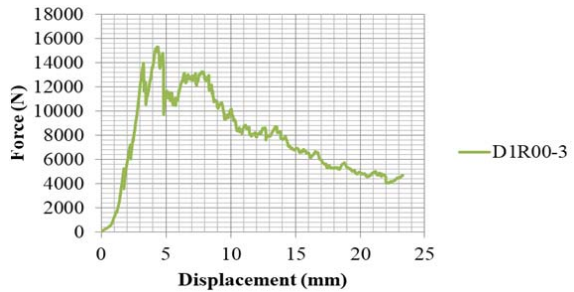
Fig. 9 Force-displacement diagram of the D1R00-3

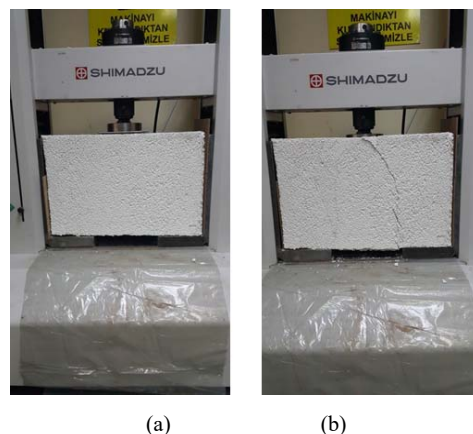
Fig. 10 (a) Initial state and (b) final state of D1G03-1

In the second stage of the experimental study, the effect of the applied seismic textile and the plaster made of expanded glass granular on the shear capacity of mortar joints was investigated. Hereby, the one-sided retrofitted brick specimen with 20 mm reinforcing layer is named as D1G03 for triplet shear test. Firstly, D1G03-1 was tested. The crack pattern of this specimen can be seen in Fig. 10.

The first cracks on the specimens under shear forces were

experienced in vertical form and occurred in brick-mortar interface. When the imposed load reached close to the shear strength capacity of the specimen, the crack widths increased and the middle block separated from the joint plane.

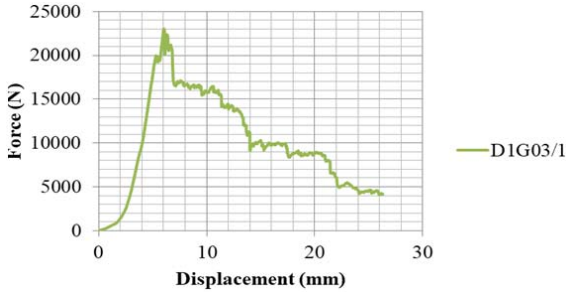
Fig. 11 Force-displacement diagram of the D1G03-1

As shown in Fig. 11, the maximum shear force F_{max} is obtained as 23033 N and the corresponding shear stress value f_v is calculated as 0.209 MPa for specimen of D1G03-1.

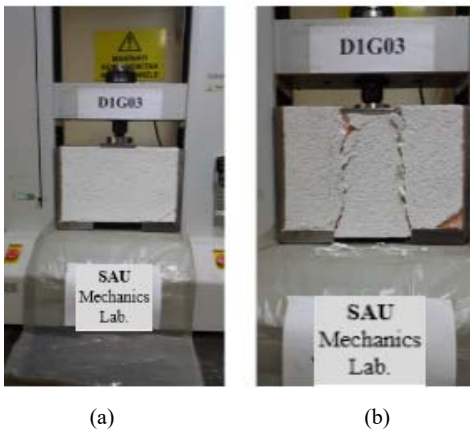
Fig. 12 (a) Initial state and (b) final state of D1G03-2

For the D1G03-2 and D1G03-3 specimens; crack patterns, maximum shear loads and strength parameters were similarly determined. The failure mechanism of the test specimens under the vertical load is shown in Figs. 12 and 14. The maximum shear forces of the second and third sample of the D1G03 test set are equal to 24548 N and 29427 N, respectively (Figs. 13 and 15).

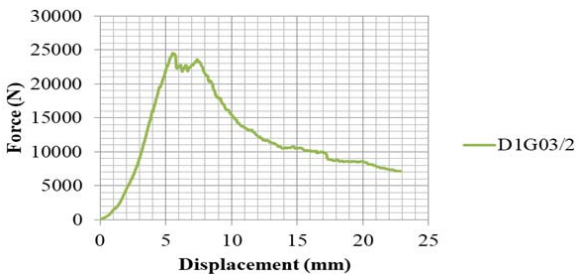
Fig. 13 Force-displacement diagram of the D1G03-2

The values of f_v are 0.220 MPa and 0.267 MPa for D1G03-2

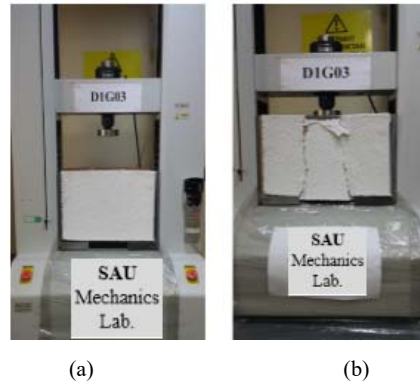
Fig. 14 (a) Initial state and (b) final state of D1G03-3

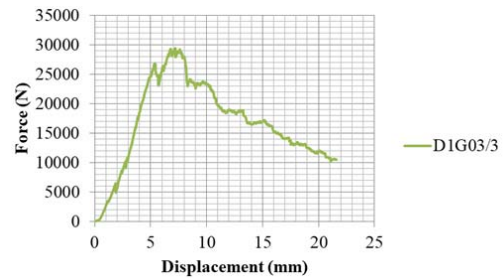
Fig. 15 Force-displacement diagram of the D1G03-3

and D1G03-3, respectively. Single-sided retrofitted triplets exhibited more ductile behavior when compared to the reference samples. Furthermore, it was clearly observed that the unilateral strengthening application significantly increased the shear capacity of the masonry building units. The measured value of F_{max} is 32611 N for this case. Also, f_v is calculated as 0.296 MPa. The curve of force-displacement relationship for D1G04-T/1 is depicted in Fig. 17.

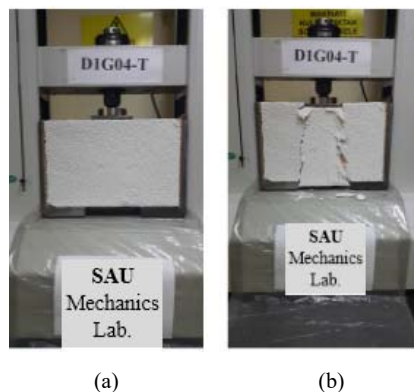
Fig. 16 (a) Initial state and (b) final state of D1G04-T/1

In the final phase of the study, the above mentioned strengthening system was applied to both surfaces of the three specimens and the results were analyzed comparatively. The thickness of the plaster on each surface was considered as 1 cm. The experiment set was named as D1G04-T. Initial and final states of D1G04-T/1 under shear force were in Fig. 16.

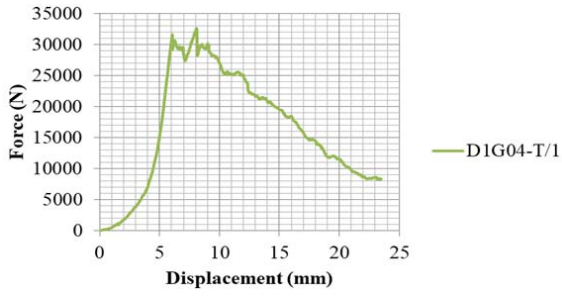
Fig. 17 Force-displacement diagram of the D1G04-T/1

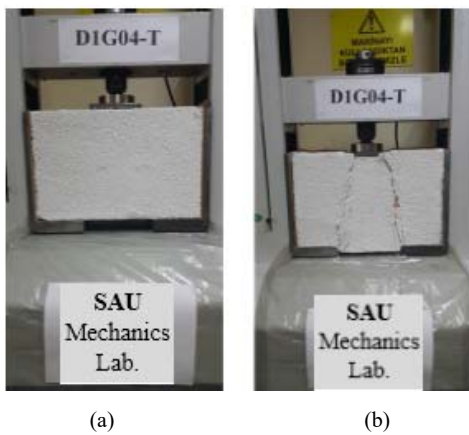
Fig. 18 (a) Initial state and (b) final state of D1G04-T/2

The second and third specimens of the D1G04-T set were also tested. At all specimens in this experiment group, it was obviously seen that the damage started in a similar way to the D1G03 set (Fig. 18).

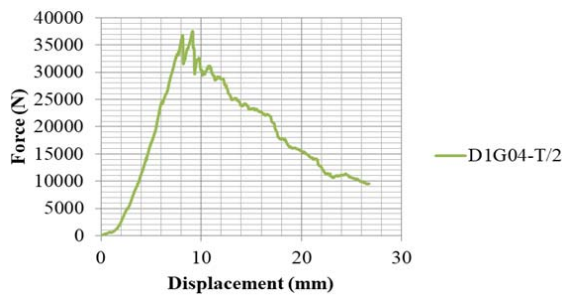
Fig. 19 Force-displacement diagram of the D1G04-T/2

The F_{max} values were determined for these specimens as 37544 N and 36394 N, respectively. The shear strengths were calculated as 0.340 MPa and 0.330 MPa, respectively. The experimental shear force-displacement curve for D1G04-T/2 and D1G04-T/3 are illustrated in Figs. 19 and 21.

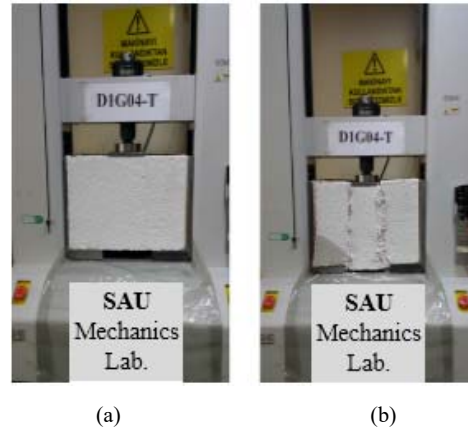
Fig. 20 (a) Initial state and (b) final state of D1G04-T/3

The failure modes of all plastered specimens were similar due to vertical cracks in the direction of loading, which followed the interface between the bricks and joint mortar (Fig. 20).

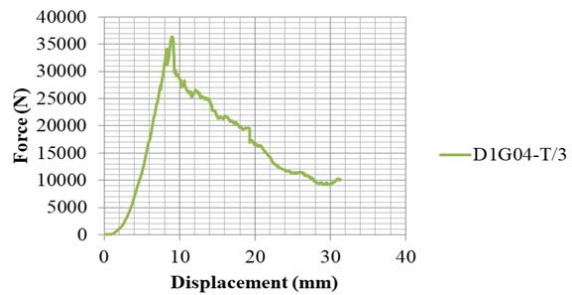
Fig. 21 Force-displacement diagram of the D1G04-T/3

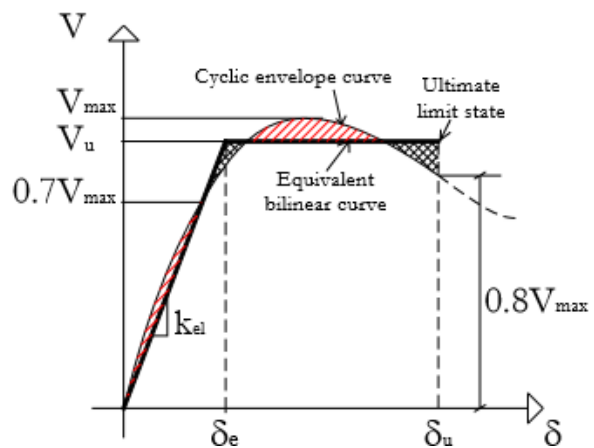
Fig. 22 Bilinear Idealization

Magenes and Morandi [11] calculated the ductility coefficients by idealizing the envelope curve obtained from the experiment with equivalent bilinear curves (Fig. 22). In a similar way, the energy-dissipation capacities of the samples were determined (3), with the force-displacement curves being idealized in this research.

$$\mu = \frac{\delta_u}{\delta_e} \quad (3)$$

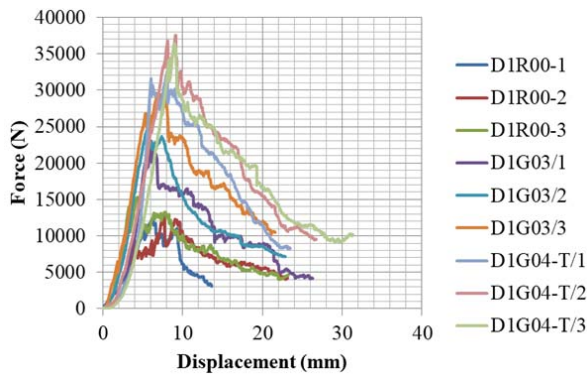
Fig. 23 Comparison of force-displacement diagrams

It is easy to see from the obtained ductility coefficients in Table III, D1G04-T coded samples exhibit a more ductile behavior compared to the other set of experiments (D1G03) and reference samples are insufficient in terms of load bearing capacity, shear strength and energy dissipation. The results of all triplet shear tests performed were compared in Fig. 23.
