Triplet Shear Tests on Retrofitted Brickwork Masonry Walls

Berna Istegun, Erkan Celebi

Abstract—The main objective of this experimental study is to assess the shear strength and the crack behavior of the triplets built of perforated brickwork masonry elements. In order to observe the influence of shear resistance and energy dissipating before and after retrofitting applications by using the reinforcing system, static-cyclic shear tests were employed in the structural mechanics laboratory of Sakarya University. The reinforcing system is composed of hybrid multi-axial seismic fabric consisting of alkali resistant glass and polypropylene fibers. The plaster as bonding material used in the specimen's retrofitting consists of expanded glass granular. In order to acquire exact measuring data about the failure behavior of the two mortar joints under shear stressing, vertical load-controlled cylinder having force capacity of 50 kN and loading rate of 1.5 mm/min. with an internal inductive displacement transducers is carried out perpendicular to the triplet specimens. In this study, a total of six triplet specimens with textile reinforcement were prepared for these shear bond tests. The t

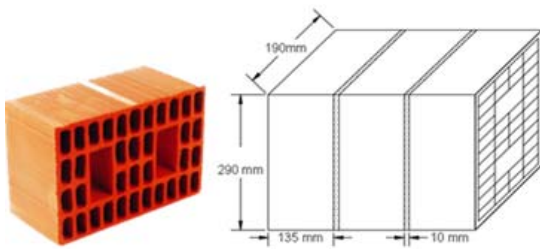
Fig. 1 Brick block and triplet specimen

Technical features of perforated bricks are given in the Table I. Each produced test set consists of a triplet of perforated brick blocks with three identical specimens (Fig. 1). Moreover, there are three sets of triplet specimens of which two of them were strengthened by using seismic fabric and its special plaster. The remaining one set of non-strengthening

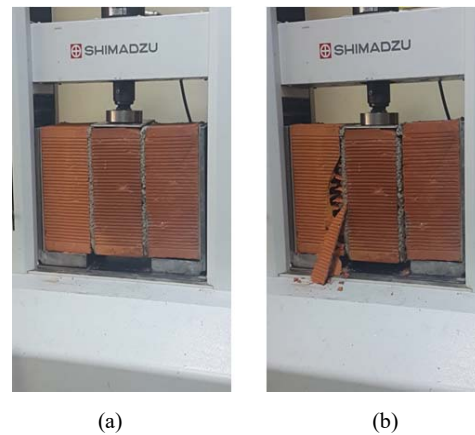
Fig. 4 (a) Initial state and (b) final state of D1R00-1

Firstly, the shear capacity was investigated without applying any plaster which was defined as the reference sample of the non-retrofitted masonry specimen. To describe this case, the non-strengthened control specimens are called as D1R00. Due to the fact that there are three specimens for each experiment set, each sample in the set is designated as D1R00-1, D1R00-2, and D1R00-3, respectively. Both initial and final states of failure under triplet shear test for D1R00-1 are given in Fig. 4.

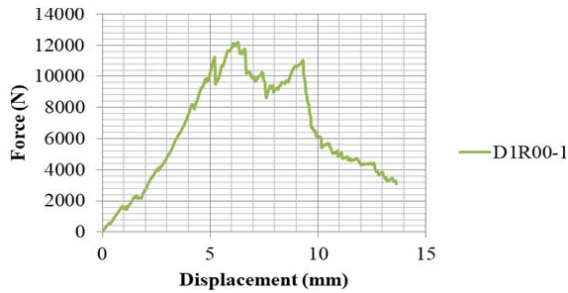
Fig. 5 Force-displacement diagram of the D1R00-1

The maximum shear force F_{max} for this sample is obtained as 12200 N. The attained force-displacement relationship is illustrated in Fig. 5.

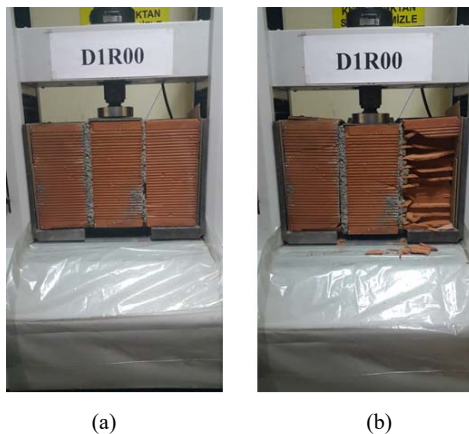
Fig. 6 (a) Initial state and (b) final state of D1R00-2

Similarly, triplet shear tests were performed for the D1R00-2 and D1R00-3 and the resulting crack forms are shown in Figs. 6 and 8, respectively.

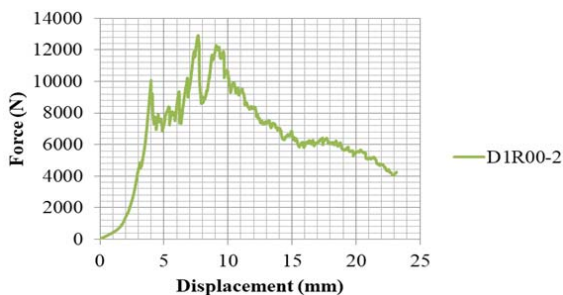
Fig. 7 Force-displacement diagram of the D1R00-2

As can be seen from Figs. 7 and 9, due to lack of ductility, the shear strength of the brick units suddenly decreased and brittle fractures occurred rapidly under stress. These damages are abrupt. The failure surface of specimen exhibits little degradation before the fracture occurs.

In this case, the shear strength, f_v are calculated as 0.117 MPa and 0.138 MPa by considering the experimentally

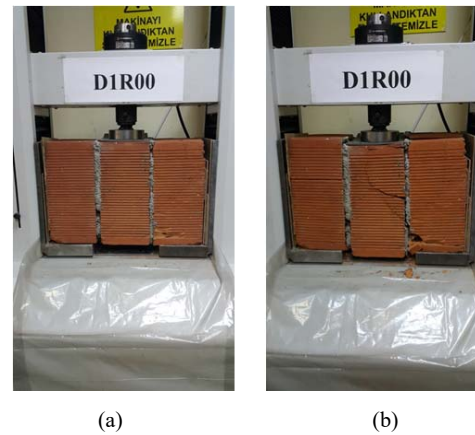
Fig. 8 (a) Initial state and (b) final state of D1R00-3

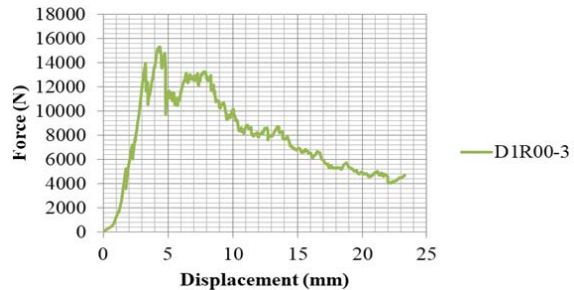
Fig. 9 Force-displacement diagram of the D1R00-3

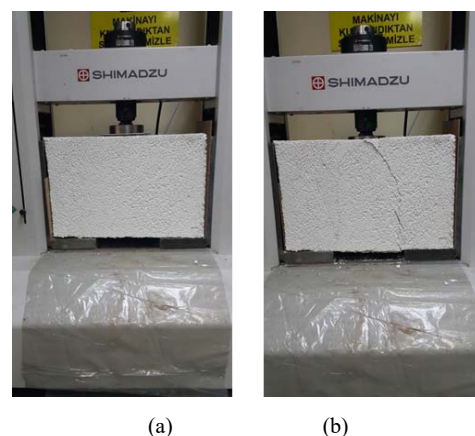
Fig. 10 (a) Initial state and (b) final state of D1G03-1

In the second stage of the experimental study, the effect of the applied seismic textile and the plaster made of expanded glass granular on the shear capacity of mortar joints was investigated. Hereby, the one-sided retrofitted brick specimen with 20 mm reinforcing layer is named as D1G03 for triplet shear test. Firstly, D1G03-1 was tested. The crack pattern of this specimen can be seen in Fig. 10.

The first cracks on the specimens under shear forces were

experienced in vertical form and occurred in brick-mortar interface. When the imposed load reached close to the shear strength capacity of the specimen, the crack widths increased and the middle block separated from the joint plane.

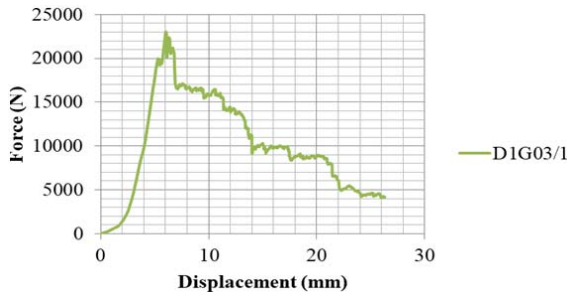
Fig. 11 Force-displacement diagram of the D1G03-1

As shown in Fig. 11, the maximum shear force F_{max} is obtained as 23033 N and the corresponding shear stress value f_v is calculated as 0.209 MPa for specimen of D1G03-1.

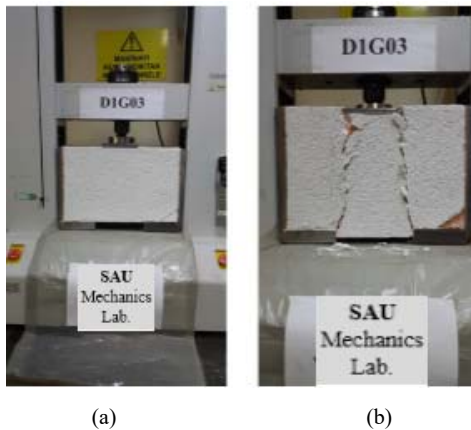
Fig. 12 (a) Initial state and (b) final state of D1G03-2

For the D1G03-2 and D1G03-3 specimens; crack patterns, maximum shear loads and strength parameters were similarly determined. The failure mechanism of the test specimens under the vertical load is shown in Figs. 12 and 14. The maximum shear forces of the second and third sample of the D1G03 test set are equal to 24548 N and 29427 N, respectively (Figs. 13 and 15).

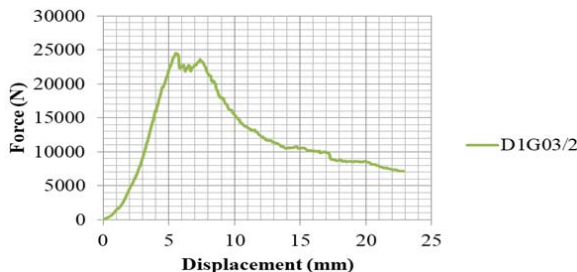
Fig. 13 Force-displacement diagram of the D1G03-2

The values of f_v are 0.220 MPa and 0.267 MPa for D1G03-2

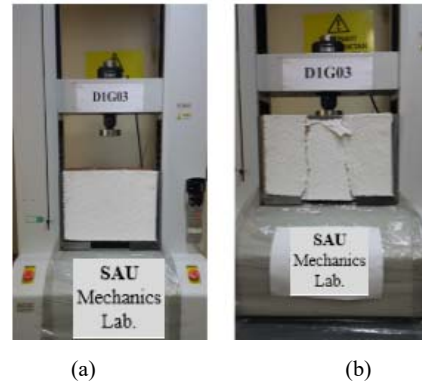
Fig. 14 (a) Initial state and (b) final state of D1G03-3

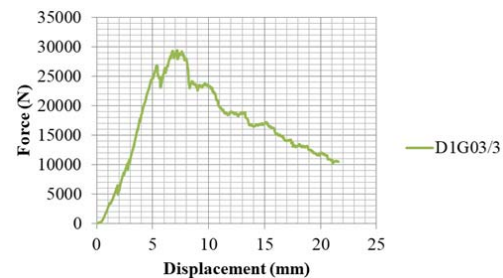
Fig. 15 Force-displacement diagram of the D1G03-3

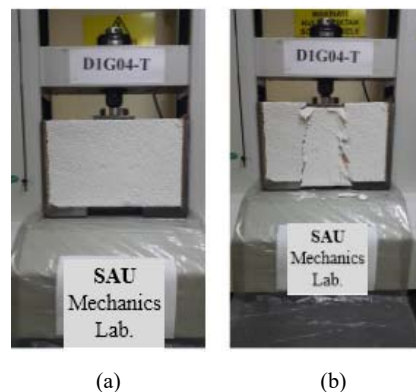
Fig. 16 (a) Initial state and (b) final state of D1G04-T/1

In the final phase of the study, the above mentioned strengthening system was applied to both surfaces of the three specimens and the results were analyzed comparatively. The thickness of the plaster on each surface was considered as 1 cm. The experiment set was named as D1G04-T. Initial and final states of D1G04-T/1 under shear force were in Fig. 16.

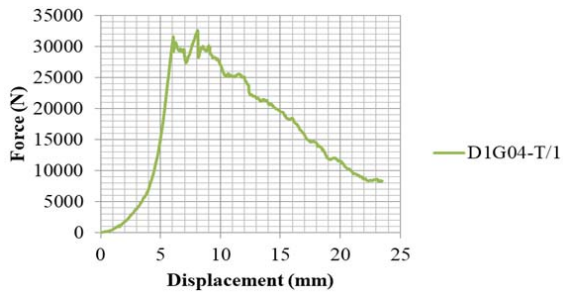
Fig. 17 Force-displacement diagram of the D1G04-T/1

and D1G03-3, respectively. Single-sided retrofitted triplets exhibited more ductile behavior when compared to the reference samples. Furthermore, it was clearly observed that the unilateral strengthening application significantly increased the shear capacity of the masonry building units. The measured value of F_{max} is 32611 N for this case. Also, f_v is calculated as 0.296 MPa. The curve of force-displacement relationship for D1G04-T/1 is depicted in Fig. 17.

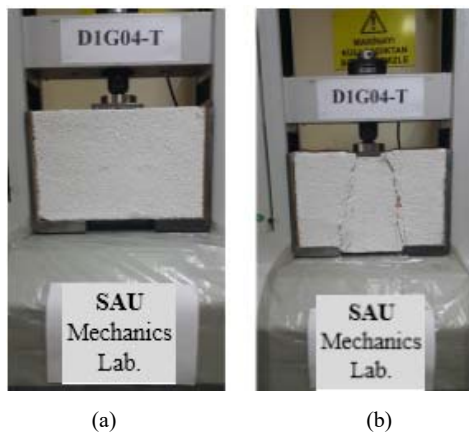
Fig. 18 (a) Initial state and (b) final state of D1G04-T/2

The second and third specimens of the D1G04-T set were also tested. At all specimens in this experiment group, it was obviously seen that the damage started in a similar way to the D1G03 set (Fig. 18).

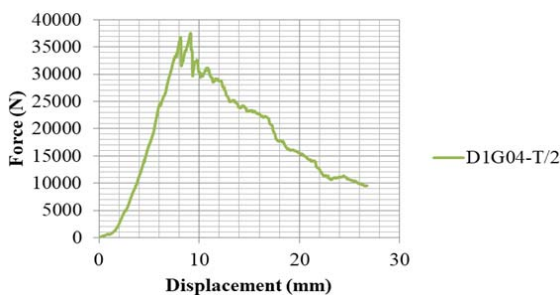
Fig. 19 Force-displacement diagram of the D1G04-T/2

The F_{max} values were determined for these specimens as 37544 N and 36394 N, respectively. The shear strengths were calculated as 0.340 MPa and 0.330 MPa, respectively. The experimental shear force-displacement curve for D1G04-T/2 and D1G04-T/3 are illustrated in Figs. 19 and 21.

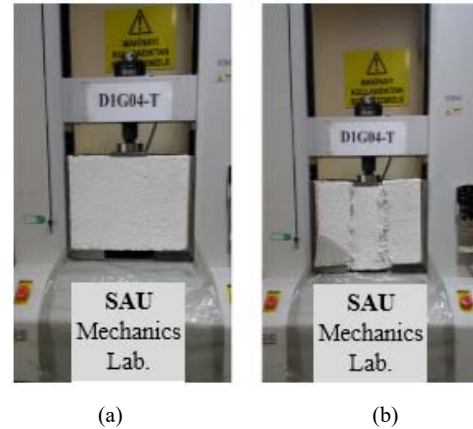
Fig. 20 (a) Initial state and (b) final state of D1G04-T/3

The failure modes of all plastered specimens were similar due to vertical cracks in the direction of loading, which followed the interface between the bricks and joint mortar (Fig. 20).

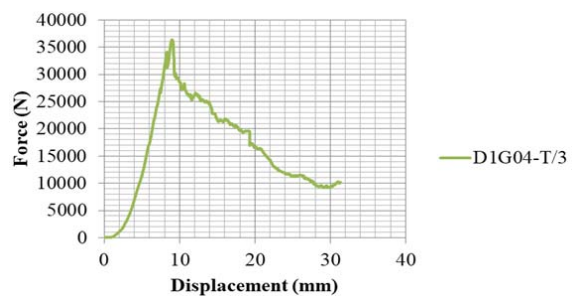
Fig. 21 Force-displacement diagram of the D1G04-T/3
