Use of Short Piles for Stabilizing the Side Slope of the Road Embankment along the Canal

Abstract—This research presents the behavior of slope of the road along the canal stabilized by short piles. In this investigation, the centrifuge machine was used, modelling the condition of the water levels in the canal. The centrifuge tests were performed at 35 g. To observe the movement of the soil, visual analysis was performed to evaluate the failure behavior. Conclusively, the use of short piles to stabilize the canal slope proved to be an effective solution. However, the certain amount of settlement was found behind the short pile rows.

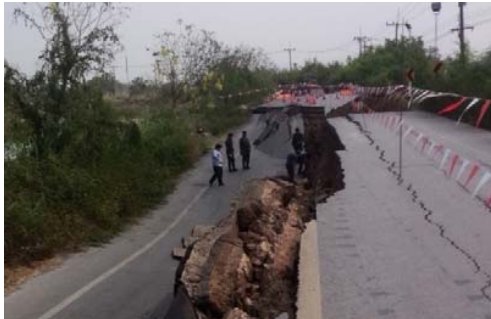
Fig. 1 Road along the canal no.13 collapsed

On the 2nd of March 2016, the road embankment along Canal no.13 (Klong 13) collapsed (Fig. 1) for approximately 100 m long. The canal at the failure area was found to be nearly dry, and a large water pond was found to be located near the failure section (Fig. 2).

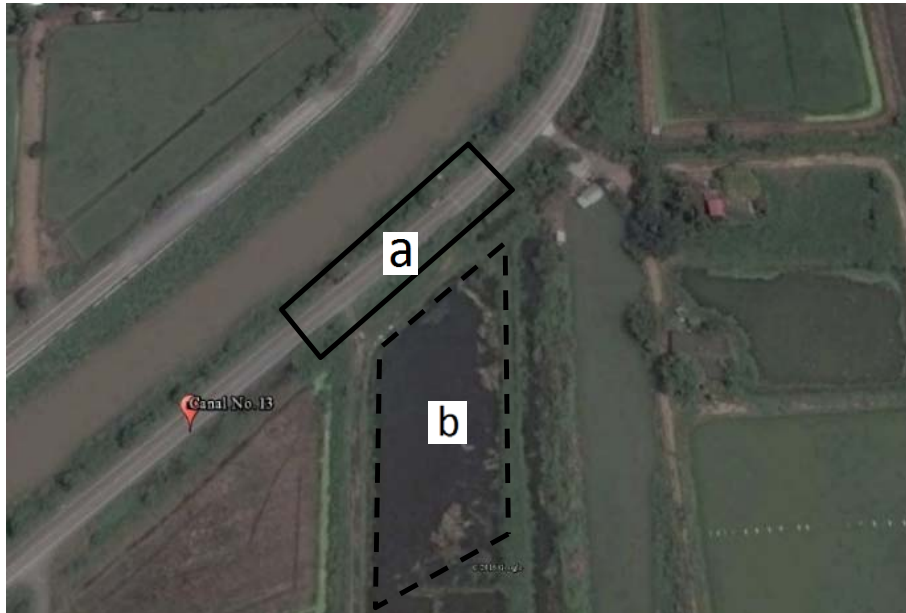
Fig. 2 a. The collapsed areas b. Shrimp ponds

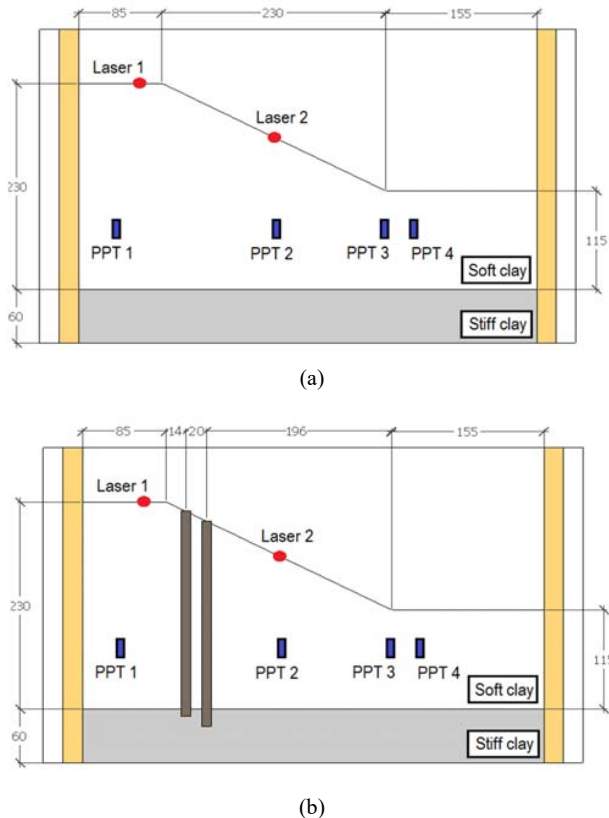
Fig. 3 The setup of instrumentations in both boxes (a) The box without reinforced piles (b) The box with reinforced piles

- PIV Camera: Located in front of the box to record the direction of soil movement.
- Laser: Record the settlement data.
- Pore Pressure water (PPT): Record the changes of water pressure.
- Water Tanks with flow control valve: Control the head of water while testing and the flow rate.

Fig. 3 illustrates the setup of instrumentations of both boxes.

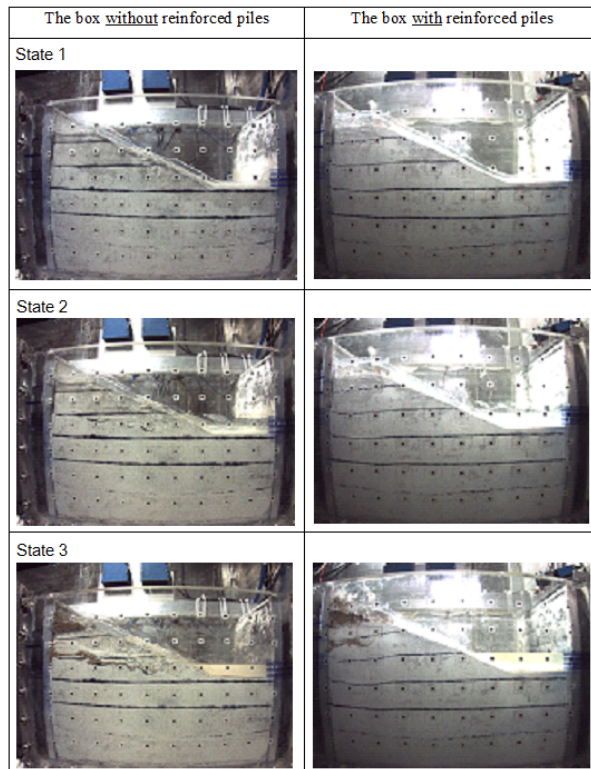
Fig. 6 The results of testing

The results of the centrifuge test can be classified into three states as (Fig. 6):

- State 1: Initial state, after soil preparation but before being spun up to 35 g.
- State 2: Water level changes according to test plan but before CDG was added:
 1. In the box without reinforced piles, the soil moved down the slope, and the failure plane was found.
 2. In the box with reinforced piles, the soil behind short pile rows moved vertically, but no failure plane was observed.
- State 3: The final step, CDG was added to represent the embankment road:
 1. In the box without reinforced pile, the slope failure was clearly shown (Fig. 7).
 2. In the box with reinforced pile, the soil behind short pile rows moved vertically. Although, more settlement was found and the piles moved slightly, failure plane was not found (Fig. 8).

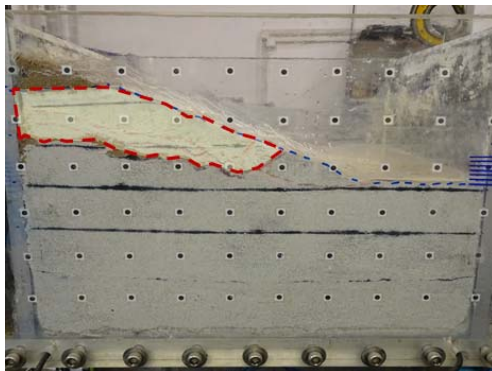
Fig. 7 Failure plane in the box without reinforced piles

1. The slope failure was found in the unreinforced slope when groundwater was raised up because of the delay flow.
2. Reinforced piles forced the road embankment to road embankment moved vertically instead of horizontally.
3. CDG weight exerted on the road embankment affected both horizontal and vertical movements.
4. The alternated piles presented the piles group behaved as a retaining wall.

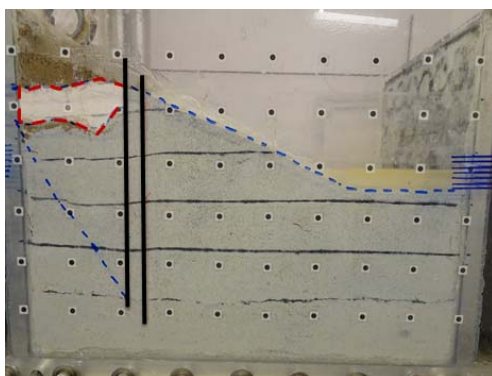
Fig. 8 The vertical settlement area in the box with reinforced piles
