Vibration, Lubrication and Machinery Consideration for a Mixer Gearbox Related to Iran Oil Industries

Abstract—In this paper, some common gearboxes vibration analysis methods and condition monitoring systems are explained. In addition, an experimental gearbox vibration analysis is discussed through a critical case history for a mixer gearbox related to Iran oil industry. The case history also consists of gear manufacturing (machining) recommendations, lubrication condition of gearbox and machinery maintenance activities that caused reduction in noise and vibration of the gearbox. Besides some of the recent patents and innovations in gearboxes, lubrication and vibration monitoring systems explained. Finally micro pitting and surface fatigue in pinion and bevel of mentioned horizontal to vertical gearbox discussed in details.

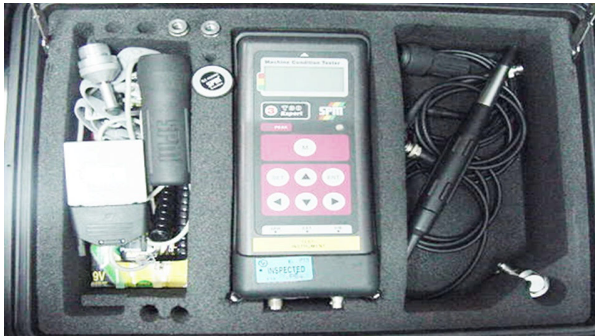
Fig. 2 Shock Pulse Transducer with Probe TRA-22 and a typical SPM data collector

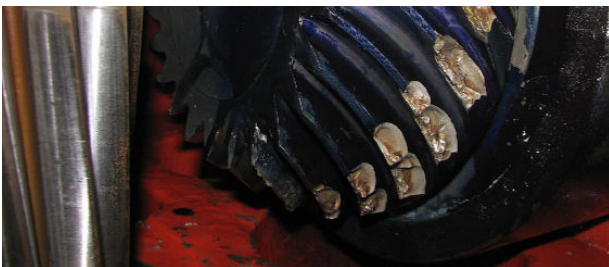
The vibration evidences showed that the pinion damaged seriously and recommended the process to change mixer with spare equipment then the machinery group checked the gearbox pinion and it was damaged in 1/3 of its parts.

Fig. 12 Damaged pinion

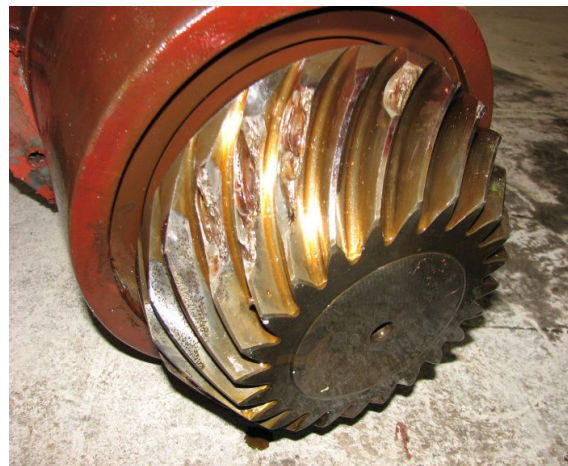
The abnormal noise was increased in gearbox considerably then the monitoring group decided to recommend the machinery to check the gears. Both pinion and bevel was damaged. [17].

Fig. 16 Damaged gear (pinion)

Furthermore, the temperature of gearbox oil should be monitored. The higher amount of temperature could cause increasing in micro pitting rate. The machinery maintenance action Performed to this gear box by new pinion and bevel engaged gears, grinding the gear shaft, PT (there was no crack in new gears), coupling treatment, balancing all gear box rotors, shafts run out checks and treatment, measuring housing input shaft, manufacturing two spacer shims for housing bearing, Assembling bearing housing accurately, cover casing cleaning, changing the O-Rings outlet shaft and oil injection.

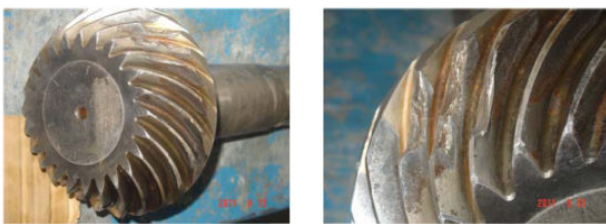
Spare mixer was in rough condition and we had to send that gearbox to machinery workshop. Then we had to continue running of this equipment. The damages developed to other gears teeth with the same mechanical and metallurgical nature and characteristics.

Fig. 18 Damage in gears in the next stage

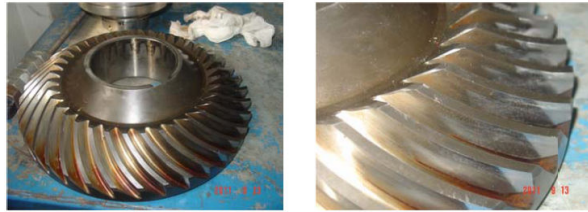
The bevel gear engaged with pinion seemed to be ok but after checking this gear accurately, the microscopic porosities and a light changing in color was visible. That phenomenon was because of higher strength in these kinds of gears [20].

Fig. 19 Bevel gear engaged with pinion
