Wear Behavior of Commercial Aluminium Engine Block and Piston under Dry Sliding Condition

Abstract—In the present work, the effect of load and sliding distance on the performance tribology of commercially used aluminium-silicon engine block and piston was evaluated at ambient conditions with humidity of 80% under dry sliding conditions using a pin-on-disc with two different loads of 5N and 20N yielding applied pressure of 0.30MPa and 1.4MPa, respectively, at sliding velocity of 0.29ms^{-1} and with varying sliding distance ranging from 260m-4200m. Factors and conditions that had significant effect were identified. The results showed that the load and the sliding distance affect the wear rate of the alloys and the wear rate increased with increasing load for both the alloys. Wear rate also increases almost linearly at low loads and increase to a maximum then attain a plateau with increasing sliding distance. For both applied loads the piston alloy showed the better performance due to higher Ni and Mg content. The worn surface and wear debris was characterized by optical microscope, SEM and EDX analyzer. The worn surface was characterized by surface with shallow grooves at loads whi

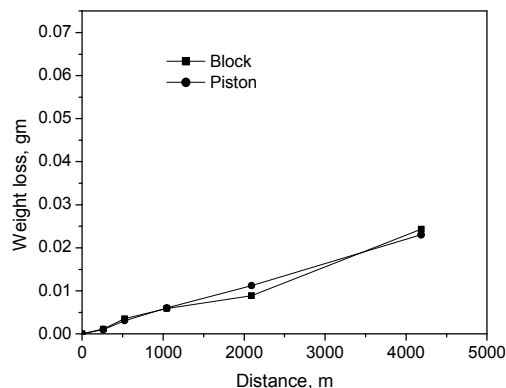
Fig. 1 Variation of weight loss (gm) with the variation of sliding distance (m) at applied pressure of 0.30MPa (Load 5N) and sliding velocity 0.29 ms^{-1}

Figs. 1 and 2 elucidate the variation of weight loss with the variation of sliding speed for both engine block and piston alloy at applied pressure of 0.30MPa (Normal Load 5N) and 1.4MPa (Normal Load 20N) respectively. Moreover, Figs. 3 and 4 depict the variation of wear rate with the variation of sliding speed for both engine block and piston alloy at applied pressure of 0.30MPa (Normal Load 5N) and 1.4MPa (Normal Load 20N) respectively. Other parameters, such as sliding velocity (0.29 ms^{-1}), surface roughness ($2 \mu\text{m}$), and humidity (80%) are identical for these four figures. It can be seen from Fig. 1 that, at lower applied pressure (0.30MPa) the weight loss at all sliding distances vary insignificantly for both block and piston. As the sliding distance increase the weight loss increases for both the alloys. At relatively higher applied pressure (1.4MPa) both the alloys show higher weight loss as compared to weight loss at low load and at all sliding distances (Fig. 2). However, for higher applied pressure, differences in weight loss values for block and piston are evident. The block showed higher weight loss at relatively low and high ends of sliding distance.

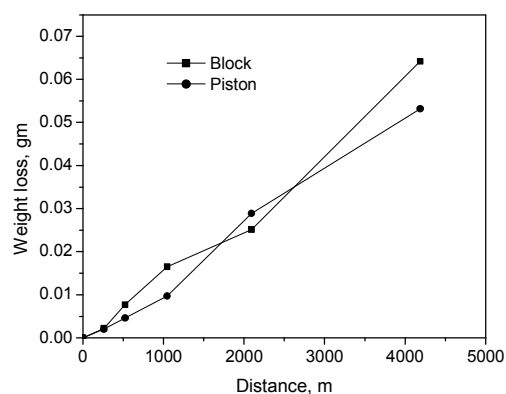
Fig. 2 Variation of weight loss (gm) with the variation of sliding distance (m) at applied pressure of 1.4 MPa (Load 20N) and sliding velocity 0.29 ms^{-1}

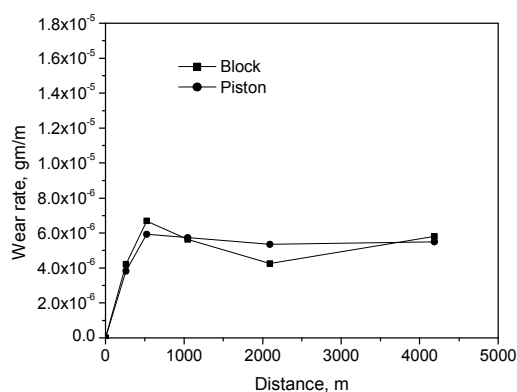
Fig. 3 Variation of wear rate (gm/m) with the variation of sliding distance (m) at applied pressure of 0.30 MPa (Load 5N) and sliding velocity 0.29 ms^{-1}

Figs. 3 and 4 present the wear rate vs. sliding distance plot for both block and piston. At lower applied pressure, it can be observed that wear rate increased at a steep rate initially for both block and piston and after a certain point onwards attained a constant value (Fig. 3). In the case of higher applied pressure, the nature of the curves are quite similar to that of the lower applied load, only difference is in the value of wear rate increased quite significantly for both the alloys (Fig. 4) with block showing higher values than piston at lower and higher realm of the investigated sliding distance range. The competition of frictional heat softening and strain hardening determined the down -and-up trend. Figs. 3 and 4 clearly indicate that the wear rates of both the alloy increased with increasing the load from 5N to 20N. The wear rate for engine block increased from $6 \times 10^{-10} \text{ gm/m}$ (5N) to 1.6×10^{-5} (20N) at sliding distance of 1000 m. For all sliding distances, the wear rate for both the alloys increased one order of magnitude with increasing load from 5N to 20N. For both applied pressures the piston alloy showed lower wear rate as compared to that of block alloy. The result is due to the presence of higher percent of Ni and Mg in piston alloy as seen from the chemical analysis (Table I). Ni forms an intermetallic Al_3Ni which

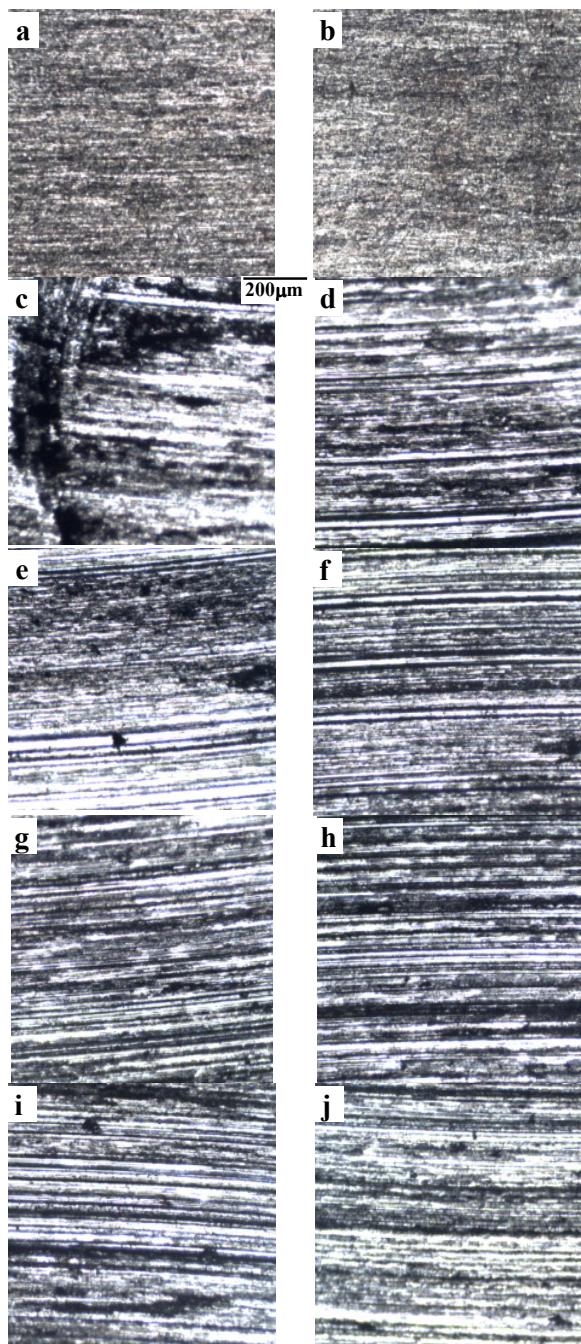
Fig. 5 Optical micrograph of worn surfaces before wear (a) block, (b) piston, after wear at applied pressure of 0.30MPa for 15 min (c) block, (d) piston, for 4 hours (e) block, (f) piston, at applied pressure of 1.40MPa for 15 min (g) block, (h) piston and for 4 hours (i) block (j) piston

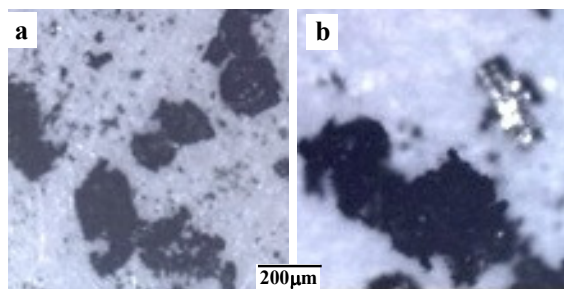
Fig. 6 Wear debris collected from wear test at 1.4 MPa (20N) applied pressure and sliding distance of 4200m for (a) Block, (b) Piston

Fig. 6 shows the typical wear debris collected from the wear test. At low loads the wear debris was equiaxed, laminar and consisted of a small iron content. An increase in the applied normal load formed wear debris of various shapes and sizes. The debris size ranged from a few microns, to a few millimeters. Visually, the debris produced at 20 N appeared in

the form of a dark, brown powder. The micrograph (Fig. 6) shows the debris produced at a load of 20 N was mainly composed of very fine, equiaxed particles but also contained plate-like and ribbon-shaped iron particles in smaller amounts. The fine and large debris particles were a mixture of Al, Si, Fe, and oxygen. The ribbon-shaped particles had an appearance similar to machined chips, and were mainly composed of Fe indicating that they were cut from the steel counter-face.

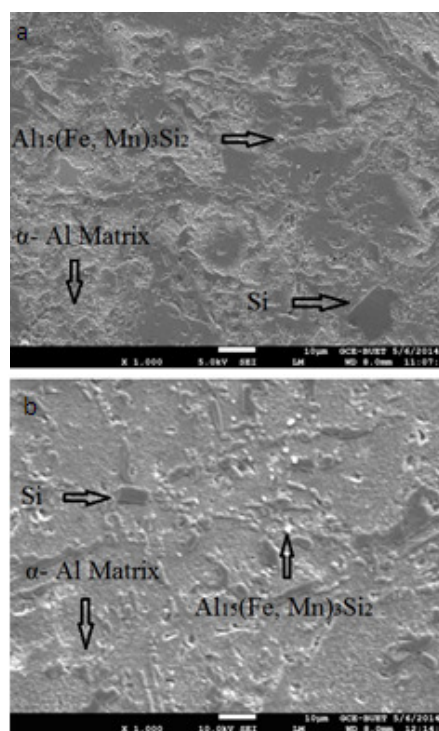
Fig. 7 SEM micrographs of as-received Al-Si (a) block and (b) piston

The SEM micrographs of as-received Al-Si block and piston are shown in Figs. 7 (a) and (b) respectively.

The microstructure consisted of mainly primary Al dendrite, eutectic Si, $Al_{15}(Fe, Mn)_3Si_2$, Mg_2Si and a few number of Fe-rich intermetallic phases on α -Al matrix in the inter-dendritic region. It can be seen that the eutectic Si phase is flake-like

and acicular morphologies. Two type of NiAl_3 phase are the plate-like and needlelike morphologies [7].

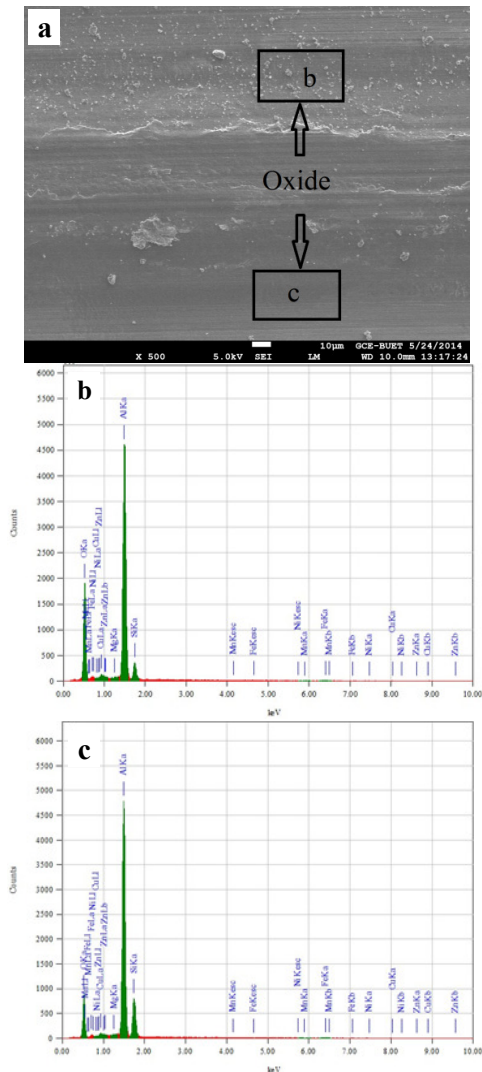
Fig. 8 SEM images of worn surfaces of aluminium engine block after wear at 1.4 MPa applied pressure and sliding distance of 4200m

The SEM micrographs of the worn surfaces of Al-Si block and piston are shown in Figs. 8 and 9. The corresponding EDX profile analysis of the block alloy for the selected area of the SEM is shown in Figs. 8 (b) and (c). The weight percentage of elements found by EDX analysis in these areas were 37.67% O, 51.03% Al, 5.60% Si, 0.75% Mn, 3.74% Fe and 0.76% Cu, 0.44% Zn and, 22.23% O, .04% Mg, 58.01% Al, 15.49% Si, 2.27% Fe, 0.72% Ni, 0.80% Cu, 0.42% Zn respectively.

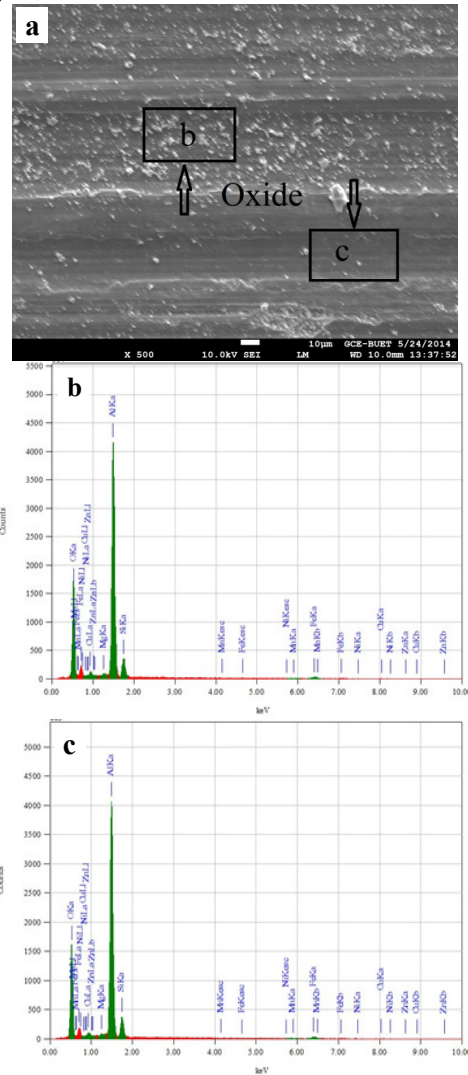
Fig. 9 SEM images of worn surfaces of aluminium engine piston after wear at 1.4 MPa applied pressure and sliding distance of 4200m

The corresponding EDX profile analysis of piston alloy for the selected area of the SEM is shown in Figs. 9 (b) and (c). The weight percentage of elements found in these areas were 33.82% O, 0.12% Mg, 48.00% Al, 5.69% Si, 0.17% Mn, 10.61% Fe, 0.42% Ni, 1.01% Cu, 0.1% Zn and 33.93% O, .15% Mg, 48.45% Al, 5.99% Si, 0.45% Mn, 9.70% Fe, 0.34% Ni,

0.86% Cu, 0.13% Zn respectively. The EDX data clearly reveals the high oxide content in the selected areas which suggest the oxidative wear was the dominant process. In case of block alloy the EDX analysis of the investigated areas reveals that the oxide content is unevenly distributed. Whereas for piston alloy the oxide content is roughly uniform which can be responsible for lower wear rate for the piston alloy. This can be due to the variation of chemical composition of the alloys.
