Experimental Inspection of Damage and Performance Evaluation after Repair and Strengthening of Jiamusi Highway Prestressed Concrete Bridge in China

Ali Fadhil Naser and Wang Zonglin

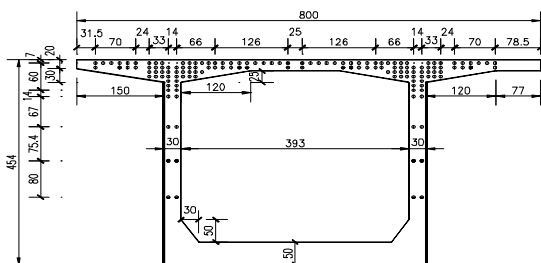
Sticking steel plate method is applied to strengthen the damaged parts in the top of box girders and corbels. The results of inspection show that the color of the overflowing glue near the edge of steel plates is consistence and the

hardening degree is good. The effective bonding area is more than 90%, indicating that the quality of sticking steel plate reaches to the designed requirement.

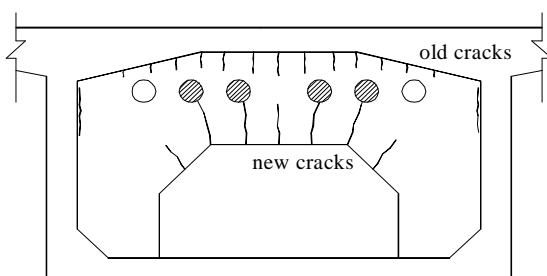
Chemical grouting method to plug all the visible cracks in web of box girders, diaphragm beam of pier top, corbels of T-shape cantilever structure, and corbel of hanging beams. According to inspection results, the crack grouting is dens, the surface of the grouting is regular, and the appearance of grouting area is clean. There are not new cracks in the grouting area, indicating that the quality of cracks grouting in good state. For anchor beam, there are more than10 cracks before application of tension force in external prestressing tendons in the concrete of anchor beam. The length of cracks ranges between 5cm to 50cm and the width ranges from 0.01mm to 0.2mm. After strengthening, inspection results show that there are a few cracks have some development and there is some new vertical cracks appear in the structure of anchor beam. There are 7 vertical cracks. The length of cracks rang from 0.5cm to 2.5cm and the width rang between 0.1mm to 0.25mm. The new cracks are related with shrinkage of concrete. Therefore, the cracks have not influence on the mechanical properties of the bridge structure, but from the point of durability, the cracks should be sealed. Figs. 3(a) and 3(b) show cracks of anchor beam after strengthening.

Fig. 3 (a) Actual view of anchor beam cracks

Fig. 3 (b) Drawing view of anchor beam cracks

Before strengthening of the bridge structure, there are many cracks within anchor beam. But after strengthening process is completed, there is not visible change in the length and width of cracks and there are not new cracks under experimental load. Therefore, the reason of cracks is not vehicles load, but the cracks are due to concrete shrinkage.

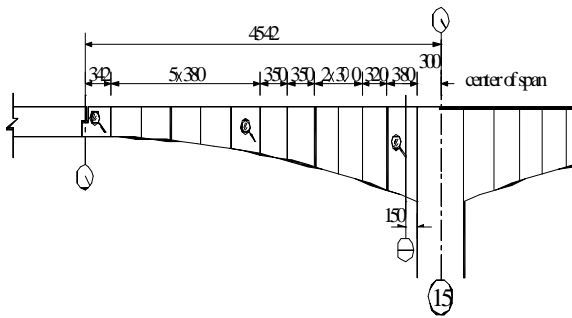
Fig. 6 Experimental span with measuring points
