# Failure Analysis of Methanol Evaporator

D. Sufi Ahmadi, B. Bagheri

*Keywords*—Thermal water hammer, Brittle Failure, Condensate thermal shock

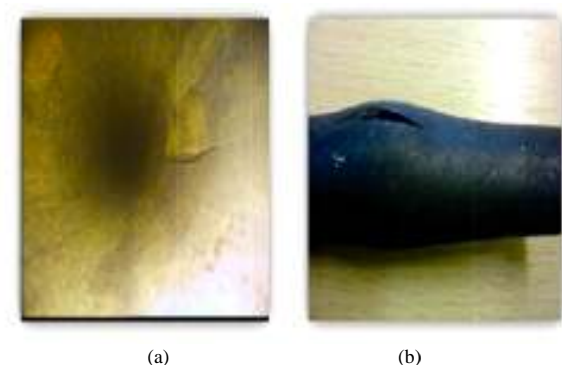
(a)                    (b)

All tubes selected for the study have the same form of failure. Fig. 2 (a) and (b) shows the samples of failures.

Fig. 2 (a) The exterior view and (b) the internal view of failure, As captured by a Video Bore scope

There were no abnormal corrosion products around and inside the failure sections, and the location of failure of damaged tubes in a particular area had not been longitudinal. Effect of brittle fracture that initially was thought to be thermal shock was not seen because this type of tube failure could have been caused by a sudden change in temperature. The other characteristics of the fracture were surface bulge and swell, and there was the short length crack at the head. As Fig.2 also implies the failure to cross is in the swollen form, which means the change of plastic deformation occurred prior to failure. This means the failure is ductile fracture and therefore chemical interactions or thermal shock can be completely ruled out. Generally, tubes failure occurs due to several causes. Therefore, the following investigations were performed in order to find the causes of failure.
