Comparison of Double Unit Tunnel Form Building before and after Repair and Retrofit under in-Plane Cyclic Loading

S. A. Anuar, N. H. Hamid, M. H. Hashim, S. M. D. Salleh

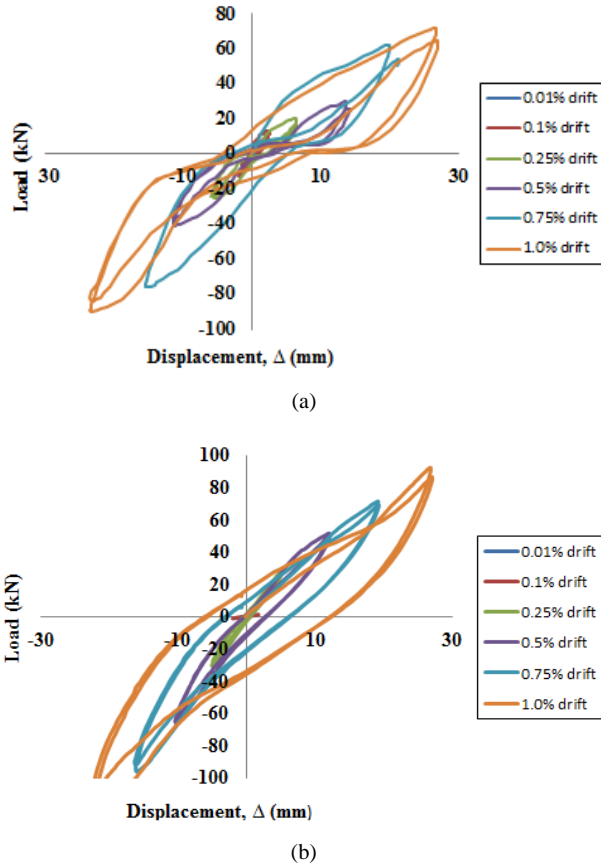
Fig. 2 Hysteresis loop (a) before retrofitting and (b) after retrofitting

Fig. 2 shows the comparison of hysteresis loop of tunnel form building before and after retrofitting up to $\pm 1.0\%$ drift. The enclosed hysteresis loops after retrofitting is bigger than the hysteresis loop before retrofitting. The usage of additional shear wall, angle steel and CFRP sheet give a higher value of lateral strength as compared before retrofitting. The greater

increment of lateral load obtained from the first cycle in pushing direction after retrofitting is 90kN as compared before retrofitting of 70kN. A similar pattern in pulling direction (first cycle) where the lateral load after retrofitting is higher (98kN) than before retrofitting (72kN). It indicates that this retrofit method could increase the lateral strength capacity of TFB in pushing and pulling direction for the first and second cycle.
