The High Temperature Damage of DV – 2 Turbine Blade Made from Ni – Base Superalloy

Juraj Belan, Lenka Hurtalová, Eva Tillová, Alan Vaško, Milan Uhríčik

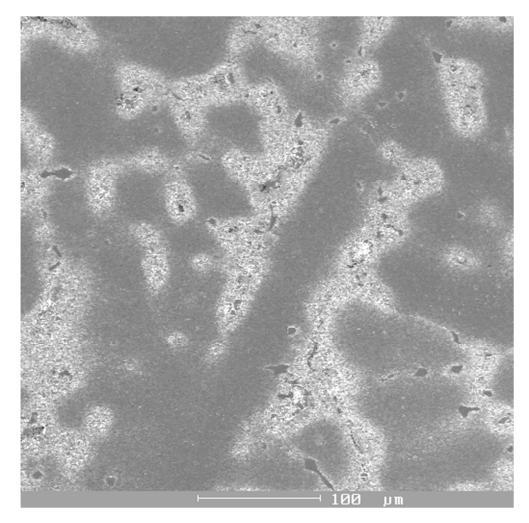
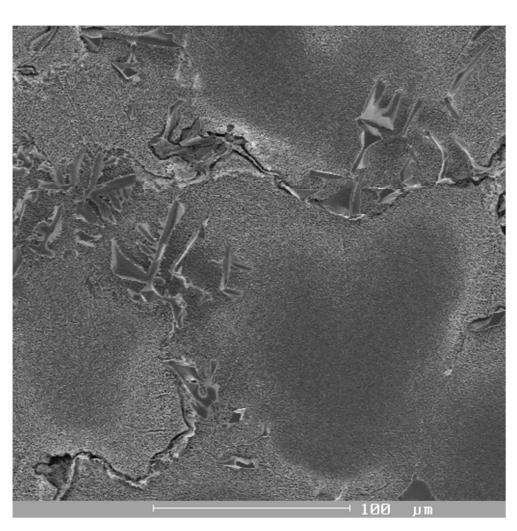
A typical microstructure of ŽS6K Ni – base superalloy as – cast is showed on Figs. 1 and 2. Microstructure of as – cast superalloy contain significant dendritic segregation caused by chemical heterogeneity (Fig. 1 (a)) and particles of primary MC and secondary $M_{23}C_6$ carbides (Fig. 1 (b)). Primary carbides (Ti, Mo, and W)C are presented as an block shaped particles mainly inside of grains. Secondary carbides are presented as a "Chinese" script shape particles on grain boundaries.

Fig. 1 Microstructure of As – cast Ni – base superalloy ŽS6K: (a) dendritic segregation, (b) primary MC and secondary $M_{23}C_6$ carbides, etch. Marble, SEM

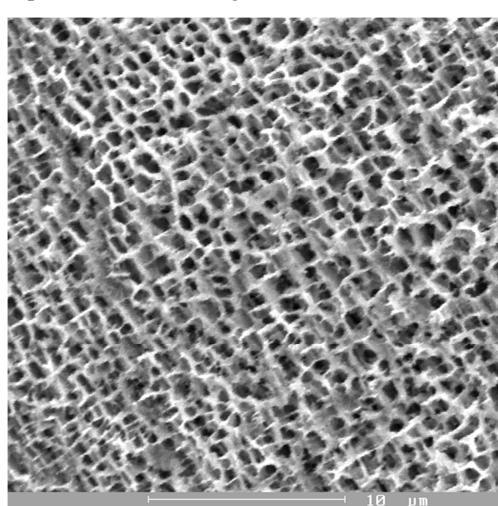
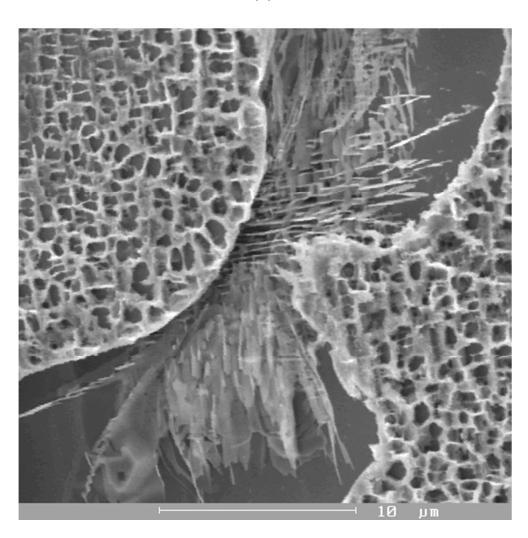
strengthening precipitates, which are a product of artificial age – hardening and has significant influence on mechanical properties and creep rupture life – so called γ' phase (gamma prime, Ni₃(Al, and Ti) – ordered coherent precipitate phase with L1₂ structure), Fig. 2 (a).

The γ' precipitates in precipitate strengthened nickel - base superalloys remain coherent up to large precipitate sizes due to the small lattice mismatch between the matrix phase γ and the γ' precipitates. The γ' precipitates are usually present in volume fractions in the range of 20÷60% depending on the alloy, with a typical precipitate size of 0.25 to 0.5 µm for high temperature applications [7]. Both of these phases, γ (gamma) and γ' (gamma prime) are also creating γ/γ' eutectic, Fig. 2 (b).

Fig. 2 Ni – base superalloy ŽS6K: (a) morphology of γ' precipitate, as - cast, (b) eutectic cell of γ/γ' , etch. Marble, SEM

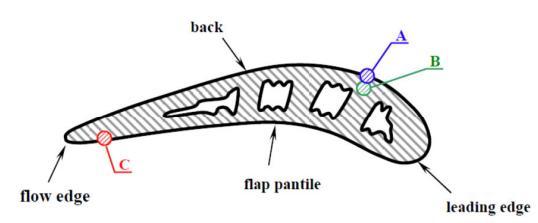
Fig. 3 The cross section of blade and description zones of interests A – checking of the uniformity and homogeneity of alitize layer from 1/4 of blade back B – evaluation of morphology and amount of γ' - phase and grain boundary right under alitize layer C – checking of alitize layer degradation or presence of Cr rich carbides needles.

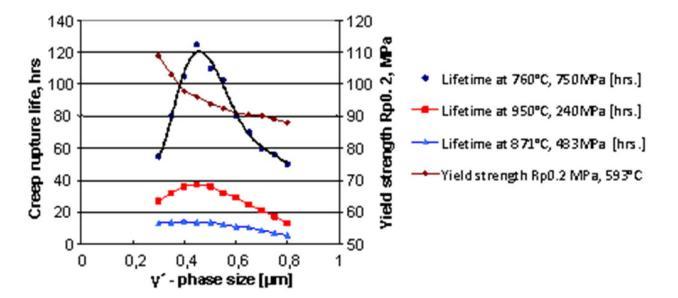
This shape and size changes cause decreasing creep rupture life of alloy, Fig. 7 [8]. As a matter of a fact, creep at high temperatures is driven mainly by diffusion mechanism and deformation rate increases with higher amount of dislocations and their easier slip, which have been previously blocked by tide distribution of cubic morphology of γ' precipitates. Coarsening and spheroiding of γ' precipitates leads to creation of wider channels between γ' particles and dislocations can easier move, so deformation of base material can propagate.

Fig. 7 Influence of γ' - phase size on mechanical properties [8]
