Failure Analysis of Pipe System at a Hydroelectric Power Plant

Ali Gökseml, Barlas Eryürek

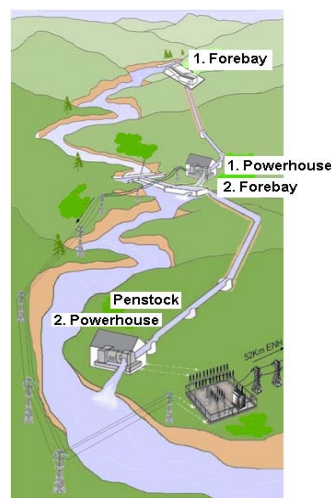
turbine [2], [3]. The turbine turns the generator which is connected to electrical loads whereby electrical power is produced. In the investigated plant, two power systems are placed in succession. Waterfall height is 295.3 m, tunnel length 6419 m, penstock length 390 m, pipe diameter 2 m and flow rate is 11 m³/s (Fig. 1). Failure had occurred at the second powerhouse pipe system.

Fig. 1 Layout of the hydraulic power plant
