Failure Analysis of Pipe System at a Hydroelectric Power Plant

Ali Göksenli, Barlas Eryürek

Keywords— Failure analysis, hydroelectric plant, water-hammer, crack, welding seam.

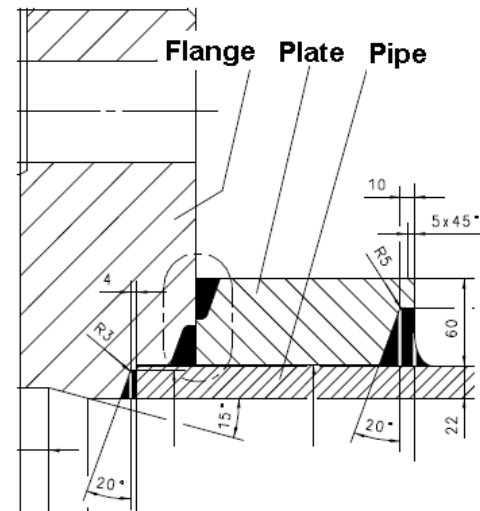
Fig. 5 Technical drawing of the pipe-plate-flange system

The design of the flange-pipe region can be seen in Fig. 5. To strengthen the pipe, a plate is welded at four regions to the pipe and flange. Flange material is steel St 52-3.

After weld seam analysis it is concluded that assembly of the plate-flange-pipe system was not applied correctly. Weld seams 1 and 2 were not applied; only weld grooves of weld 1 and 2 were constituted. The unfilled grooves 1 and 2 acted as inside cracks resulting in a strong notch effect. Stresses raised at this region caused crack propagation to the weld seam 5. By further investigation it is detected that weld groove for weld 3 was prepared incorrect. Groove angle was 70° instead of 20°. This had resulted in an increase of weld thickness from 25 mm to 110 mm, as can be seen in Fig. 10. This has resulted in a decrease of safety of the pipe-plate system, due to the low strength and high brittleness of weld seam according to base material.
