Structural Analysis and Strengthening of the National Youth Foundation Building in Igoumenitsa, Greece

Chrysanthos Maraveas, Argiris Plesias, Garyfalia G. Triantafyllou, Konstantinos Petronikolos

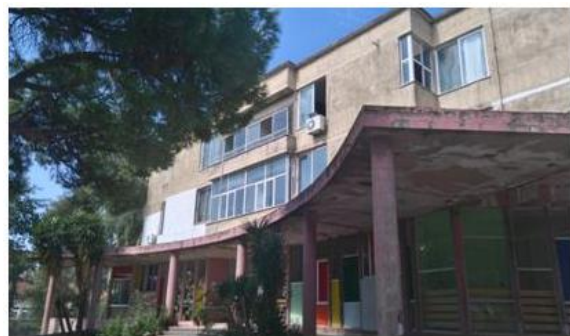
Fig. 1 The National Youth Foundation Building in Igoumenitsa, Greece

All buildings in the newly built complex suffered damage. Specifically: Building I presented:

- Differential subsidence between columns, resulting in rotation and deformation of the building in relation to the central Building II.
- Fractures in the cantilever slabs on the ground floor and the A' floor at support positions.
- Cracking of the lower 10 cm-thick slab of the pilotis ceiling. It is noted that these slabs are of secondary use and act as insulating structural components.
- Fracture of the shared foundation between Buildings I and II and of the corresponding column.

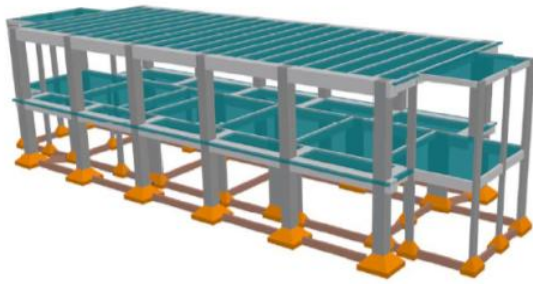
Building IV presented:

- Cracking of the bottom of a folded concrete slab shell of the ceiling of the ground floor.
- Cracking between the supports of beams and columns.
- Cracking between the supports of two basement ceiling beams at a concrete wall.
- Cracking at the opening of a beam.
- Cracking of a ground floor ceiling slab around a column.
- Cracking of circular columns at the basement floor level.

Building IV was first designed as a symmetrical RC structure with two symmetrically protruding parts at its eastern and western boundaries, as illustrated in Fig. 5. It is a two-story building with a balcony that acts as a "loft" and that is to be demolished. The layout varies from level to level. Concrete slabs were used as surface elements for transferring vertical actions on each service level of the structure. They carry vertical loads through a system of beams, followed by columns or concrete walls that go to the ground. The slabs have rectangular cross-sections. The slab of the event venue (with a length of approximately 13 m) was a folded concrete slab shell. It was assumed that the vertical elements of the folded concrete slab shell were the beams of the system and the horizontal parts were the small slabs. The behavior of the simulation after the earthquake proved the ineffectiveness of the latter. Structural meshes of the standard dimensions used in Building II had been used as steel reinforcement, producing the problem of cross-section loss in corrosive environments that is mentioned above. The slabs were 15 cm-thick, which is considered sufficient for usual length of 4 m, but for Building IV where slabs often exceeded 6 m in length, this thickness is marginal for ensuring the required slenderness. Beams were reinforced with marginal quantities of steel, which often resulted in under-reinforced elements.

- Two frames in the East–West direction within the story
- Two frames in the North–South direction within the story (and two additional lateral frames)
- Four frames in the East–West direction on the ground floor
- multiple frames in the North–South direction on the ground floor

Fig. 5 Illustration of the structural layout of Building IV

The retrofitting techniques of the initial study focused on the installation of strong North–South beams on the ground floor that strengthened the diaphragmatic function of this level even though the connection points with the existing beams did not ensure good function for the nodes. Tensile tendons were installed on the tops of the perimeter columns of the folded concrete slab shell of the ground floor ceiling. Columns were strengthened via concrete jacketing.
