# Railway Crane Accident: A Comparative Metallographic Test on Pins Fractured during Operation

Thiago Viana

**Keywords**—Crane, fracture, pin, railway.

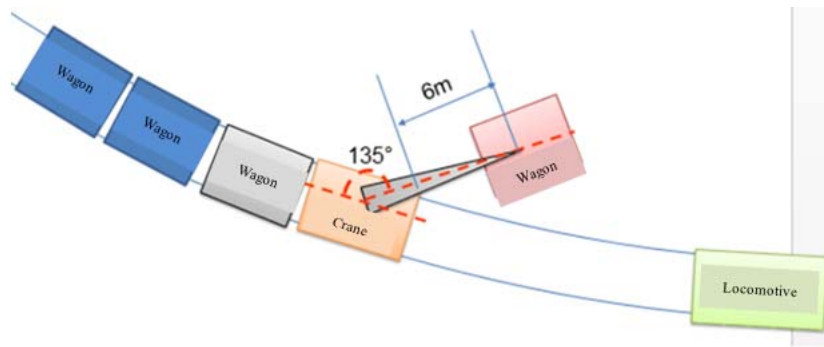
Fig. 2 Schematic diagram of formation of the rescue train during the fracture of the pins and fall of the crane hoist

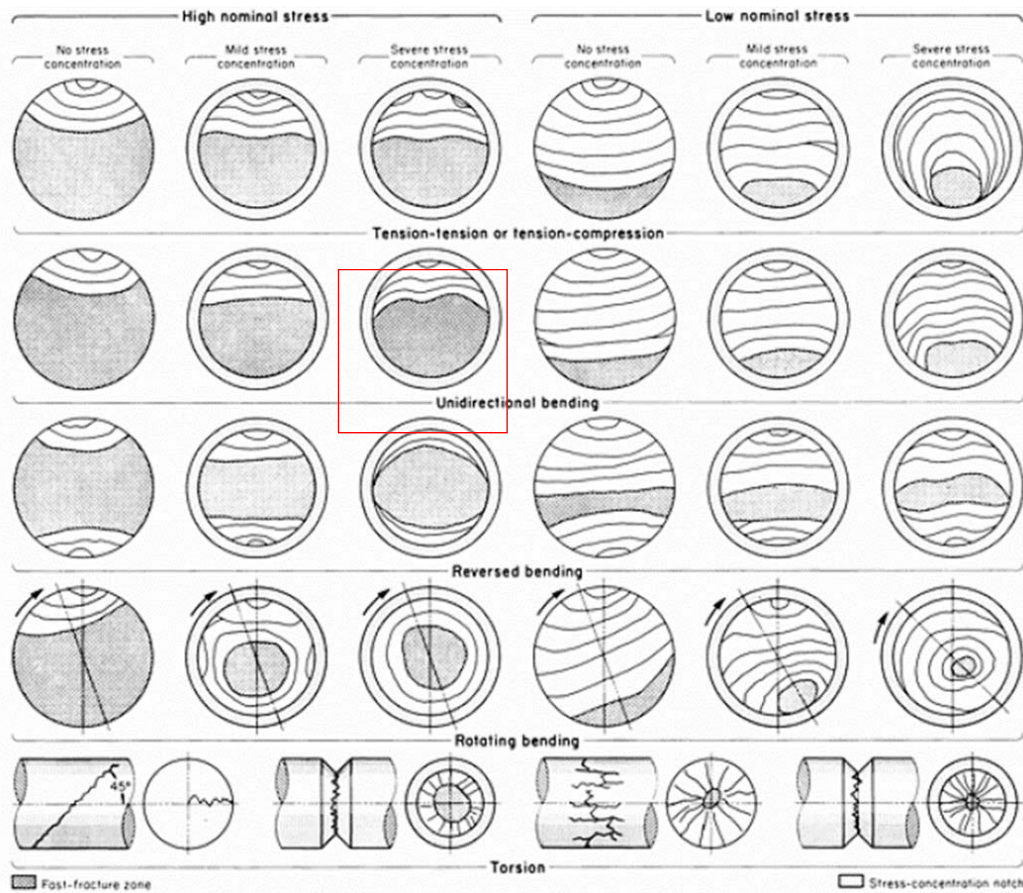
Fig. 4 Schematic diagram to aid in the definition of fatigue fracture type in components with circular cross-section [7]

The schematic drawing highlighted by the red square in Fig. 4 presented in the literature review is similar to the fracture of pin 1. This figure shows that there is a severe stress
