# Causes of Rotor Distortions and Applicable Common Straightening Methods for Turbine Rotors and Shafts

Esmaeil Poursaeidi, Mostafa Kamalzadeh Yazdi

**Key words**—Distortion, FEM, Hot Spot Area, Rotor Straightening

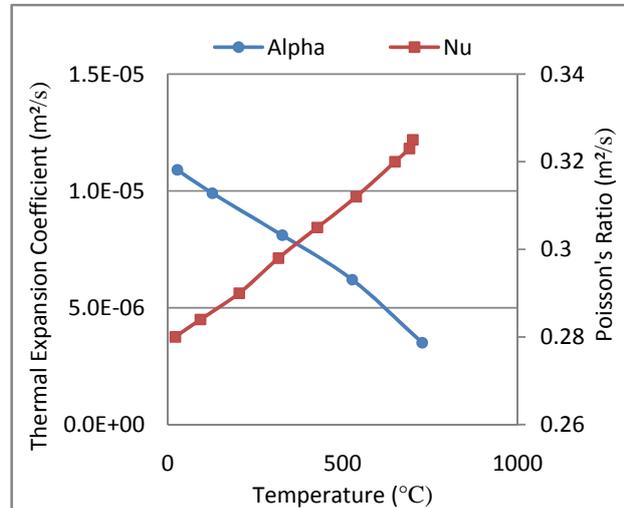
Fig. 5 Nonlinear material properties of the rotor

various models. Thermal expansion coefficient and poisson's ratio were modeled as shown in Fig. 5 Also other parameters such as thermal conductivity, specific heat, mass density and elastic modules were defined considering rotor material properties at different temperatures. Initial temperature assumed as a uniform temperature of  $21^{\circ}\text{C}$ .
