# Diagnosis of Intermittent High Vibration Peaks in Industrial Gas Turbine Using Advanced Vibrations Analysis

Abubakar Rashid, Muhammad Saad, Faheem Ahmed

**Abstract**— This paper provides a comprehensive study pertaining to diagnosis of intermittent high vibrations on an industrial gas turbine using detailed vibrations analysis, followed by its rectification. Engro Polymer & Chemicals Limited, a Chlor-Vinyl complex located in Pakistan has a captive combined cycle power plant having two 28 MW gas turbines (make Hitachi) & one 15 MW steam turbine. In 2018, the organization faced an issue of high vibrations on one of the gas turbines. These high vibration peaks appeared intermittently on both compressor's drive end (DE) & turbine's non-drive end (NDE) bearing. The amplitude of high vibration peaks was between 150-170% on the DE bearing & 200-300% on the NDE bearing from baseline values. In one of these episodes, the gas turbine got tripped on "High Vibrations Trip" logic actuated at  $155\mu\text{m}$ . Limited instrumentation is available on the machine, which is monitored with GE Bently Nevada 3300 system having two proximity probes installed at Turbine NDE, Compressor DE & at Gen

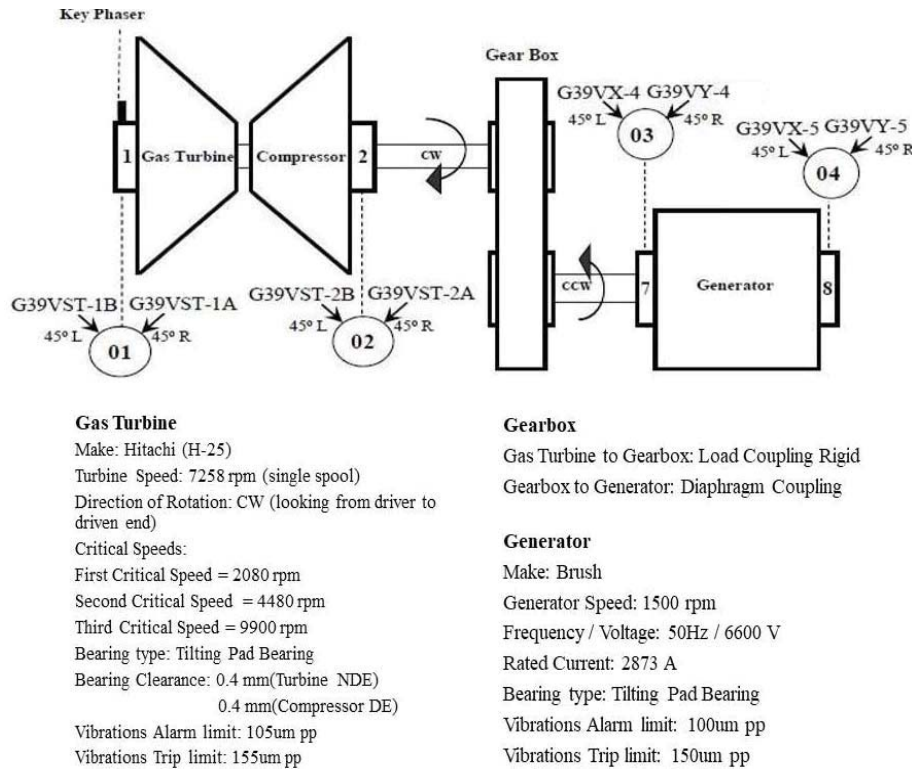
Fig. 3 Details used for route creation in ADRE DSP 408

Vibration peaks was observed during steady state data recorded on 1<sup>st</sup> November 2018. Vibration peak was recorded at 1435hrs up to  $40.09$  &  $35.54\mu\text{m pp}$  at Turbine Bearing#01 against normal vibrations of  $22$  &  $24\mu\text{m pp}$  & at Turbine Bearing#02 up to  $64.09$  &  $58.98\mu\text{m pp}$  against its normal trend of  $43$  &  $45\mu\text{m pp}$ . As per vibration trend data, vibration peaks were observed to appear at different times & the peak lasted for duration of approximately 15 minutes (as shown in Fig. 3).

Based on the data gathered from ADRE SXP, there was a vibration increase with high 1X rpm response & 1X phase change [6], [7] is most probably suspected due to intermittent rubbing either in Turbine NDE bearing or bearing seals. Rubbing in the bearing oil (labyrinth) seal may be caused by

build-up of deposits resulting in localized reduction in seal clearance. Carbon deposits may be formed if lubricating oil comes in contact with high temperature causing oil to overheat. This may cause intermittent contact of rotor with deposits resulting in high vibration which tends to become normal upon clearance of deposits; however, vibration cycle may be repeated upon formation of new deposits.
