# Failure Analysis of Pipe System at a Hydroelectric Power Plant

Ali Göksenli, Barlas Eryürek

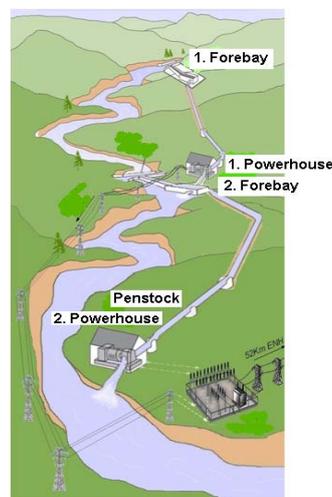
Fig. 1 Layout of the hydraulic power plant

turbine [2], [3]. The turbine turns the generator which is connected to electrical loads whereby electrical power is produced. In the investigated plant, two power systems are placed in succession. Waterfall height is 295.3 m, tunnel length 6419 m, penstock length 390 m, pipe diameter 2 m and flow rate is 11 m<sup>3</sup>/s (Fig. 1). Failure had occurred at the second powerhouse pipe system.

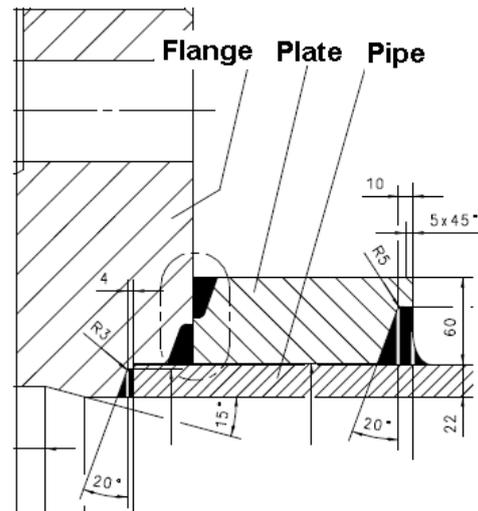
Fig. 5 Technical drawing of the pipe-plate-flange system

The design of the flange-pipe region can be seen in Fig. 5. To strengthen the pipe, a plate is welded at four regions to the pipe and flange. Flange material is steel St 52-3.

To determine stresses occurring at the weld zones during water stream, calculations were carried out. Pipe inside diameter is 1984 mm and wall thickness is 84 mm. Water fall height is 295.3 m, penstock length 390 m and flow rate is 11 m<sup>3</sup>/s. According to the given values, pressure inside the pipe is calculated as 34.6 bars. Stress values at the weld zone is

calculated by considering sections A-A and C-C, which can be seen in Table I.

By static water flow (34.6 bar), stresses acting in welded sections are lower than yield strength and safety factor is high (min. 2.2 in section A-A). To determine the water-hammer effect, Jowkowsky's equation (1) is considered [12]:

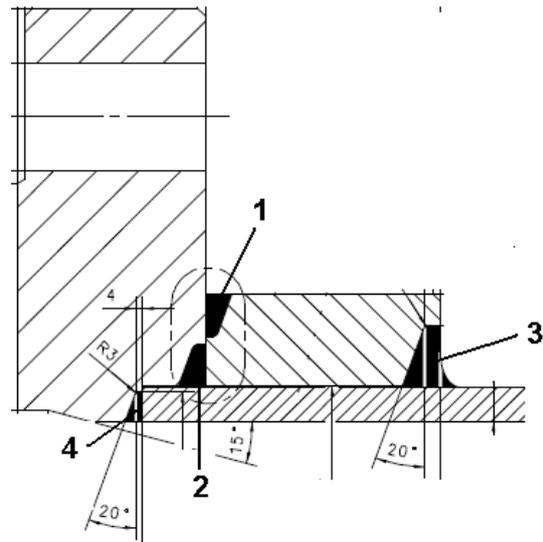
Fig. 7 Assembly drawing of the plate-plate-pipe system

From Table I can be seen, that safety factor in the critical A-A section is 2.2, which demonstrates that inside water pressure during operation could not be the reason for the crack formation. Therefore detailed analysis was carried out on the welded flange, plate and pipe region. Considering technical drawing of the assembly of the plate, as can be seen in Fig. 7, the plate is welded to the pipe and flange by using four weld seams.

Weld seams 1 and 2 are applied between plate and flange, weld 3 between plate and pipe and weld 4 between pipe and flange as can be seen in Fig. 7. For further detailed weld analysis it is investigated if these mentioned four weld seams are applied correct as can be seen in Fig. 7. During observation an additional weld seam, which was not mentioned in assembly drawing in Fig. 7 was detected, as can be seen in Fig. 8.

After weld seam analysis it is concluded that assembly of the plate-flange-pipe system was not applied correctly. Weld seams 1 and 2 were not applied; only weld grooves of weld 1 and 2 were constituted. The unfilled grooves 1 and 2 acted as inside cracks resulting in a strong notch effect. Stresses raised at this region caused crack propagation to the weld seam 5. By further investigation it is detected that weld groove for weld 3 was prepared incorrect. Groove angle was 70° instead of 20°. This had resulted in an increase of weld thickness from 25 mm to 110 mm, as can be seen in Fig. 10. This has resulted in a decrease of safety of the pipe-plate system, due to the low strength and high brittleness of weld seam according to base material.

In consequence of the calculations, it was detected that safety factor is 2.2. But considering water-hammer effect, inside pressure was higher than calculated water pressure of 34.6 bar, which resulted in an increase in stress value and decrease in safety factor values in the flange-pipe region. Considering the incorrect welding seams, resulting in a further increase in stress values, will decrease further the safety factor to a critical value. Therefore reason for the crack formation was water-hammer effect and defective and deficient welding seams.
