Modelling for Roof Failure Analysis in an Underground Cave

Keywords—Forensic analysis, hypothesis modelling, roof failure, seismic monitoring.

This work is the failure analysis of a roof incident in a coal mine in northern Spain and its principal scope is to establish the causes of the accident to improve the security in other mining areas of this exploitation. The followed methodology begins with field works to recognize the area and to characterize geological materials. Then, different hypotheses were developed and a computational simulation was used to evaluate their viability.

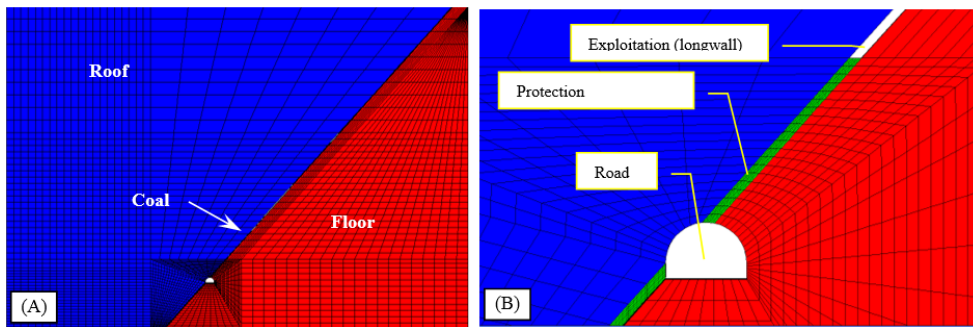
Fig. 4 Model description

The model shown in Fig. 4 has 350 m width and 270 m height. The rest of the ground, until reaching the 700 m depth, was replaced by an equivalent overload. In the figure, it is possible to see the different simulated materials: the layer of coal (in green), the roof of the layer (sandstones, in blue), the wall of the layer (shales, in red), and the simulated works of the exploitation: the tailgate and the workshop of the
