# The High Temperature Damage of DV – 2 Turbine Blade Made from Ni – Base Superalloy

Juraj Belan, Lenka Hurtalová, Eva Tillová, Alan Vaško, Milan Uhrčík

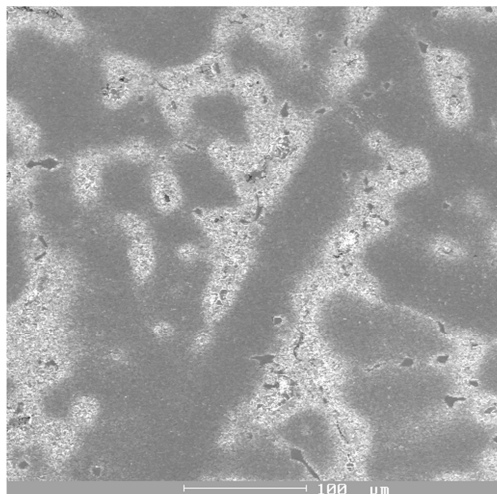
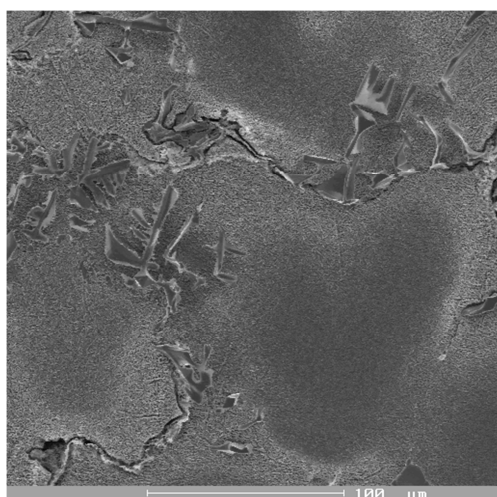
A typical microstructure of ŽS6K Ni – base superalloy as – cast is showed on Figs. 1 and 2. Microstructure of as – cast superalloy contain significant dendritic segregation caused by chemical heterogeneity (Fig. 1 (a)) and particles of primary MC and secondary M<sub>23</sub>C<sub>6</sub> carbides (Fig. 1 (b)). Primary carbides (Ti, Mo, and W)C are presented as an block shaped particles mainly inside of grains. Secondary carbides are presented as a “Chinese” script shape particles on grain boundaries.

Fig. 1 Microstructure of As – cast Ni – base superalloy ŽS6K: (a) dendritic segregation, (b) primary MC and secondary  $\text{M}_{23}\text{C}_6$  carbides, etch. Marble, SEM

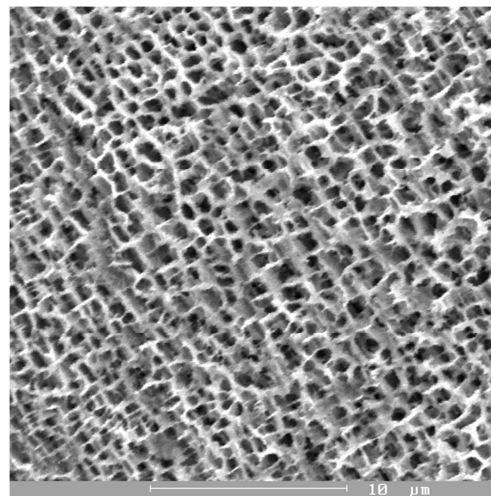
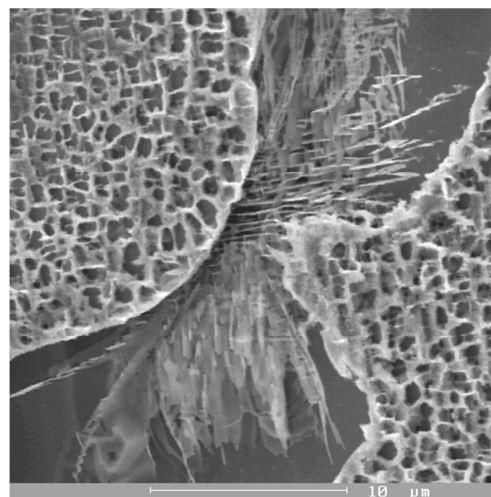
strengthening precipitates, which are a product of artificial age – hardening and has significant influence on mechanical properties and creep rupture life – so called  $\gamma'$  phase (gamma prime,  $\text{Ni}_3(\text{Al, and Ti})$  – ordered coherent precipitate phase with  $\text{L1}_2$  structure), Fig. 2 (a).

The  $\gamma'$  precipitates in precipitate strengthened nickel - base superalloys remain coherent up to large precipitate sizes due to the small lattice mismatch between the matrix phase  $\gamma$  and the  $\gamma'$  precipitates. The  $\gamma'$  precipitates are usually present in volume fractions in the range of 20÷60% depending on the alloy, with a typical precipitate size of 0.25 to 0.5  $\mu\text{m}$  for high temperature applications [7]. Both of these phases,  $\gamma$  (gamma) and  $\gamma'$  (gamma prime) are also creating  $\gamma/\gamma'$  eutectic, Fig. 2 (b).

Fig. 2 Ni – base superalloy ŽS6K: (a) morphology of  $\gamma'$  precipitate, as - cast, (b) eutectic cell of  $\gamma/\gamma'$ , etch. Marble, SEM

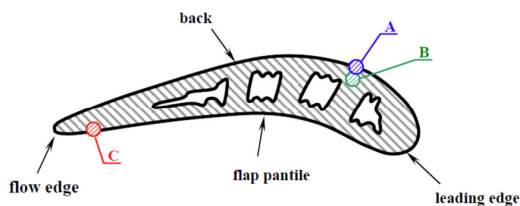
Fig. 3 The cross section of blade and description zones of interests  
A – checking of the uniformity and homogeneity of alitize layer from 1/4 of blade back B – evaluation of morphology and amount of  $\gamma'$  - phase and grain boundary right under alitize layer C – checking of alitize layer degradation or presence of Cr rich carbides needles.

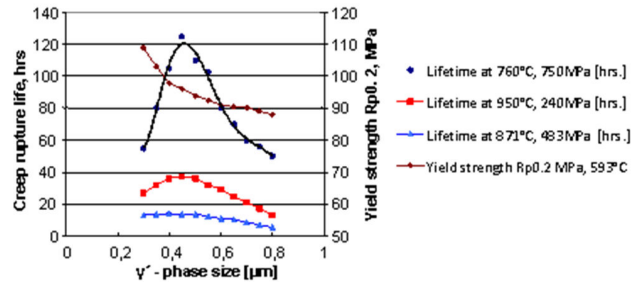
This shape and size changes cause decreasing creep rupture life of alloy, Fig. 7 [8]. As a matter of a fact, creep at high temperatures is driven mainly by diffusion mechanism and deformation rate increases with higher amount of dislocations and their easier slip, which have been previously blocked by tide distribution of cubic morphology of  $\gamma'$  precipitates. Coarsening and spheroiding of  $\gamma'$  precipitates leads to creation of wider channels between  $\gamma'$  particles and dislocations can easier move, so deformation of base material can propagate.

Fig. 7 Influence of  $\gamma'$  - phase size on mechanical properties [8]
