The High Temperature Damage of DV – 2 Turbine Blade Made from Ni – Base Superalloy

Abstract—High pressure turbine (HPT) blades of DV – 2 jet engines are made from Ni – based superalloy. This alloy was originally manufactured in the Soviet Union and referred as ŽS6K. For improving alloy's high temperature resistance are blades coated with Al – Si diffusion layer. A regular operation temperature of HPT blades vary from 705°C to 750°C depending on jet engine regime. An overcrossing working temperature range causes degradation of the protective coating as well as base material which microstructure is formed by the gamma matrix and strengthening phase gamma prime (forming small particles in the microstructure). Diffusion processes inside the material during exposition of the material to high temperatures causes mainly coarsening of the gamma prime particles, thus decreasing its strengthening effect. Degradation of the Al – Si coating caused its thickness growth. All the microstructure changes and coating layer thickness growth results in decreasing of the turbine blade operation lifetime.

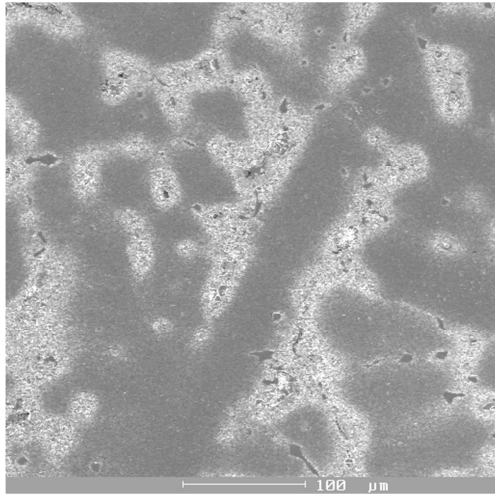
A typical microstructure of ŽS6K Ni – base superalloy as – cast is showed on Figs. 1 and 2. Microstructure of as – cast superalloy contain significant dendritic segregation caused by chemical heterogeneity (Fig. 1 (a)) and particles of primary MC and secondary M₂₃C₆ carbides (Fig. 1 (b)). Primary carbides (Ti, Mo, and W)C are presented as an block shaped particles mainly inside of grains. Secondary carbides are presented as a “Chinese” script shape particles on grain boundaries.

Fig. 1 Microstructure of As – cast Ni – base superalloy ŽS6K: (a) dendritic segregation, (b) primary MC and secondary M_{23}C_6 carbides, etc. Marble, SEM

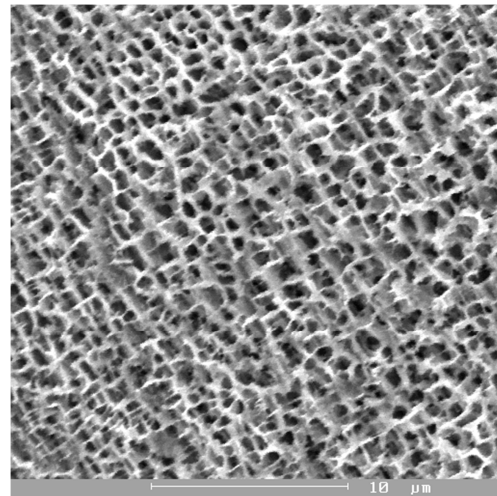
strengthening precipitates, which are a product of artificial age – hardening and has significant influence on mechanical properties and creep rupture life – so called γ' phase (gamma prime, $\text{Ni}_3(\text{Al}, \text{Ti})$ – ordered coherent precipitate phase with L1_2 structure), Fig. 2 (a).

Fig. 2 Ni – base superalloy ŽS6K: (a) morphology of γ' precipitate, as - cast, (b) eutectic cell of γ/γ' , etc. Marble, SEM

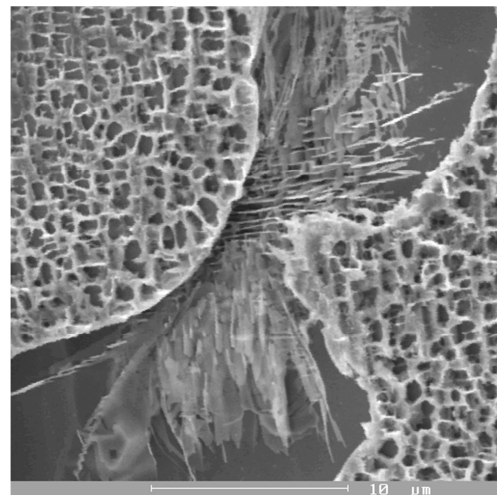
(b)

The γ' precipitates in precipitate strengthened nickel - base superalloys remain coherent up to large precipitate sizes due to the small lattice mismatch between the matrix phase γ and the γ' precipitates. The γ' precipitates are usually present in volume fractions in the range of 20÷60% depending on the alloy, with a typical precipitate size of 0.25 to 0.5 μm for high temperature applications [7]. Both of these phases, γ (gamma) and γ' (gamma prime) are also creating γ/γ' eutectic, Fig. 2 (b).

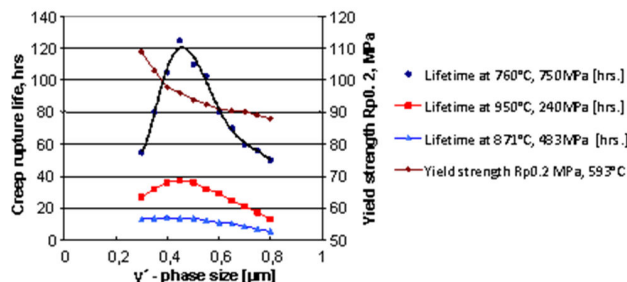
This shape and size changes cause decreasing creep rupture life of alloy, Fig. 7 [8]. As a matter of a fact, creep at high temperatures is driven mainly by diffusion mechanism and deformation rate increases with higher amount of dislocations and their easier slip, which have been previously blocked by tide distribution of cubic morphology of γ' precipitates. Coarsening and spheroiding of γ' precipitates leads to creation of wider channels between γ' particles and dislocations can easier move, so deformation of base material can propagate.

Fig. 7 Influence of γ' - phase size on mechanical properties [8]
