# Directing the Forensic Investigation of a Catastrophic Structure Collapse: The Jacksonville Parking Garage Collapse

W. C. Bracken

**Keywords**—Catastrophic structure collapse, collapse investigation, Jacksonville parking garage collapse, forensic investigation.

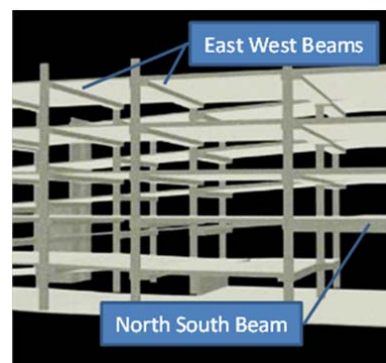
Fig. 1 Beam Configuration

The design called for the beams to run from each outside columns to its corresponding interior column. With one exception, the design only called for beams in the East West direction. The beams were simply reinforced and heavily post-tensioned using up to as many as 78 mono strand tendons. The beams were discontinuous at their center and their dimensions varied. The largest beam measured 84cm (33 in) deep by 152 cm (60 in) wide and the smallest measured 69 cm (27 in) deep by 46 cm (18 in) wide. These beams spanned between 12 m to 17.6 m (40 to 58 ft). The North South beam measured 183 cm (72 in) deep by 76 cm (30 in) wide and spanned 18.3 m (60 ft). An isometric view of the beam configurations is depicted in Fig. 1.

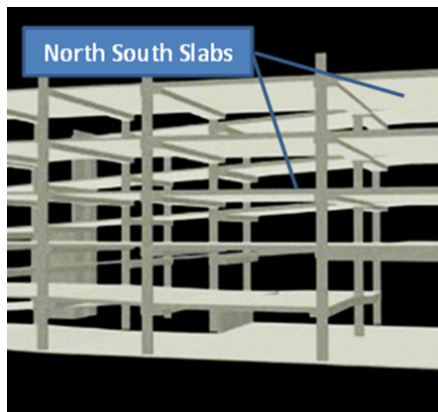
Fig. 2 Slab Configuration

structure, 75 m (246 ft) in length. The slab configuration is depicted in Fig. 2.
