Investigation of Failures in Wadi-Crossing Pipe Culverts, Sennar State, Sudan

Magdi M. E. Zumrawi

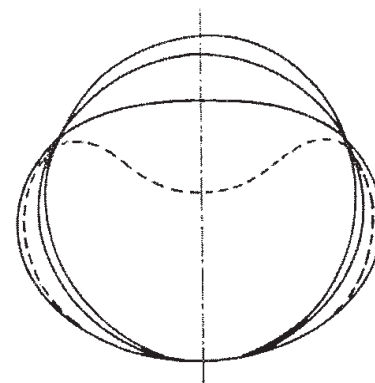
The manner in which a culvert fails by deformation has been described clearly by [9]. The deformation failure description is given below and is illustrated on Fig. 5. A flexible culvert will deform under the vertical backfill load, with vertical diameter decreasing and the horizontal diameter increasing. The outward movement of the sides of the culvert against the backfill develops the passive resistance of the backfill soil which acts horizontally against the culvert. The horizontal passive backfill resistance keeps the actual deformation of the culvert considerably below the amount of culvert would deform if located by the backfill, but without lateral support.

Fig. 5 Stages during deformation of a flexible culvert [9]
