Structural Analysis and Strengthening of the National Youth Foundation Building in Igoumenitsa, Greece

Chrysanthos Maraveas, Argriris Plesias, Garyfalia G. Triantafyllou, Konstantinos Petronikolos

Keywords—Earthquake resistance, pushover analysis, reinforced concrete, retrofit, strengthening.

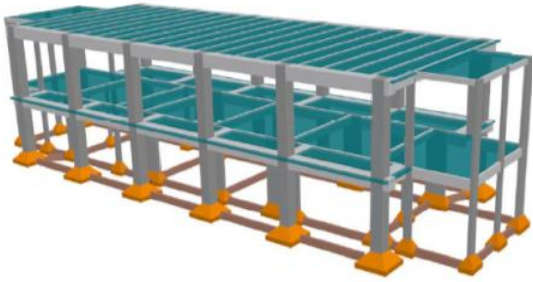
Fig. 5 Illustration of the structural layout of Building IV

Building IV was first designed as a symmetrical RC structure with two symmetrically protruding parts at its eastern and western boundaries, as illustrated in Fig. 5. It is a two-story building with a balcony that acts as a "loft" and that is to be demolished. The layout varies from level to level. Concrete slabs were used as surface elements for transferring vertical actions on each service level of the structure. They carry vertical loads through a system of beams, followed by columns or concrete walls that go to the ground. The slabs have rectangular cross-sections. The slab of the event venue (with a length of approximately 13 m) was a folded concrete slab shell. It was assumed that the vertical elements of the folded concrete slab shell were the beams of the system and the horizontal parts were the small slabs. The behavior of the simulation after the earthquake proved the ineffectiveness of the latter. Structural meshes of the standard dimensions used in Building II had been used as steel reinforcement, producing the problem of cross-section loss in corrosive environments that is mentioned above. The slabs were 15 cm-thick, which is considered sufficient for usual length of 4 m, but for Building IV where slabs often exceeded 6 m in length, this thickness is marginal for ensuring the required slenderness. Beams were reinforced with marginal quantities of steel, which often resulted in under-reinforced elements.

The retrofitting techniques of the initial study focused on the installation of strong North–South beams on the ground floor that strengthened the diaphragmatic function of this level even though the connection points with the existing beams did not ensure good function for the nodes. Tensile tendons were installed on the tops of the perimeter columns of the folded concrete slab shell of the ground floor ceiling. Columns were strengthened via concrete jacketing.
