Fatigue Failure Analysis in AISI 304 Stainless Wind Turbine Shafts

M. F. V. Montezuma, E. P. Deus, M. C. Carvalho

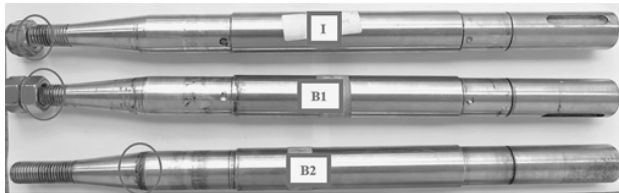
Fig. 3 Wind turbine shafts – Model A3300

Figs. 2 and 3 show the parts as received, the motivating shafts of the analysis, and the failure region, differentiated according to the manufacturer.

Four different types of failures were observed in the visual analysis: two shafts fractured in the thread region (I and B1) and two at the beginning of the thread (RA and AP); two shafts showed flaws in the tapered region of the axis (PP and B2).
